Mississippi Department of Transportation

ADA TRANSITION PLAN

October 1, 2014

UPDATE

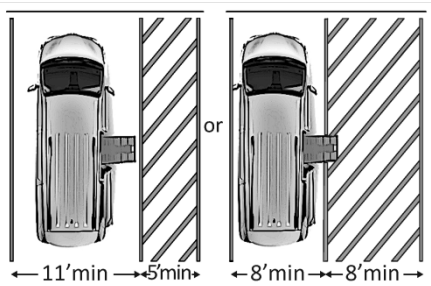
1.5	Is the van accessible space: At least 11 feet wide with an access aisle at least 5 feet wide? Or At least 8 feet wide with an access aisle at least 8 feet wide?	☐ Yes ☒ No Measurement: ☐ Yes ☒ No Measurement:

1991 on RT. 2010 on LT. Photo #:	• Reconfigure to provide van-accessible space(s) • •

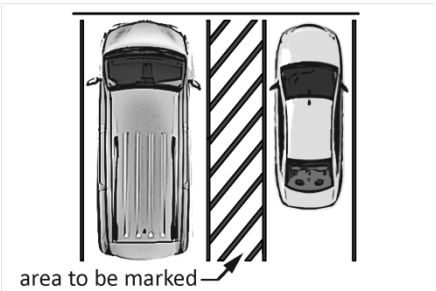
1.7	Are the access aisles marked so as to discourage parking in them?	☐ Yes ☒ No

Photo #:	• Mark access aisles • • The marking method and color may be addressed by state/local requirements

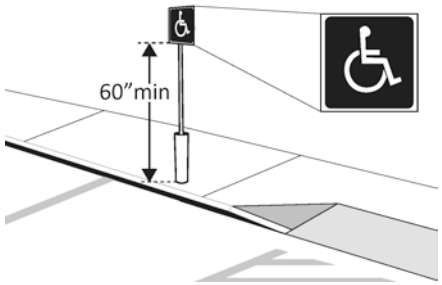
1.9	Do the access aisles adjoin an accessible route?	☐ Yes ☒ No		Photo #:	• Create accessible route • Relocate accessible space •
1.10	Are accessible spaces Identified with a sign that includes the International Symbol of Accessibility? Is the bottom of the sign at least 60 inches above the ground? MDOT say 7' to bottom of sign	☐ Yes ☒ No ☐ Yes ☐ No Measurement:

Photo #:	• Install signs • • The International Symbol of Accessibility is not required on the ground by the 2010 Standards

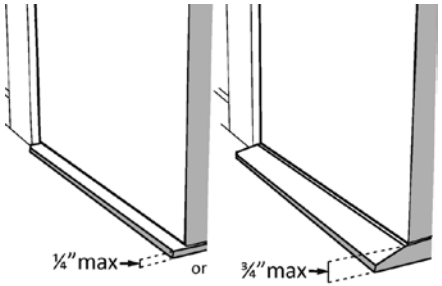
1.43	Is the door threshold edge no more than ¼ inch high? Or No more than ¾ inch high if slope is beveled no steeper than 1:2? Note: The first ¼ inch of the threshold may be vertical; the rest must be beveled.	☐ Yes ☒ No Measurement: 6" ☐ Yes ☐ No Measurement:

Photo #:	• Remove or replace threshold • •
1.44	Is the door equipped with hardware, including locks, that is operable with one hand and does not require tight grasping, pinching, or twisting of the wrist?	☐ Yes ☒ No		Photo #:	• Replace inaccessible knob with lever, loop or push hardware • Add automatic door opener •

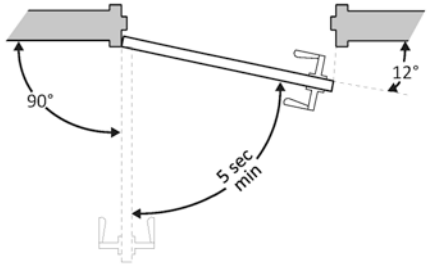
1.46	If the door has a closer, does it take at least 5 seconds to close from an open position of 90 degrees to a position of 12 degrees from the latch? 70 Degrees and 3 min 1991 ADA	☐ Yes ☒ No Measurement: 2

Photo #:	• Adjust closer • •

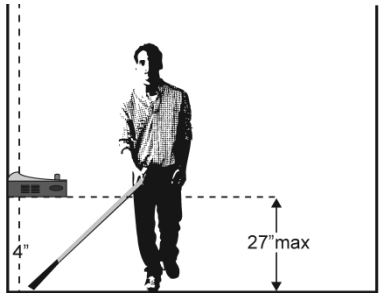
Priority 2 – Access to Goods & Services				Comments	Possible Solutions
Interior Accessible Route *(2010 Standards – Ch.4)*					
2.8	Do all objects on circulation paths through public areas, e.g. fire extinguishers, drinking fountains, signs, etc., protrude no more than 4 inches into the path? Or If an object protrudes more than 4 inches, is the bottom leading edge at 27 inches or lower above the floor?	☐ Yes ☒ No Measurement: 21" ☐ Yes ☒ No Measurement: 32"	 Or

Photo #: 	• Remove object • Add tactile warning such as permanent planter or partial walls •
Sales & Service Counters – banks, stores, dry cleaners, auto repair shops, fitness clubs, etc. *(2010 Standards – 904)*

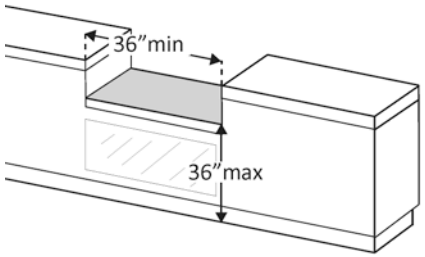
2.76	Is there a portion of at least one of each type of counter that is: No higher than 36 inches above the floor? At least 36 inches long?	☒ Yes ☐ No Measurement: 34" ☐ Yes ☒ No Measurement: 14"

Photo #: 	• Lower section of counter • Lengthen section of counter •

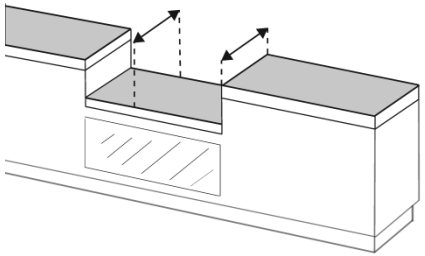
2.77	Does the accessible portion of the counter extend the same depth as the counter top?	☐ Yes ☒ No Measurement:

Photo #: 	• Alter accessible portion • •
2.80	For a forward approach: Do no less than 17 and no greater than 25 inches of the clear floor space extend under the accessible length of the counter?	☐ Yes ☒ No Measurement: 13"

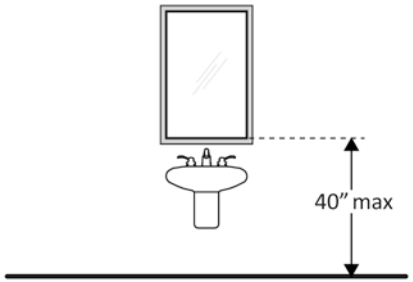
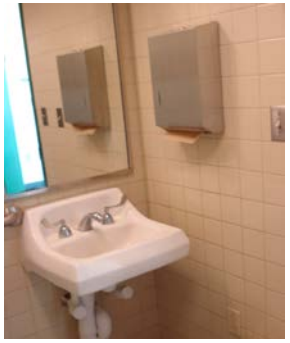
Priority 3 – Toilet Rooms				**Comments**	**Possible Solutions**
Signs at Toilet Rooms *(2010 Standards – 703)*					
3.19	If the mirror is over a lavatory or countertop, is the bottom edge of the reflecting surface no higher than 40 inches above the floor?	☐ Yes ☒ No Measurement: 42"

* If installed before 3/15/2012 and the bottom edge of the reflecting surface is no higher than 40 inches above the floor, lowering the mirror to 35 inches is not required • Lower the mirror • Add another mirror •
Water Closets in Single-User Toilet Rooms and Compartments (Stalls) *(2010 Standards – 603 & 609)* **Note: 2010 Standards refer to toilets as water closets.**

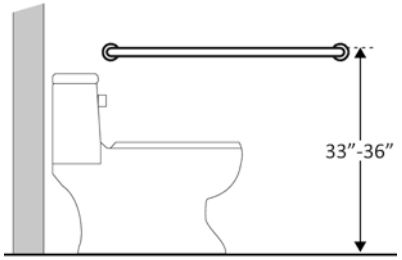
3.33	Is it mounted no less than 33 inches and no greater than 36 inches above the floor to the top of the gripping surface?	☐ Yes ☒ No Measurement: 38"

Photo #: 	• Install grab bar • Relocate grab bar • Relocate objects • * If constructed before 3/15/2012 grab bars do not need to be relocated; there are no space requirements above and below grab bars in the 1991 Standards

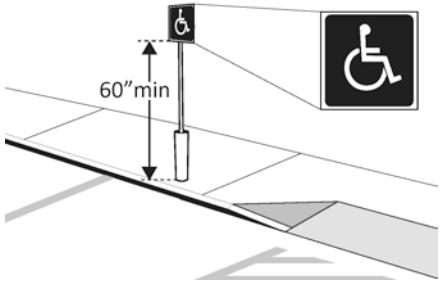
1.10	Are accessible spaces Identified with a sign that includes the International Symbol of Accessibility? Is the bottom of the sign at least 60 inches above the ground? MDOT say 7' to bottom of sign	☒ Yes ☐ No ☐ Yes ☒ No Measurement: 51"

Photo #: 	• Install signs • • The International Symbol of Accessibility is not required on the ground by the 2010 Standards

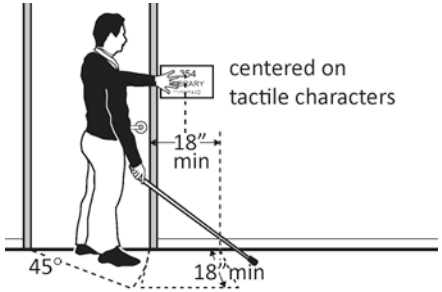
Is the sign mounted: On the wall on the latch side of the door?	☐ Yes ☒ No		Photo #:	
Note: Signs are permitted on the push side of doors with closers and without hold-open devices.				*If constructed before 3/15/2010 and a person may approach within 3 inches of the sign without encountering protruding objects or standing within the door swing, relocation not required
With clear floor space beyond the arc of the door swing between the closed position and 45-degree open position, at least 18 x 18 inches centered on the tactile characters?*	☐ Yes ☒ No Measurement:

*If constructed before 3/15/2012 and mounted no higher than 60 inches to the centerline of the sign, relocation not required

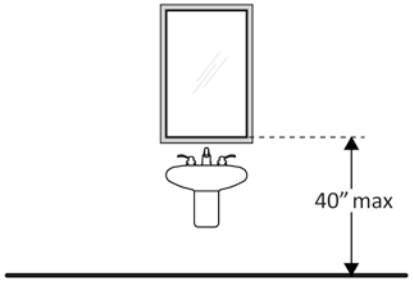
Priority 3 – Toilet Rooms				**Comments**	**Possible Solutions**
In the Toilet Room					
3.19	If the mirror is over a lavatory or countertop, is the bottom edge of the reflecting surface no higher than 40 inches above the floor? Or If the mirror is not over the lavatory or countertop, is the bottom edge of the reflecting surface no higher than 35 inches above the floor?*	☐ Yes ☒ No Measurement: 51" ☐ Yes ☐ No Measurement:

Photo #: 	* If installed before 3/15/2012 and the bottom edge of the reflecting surface is no higher than 40 inches above the floor, lowering the mirror to 35 inches is not required • Lower the mirror • Add another mirror •

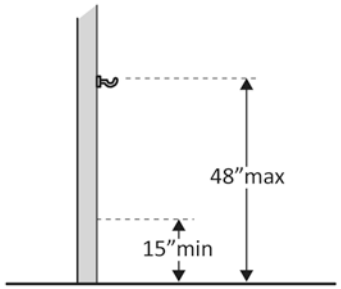
3.20	If there is a coat hook, is it no less than 15 inches and no greater than 48 inches above the floor? 54" for side reach 1991 ADA	☐ Yes ☒ No Measurement: 55"

Photo #: 	• Adjust hook • Replace with or provide additional accessible hook •
Water Closets in Single-User Toilet Rooms and Compartments (Stalls) *(2010 Standards – 603 & 609)* **Note: 2010 Standards refer to toilets as water closets.**

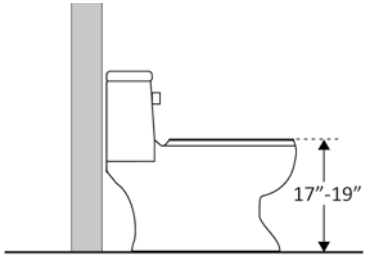
3.32	Is the height of the water closet no less than 17 inches and no greater than 19 inches above the floor measured to the top of the seat?	☐ Yes ☒ No Measurement: 21"

The water closet is on platform. Photo #: See photo above	• Adjust toilet height • Replace toilet •

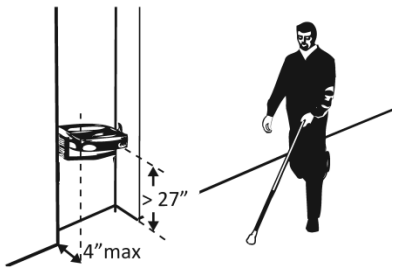
Priority 4 – Additional Access				Comments	Possible Solutions
Drinking Fountains *(2010 Standards – 602)*					
4.9	If the leading (bottom) edge of the fountain is higher than 27 inches above the floor, does the front of the fountain protrude no more than 4 inches into the circulation path?	☐ Yes ☒ No Measurement: 32”

The fountains are in the flow of walking traffic. Photo #: 	• Adjust drinking fountain • Replace drinking fountain • Add tactile warning such as permanent planter or partial walls

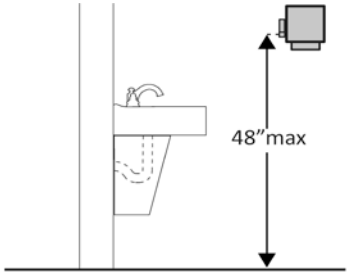
Priority 3 – Toilet Rooms				**Comments**	**Possible Solutions**
Soap Dispensers and Hand Dryers *(2010 Standards – 603)*					
3.29	Are the operable parts of the hand dryer or towel dispenser within one of the following reach ranges: Not over an obstruction: no higher than 48 inches above the floor?	☐ Yes ☒ No Measurement: 53"

Photo #:	• Adjust dispensers • Replace with or provide additional accessible dispensers •
Water Closets in Single-User Toilet Rooms and Compartments (Stalls) *(2010 Standards – 603 & 609)* **Note: 2010 Standards refer to toilets as water closets.**

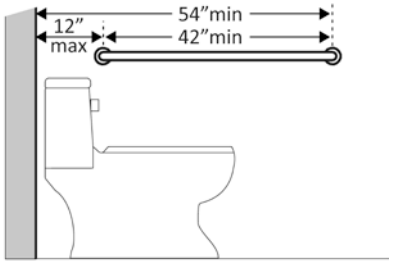
3.33	Does it extend at least 54 inches from the rear wall?	☐ Yes ☒ No Measurement: 49"

Photo #:	• Install grab bar • Relocate grab bar • Relocate objects * If constructed before 3/15/2012 grab bars do not need to be relocated; there are no space requirements above and below grab bars in the 1991 Standards
Toilet Compartments (Stalls) *(2010 Standards – 604)*

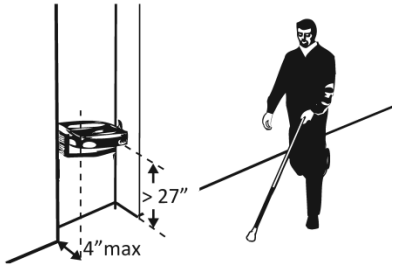
Priority 4 – Additional Access				Comments	Possible Solutions
Drinking Fountains *(2010 Standards – 602)*					
4.9	If the leading (bottom) edge of the fountain is higher than 27 inches above the floor, does the front of the fountain protrude no more than 4 inches into the circulation path?	☐ Yes ☒ No Measurement:

The fountains are in alcove but it is also in a restroom traffic. Photo #:	• Adjust drinking fountain • Replace drinking fountain • Add tactile warning such as permanent planter or partial walls

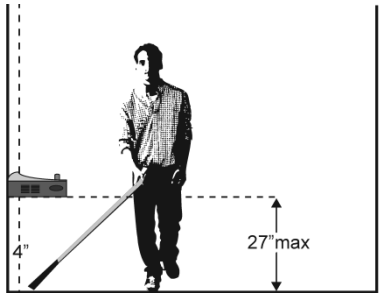
Priority 2 – Access to Goods & Services				**Comments**	**Possible Solutions**
2.8	Do all objects on circulation paths through public areas, e.g. fire extinguishers, drinking fountains, signs, etc., protrude no more than 4 inches into the path? Or If an object protrudes more than 4 inches, is the bottom leading edge at 27 inches or lower above the floor?	☒ Yes ☐ No Measurement: ☐ Yes ☒ No Measurement:	 Or

Photo #: 	• Remove object • Add tactile warning such as permanent planter or partial walls •
Interior Doors – to classrooms, medical exam rooms, conference rooms, etc. *(2010 Standards – 404)*

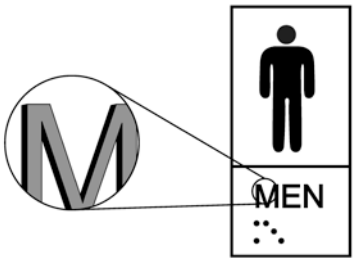
3.5 Do text characters contrast with their backgrounds?	☒ Yes ☐ No

• Install tactile sign • Relocate sign •
Are text characters raised?	☐ Yes ☒ No			
Is there Braille?	☐ Yes ☒ No			
Is the sign mounted:

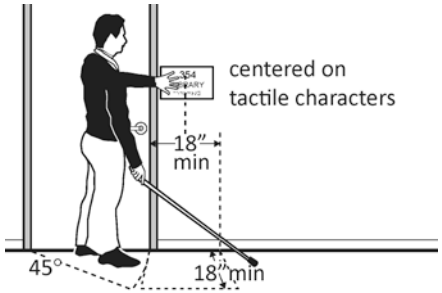
On the wall on the latch side of the door? Note: Signs are permitted on the push side of doors with closers and without hold-open devices.	☐ Yes ☒ No		Photo #:	*If constructed before 3/15/2010 and a person may approach within 3 inches of the sign without encountering protruding objects or standing within the door swing, relocation not required
	With clear floor space beyond the arc of the door swing between the closed position and 45-degree open position, at least 18 x 18 inches centered on the tactile characters? *	☐ Yes ☒ No Measurement:

*If constructed before 3/15/2012 and mounted no higher than 60 inches to the centerline of the sign, relocation is not required
	So the baseline of the lowest character is at least 48 inches above the floor and the baseline of the highest character is no more than 60 inches above the floor? *	☐ Yes ☒ No Measurement: 64"

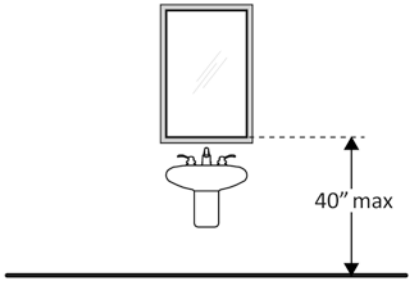
3.19	If the mirror is over a lavatory or countertop, is the bottom edge of the reflecting surface no higher than 40 inches above the floor? Or If the mirror is not over the lavatory or countertop, is the bottom edge of the reflecting surface no higher than 35 inches above the floor?*	☐ Yes ☒ No Measurement: 43" ☐ Yes ☐ No Measurement:

Photo #: 	* If installed before 3/15/2012 and the bottom edge of the reflecting surface is no higher than 40 inches above the floor, lowering the mirror to 35 inches is not required • Lower the mirror • Add another mirror •

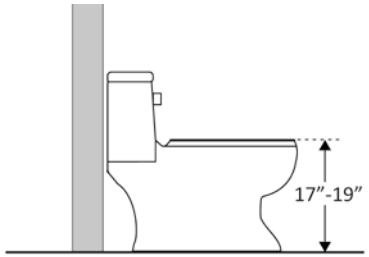
3.32	Is the height of the water closet no less than 17 inches and no greater than 19 inches above the floor measured to the top of the seat?	☐ Yes ☒ No Measurement: 15.5"

Photo #:	• Adjust toilet height • Replace toilet •
3.34	Is there a grab bar at least 36 inches long on the rear wall? Does it extend at least 12 inches from the centerline of the water closet on one side (side wall)? Does it extend at least 24 inches on the other (open) side?	☐ Yes ☒ No Measurement: 21" ☒ Yes ☐ No Measurement: ☐ Yes ☒ No Measurement:

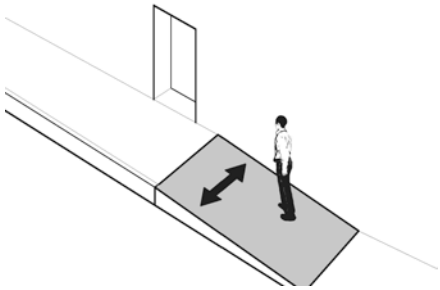
Priority 1 – Approach & Entrance			**Comments**	**Possible Solutions**
Exterior Accessible Route *(2010 Standards – Ch.4)*				
1.18 Is the cross slope no steeper than 1:48? Or 2%	☐ Yes ☒ No Measurement: 2.7 / 2.4 / 3.4

Photo #: 	• Regrade or Reconstruct to 1:48 max. • •
Entrance *(2010 Standards – 404)*				
1.49 Are edges of carpets or mats securely attached to minimize tripping hazards?	☐ Yes ☒ No		Photo #:	• Secure carpeting or mats at edges • •

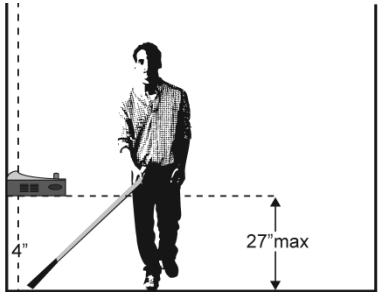
Priority 2 – Access to Goods & Services				**Comments**	**Possible Solutions**
Interior Accessible Route *(2010 Standards – Ch.4)*					
2.8	Do all objects on circulation paths through public areas, e.g. fire extinguishers, drinking fountains, signs, etc., protrude no more than 4 inches into the path? Or If an object protrudes more than 4 inches, is the bottom leading edge at 27 inches or lower above the floor?	☐ Yes ☐ No Measurement: ☐ Yes ☒ No Measurement: 34”	 Or

Photo #: 	• Remove object • Add tactile warning such as permanent planter or partial walls •
Signs *(2010 Standards – 703)* **Note: “Tactile characters” are read using touch, i.e. raised characters and Braille.**

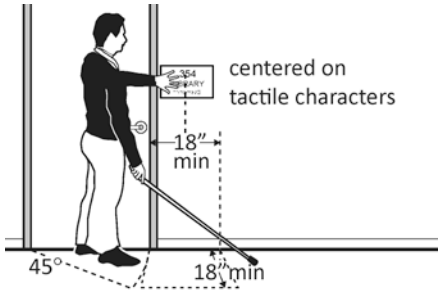
Interior signs are mounted on the doors.	• Install tactile sign • Relocate sign •

Are text characters raised? Is there Braille? Is the sign mounted: On the wall on the latch side of the door? Note: Signs are permitted on the push side of doors with closers and without hold-open devices.	☐ Yes ☒ No ☐ Yes ☒ No

Photo #: 	*If constructed before 3/15/2010 and a person may approach within 3 inches of the sign without encountering protruding objects or standing within the door swing, relocation not required *If constructed before 3/15/2012 and mounted no higher than 60 inches to the centerline of the sign, relocation not required
Sales & Service Counters – banks, stores, dry cleaners, auto repair shops, fitness clubs, etc. *(2010 Standards – 904)*

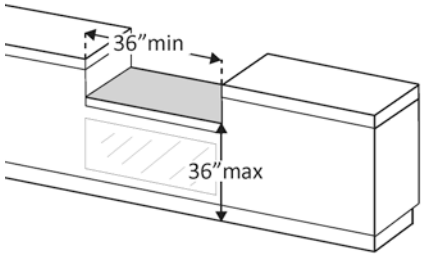
2.76 Is there a portion of at least one of each type of counter that is: No higher than 36 inches above the floor? At least 36 inches long?	☒ Yes ☐ No Measurement: 36" ☐ Yes ☒ No Measurement: 32"

Photo #: 	• Lower section of counter • Lengthen section of counter •

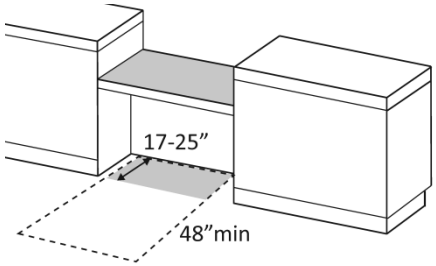
2.80	For a forward approach: Do no less than 17 and no greater than 25 inches of the clear floor space extend under the accessible length of the counter?	☐ Yes ☒ No Measurement: 5"

Photo #:	• Reconfigure to provide knee clearance • •

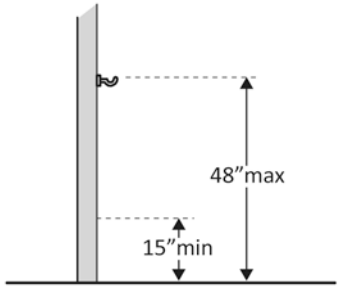
Priority 3 – Toilet Rooms				**Comments**	**Possible Solutions**
In the Toilet Room					
3.20	If there is a coat hook, is it no less than 15 inches and no greater than 48 inches above the floor? 54" for side reach 1991 ADA	☐ Yes ☒ No Measurement: 55"

Photo #: 6201	• Adjust hook • Replace with or provide additional accessible hook •
Soap Dispensers and Hand Dryers *(2010 Standards – 603)*

Photo #: 6201	• Adjust hook • Replace with or provide additional accessible hook • **Proposed solution** An additional coat hook has been added at the ADA height standard.
Soap Dispensers and Hand Dryers *(2010 Standards – 603)*

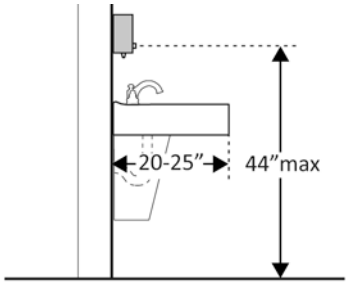
3.28	Are the operable parts of the soap dispenser within one of the following reach ranges: Above lavatories or counters no less than 20 inches and no greater than 25 inches deep: no higher than 44 inches above the floor? 48" not 44" 1991 ADA	☐ Yes ☒ No Measurement: 49"

Photo #: 	• Adjust dispensers • Replace with or provide additional accessible dispensers •
Water Closets in Single-User Toilet Rooms and Compartments (Stalls) *(2010 Standards – 603 & 609)* **Note: 2010 Standards refer to toilets as water closets.**

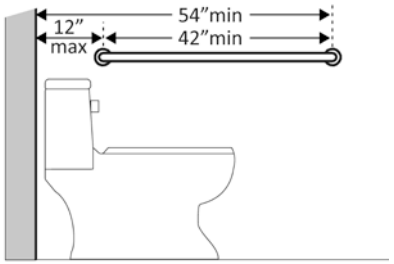
3.33	Is there a grab bar at least 42 inches long on the side wall? Is it located no more than 12 inches from the rear wall?	☐ Yes ☒ No Measurement: 36" ☒ Yes ☐ No Measurement:

Photo #:	• Install grab bar • Relocate grab bar • Relocate objects •

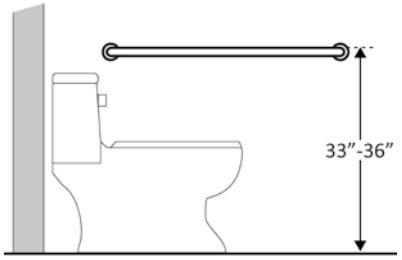
Does it extend at least 54 inches from the rear wall? Is it mounted no less than 33 inches and no greater than 36 inches above the floor to the top of the gripping surface?	☐ Yes ☒ No Measurement: 42" ☐ Yes ☒ No Measurement: 38"

* If constructed before 3/15/2012 grab bars do not need to be relocated; there are no space requirements above and below grab bars in the 1991 Standards

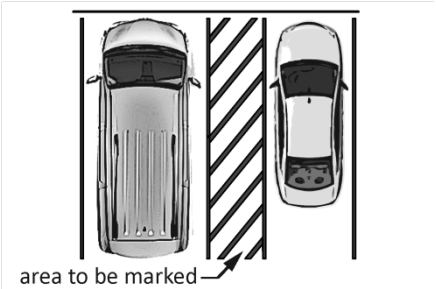
1.7	Are the access aisles marked so as to discourage parking in them?	☐ Yes ☒ No

Photo #:	• Mark access aisles • • The marking method and color may be addressed by state/local requirements

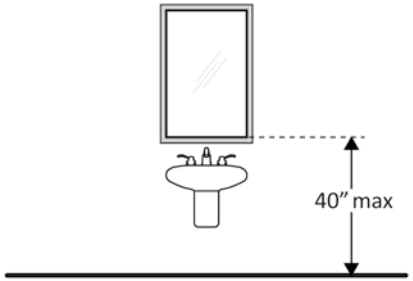
Priority 3 – Toilet Rooms				**Comments**	**Possible Solutions**
Entrance *(2010 Standards – 404)*					
3.11	Can the door be opened easily (5 pounds maximum force)?	☐ Yes ☒ No Measurement: 6lb		Photo #:	• Adjust or replace closers • Install lighter doors • Install power-assisted or automatic door openers
3.19	If the mirror is over a lavatory or countertop, is the bottom edge of the reflecting surface no higher than 40 inches above the floor? Or If the mirror is not over the lavatory or countertop, is the bottom edge of the reflecting surface no higher than 35 inches above the floor?*	☐ Yes ☒ No Measurement: 50" ☐ Yes ☐ No Measurement:

Photo #: 	* If installed before 3/15/2012 and the bottom edge of the reflecting surface is no higher than 40 inches above the floor, lowering the mirror to 35 inches is not required • Lower the mirror • Add another mirror •

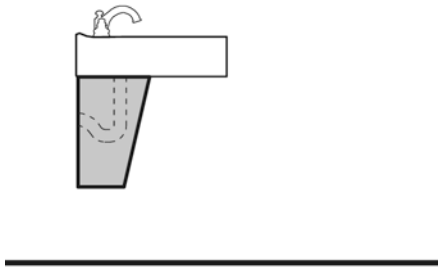
3.26	Are pipes below the lavatory insulated or otherwise configured to protect against contact?	☐ Yes ☒ No

Photo #:	• Install insulation • Install cover panel •
Soap Dispensers and Hand Dryers *(2010 Standards – 603)*

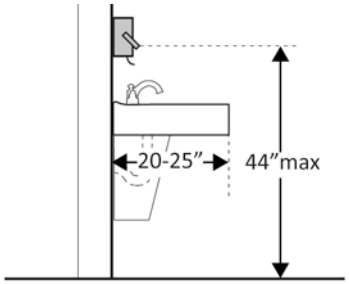
3.29	Are the operable parts of the hand dryer or towel dispenser within one of the following reach ranges: Above lavatories or counters no less than 20 inches and no greater than 25 inches deep: no higher than 44 inches above the floor?	☐ Yes ☒ No Measurement: 54"

Photo #: 	• Adjust dispensers • Replace with or provide additional accessible dispensers •

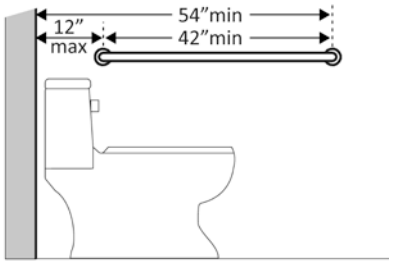
3.33 Is there a grab bar at least 42 inches long on the side wall? Is it located no more than 12 inches from the rear wall? Does it extend at least 54 inches from the rear wall?	☐ Yes ☒ No Measurement: 19" ☐ Yes ☒ No Measurement: ☐ Yes ☒ No Measurement: 42"

Photo #: See photo above	• Install grab bar • Relocate grab bar • Relocate objects • * If constructed before 3/15/2012 grab bars do not need to be relocated; there are no space requirements above and below grab bars in the 1991 Standards

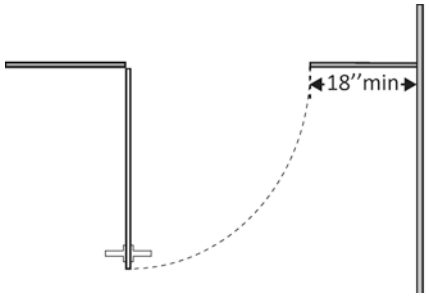
1991 Standards
Toilet Compartments (Stalls) *(2010 Standards – 604)*					
3.42	If there is a front approach to the pull side of the door, is there at least 18 inches of maneuvering clearance beyond the latch side plus 60 inches clear depth?*	☐ Yes ☒ No Measurement: 5"

Photo #: 	*See 2010 Standards 604.8.1.2 Doors for maneuvering clearance requirements on the push side of the door and side approaches to the pull side of the door • Remove obstructions •
3.44	Are there door pulls on both sides of the door that are operable with one hand and do not require tight grasping pinching or twisting of the wrist?*	☐ Yes ☒ No

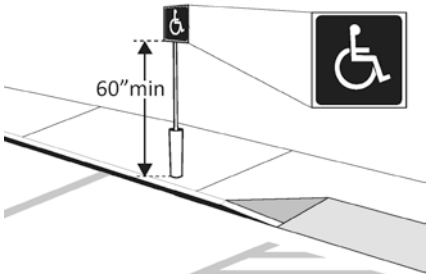
1.3	Of the accessible spaces, is at least one a van accessible space?*	☐ Yes ☒ No	*For every 6 or fraction of 6 parking spaces required by the table above, at least 1 should be a van accessible space.	Space is not marked for van accessibility Photo #: 	* If constructed before 3/15/2012, parking is compliant if at least 1 in every 8 accessible spaces is van accessible • Reconfigure by repainting lines

1.10	Are accessible spaces Identified with a sign that includes the International Symbol of Accessibility? Is the bottom of the sign at least 60 inches above the ground? MDOT say 7' to bottom of sign	☐ Yes ☒ No ☐ Yes ☒ No Measurement:

Photo #: See photo above	• Install signs • • The International Symbol of Accessibility is not required on the ground by the 2010 Standards

1.11	Are there signs reading "van accessible" at van accessible spaces?	☐ Yes ☒ No		Photo #: See photo above	• Install signs • •

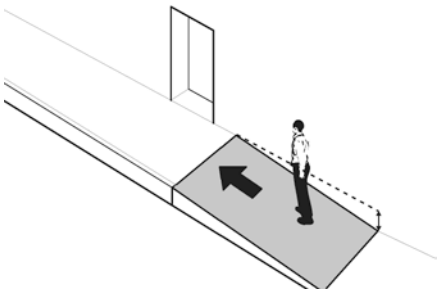
1.17	Is the running slope no steeper than 1:20, i.e. for every inch of height change there are at least 20 inches of route run? Or 5%	☐ Yes ☒ No Measurement: 6%

The sidewalk infront of intence Photo #: 	• Regrade to 1:20 max. • If steeper than 1:20 and no steeper than 1:12, treat as a ramp and add other features such as edge protection and handrails •
1.18	Is the cross slope no steeper than 1:48? Or 2%	☐ Yes ☒ No Measurement: 12%

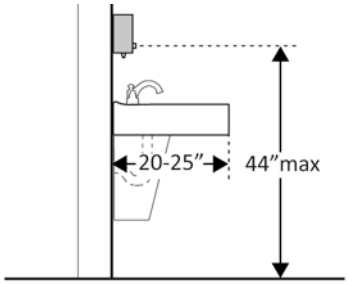
3.28	Are the operable parts of the soap dispenser within one of the following reach ranges: Above lavatories or counters no less than 20 inches and no greater than 25 inches deep: no higher than 44 inches above the floor?	☐ Yes ☒ No Measurement: 52"

Photo #:	• Adjust dispensers • Replace with or provide additional accessible dispensers •

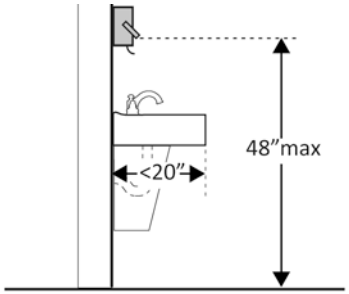
3.29	Are the operable parts of the hand dryer or towel dispenser within one of the following reach ranges: Above lavatories less than 20 inches deep: no higher than 48 inches above the floor?	☐ Yes ☒ No Measurement: 51"

Photo #:	• Adjust dispensers • Replace with or provide additional accessible dispensers •

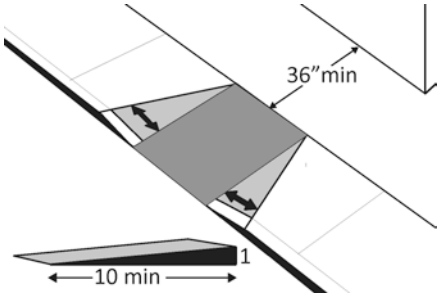
Priority 1 – Approach & Entrance			**Comments**	**Possible Solutions**
Curb Ramps *(2010 Standards – 406)*				
1.23 At the top of the curb ramp is there a level landing (slope no steeper than 1:48 in all directions) that is at least 36 inches long and at least as wide as the curb ramp?	☐ Yes ☒ No Measurement: 5.6 / 7

The ramps at the East B. RA do not level landing. Photo #: 	• Reconfigure • Add ramp flares •
Ramps *(2010 Standards – 405 & 505)* **Note: If any portion of the accessible route is steeper than 1:20, it should be treated as a ramp.**

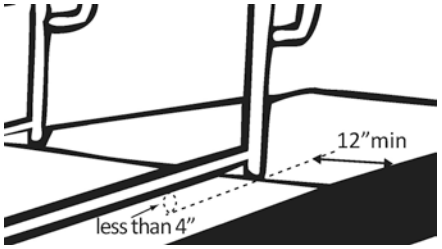
1.36 To prevent wheelchair casters and crutch tips from falling off: Does the surface of the ramp extend at least 12 inches beyond the inside face of the handrail? Or Is there a curb or barrier that prevents the passage of a 4-inch diameter sphere?	☐ Yes ☒ No Measurement: ☐ Yes ☒ No Measurement:

Photo #: 	• Add curb • Add barrier • Extend ramp width •

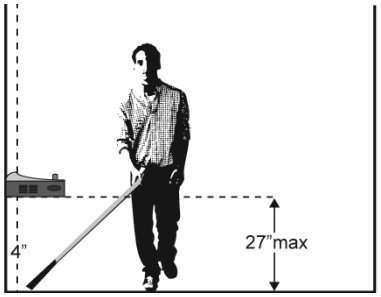
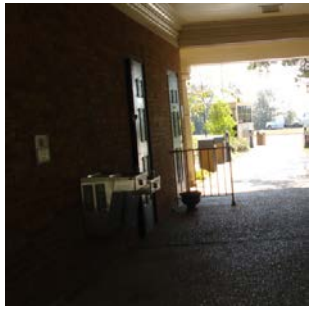
Priority 2 – Access to Goods & Services			Comments	Possible Solutions
2.8 Do all objects on circulation paths through public areas, e.g. fire extinguishers, drinking fountains, signs, etc., protrude no more than 4 inches into the path? Or If an object protrudes more than 4 inches, is the bottom leading edge at 27 inches or lower above the floor?	☐ Yes ☒ No Measurement: 19" ☐ Yes ☒ No Measurement: 32"

• Remove object • Add tactile warning such as permanent planter or partial walls •

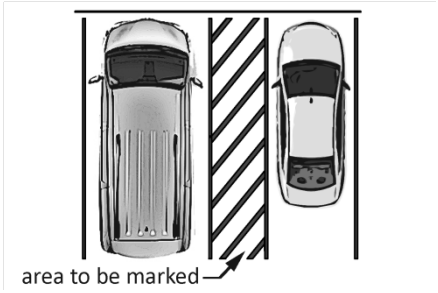
1.7	Are the access aisles marked so as to discourage parking in them?	☐ Yes ☒ No

Photo #: See photo above	• Mark access aisles • • The marking method and color may be addressed by state/local requirements

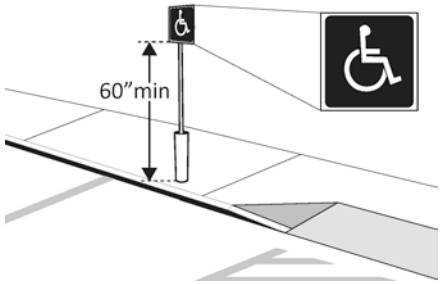
1.9	Do the access aisles adjoin an accessible route?	☐ Yes ☒ No		Photo #:	• Create accessible route • Relocate accessible space •
1.10	Are accessible spaces Identified with a sign that includes the International Symbol of Accessibility? Is the bottom of the sign at least 60 inches above the ground? MDOT say 7' to bottom of sign	☐ Yes ☒ No ☐ Yes ☒ No Measurement:

No signs Photo #: 	• Install signs • • The International Symbol of Accessibility is not required on the ground by the 2010 Standards
1.11	Are there signs reading "van accessible" at van accessible spaces?	☐ Yes ☐ No		No signs Photo #: See photo above	• Install signs • •

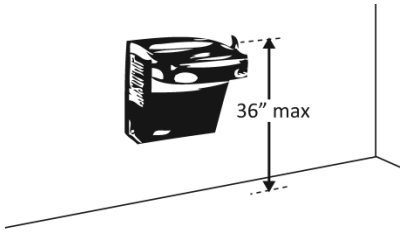
Priority 4 – Additional Access			Comments	Possible Solutions
Drinking Fountains *(2010 Standards – 602)*				
4.6 Is the spout outlet no higher than 36 inches above the floor?	☐ Yes ☒ No Measurement: 42"

Photo #: 	• Adjust drinking fountain • Replace drinking fountain •

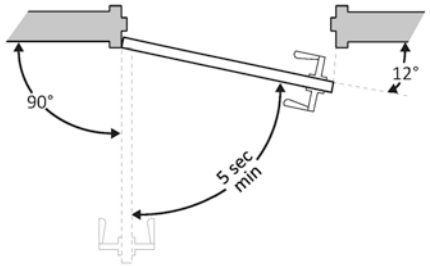
1.46 If the door has a closer, does it take at least 5 seconds to close from an open position of 90 degrees to a position of 12 degrees from the latch? 70 Degrees and 3 min 1991 ADA	☐ Yes ☒ No Measurement: 2

Photo #:	• Adjust closer • •

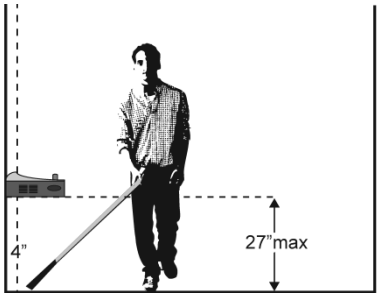
Priority 2 – Access to Goods & Services			Comments	Possible Solutions
Interior Accessible Route *(2010 Standards – Ch.4)*				
2.8 If an object protrudes more than 4 inches, is the bottom leading edge at 27 inches or lower above the floor?	☐ Yes ☒ No Measurement: 28

Drinking fountain protrudes on one side. Photo #: 	• Remove object • Add tactile warning such as permanent planter or partial walls •
Signs *(2010 Standards – 703)* **Note: "Tactile characters" are read using touch, i.e. raised characters and Braille.**

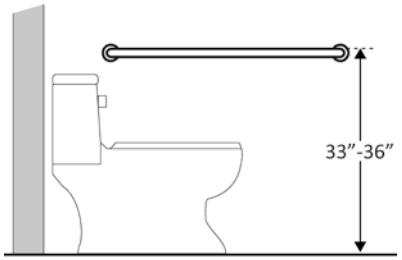
Priority 3 – Toilet Rooms			**Comments**	**Possible Solutions**
Water Closets in Single-User Toilet Rooms and Compartments (Stalls) *(2010 Standards – 603 & 609)* **Note: 2010 Standards refer to toilets as water closets.**				
3.33 Is it mounted no less than 33 inches and no greater than 36 inches above the floor to the top of the gripping surface?	☐ Yes ☒ No Measurement: 37"

Photo #: 	• Install grab bar • Relocate grab bar • Relocate objects • * If constructed before 3/15/2012 grab bars do not need to be relocated; there are no space requirements above and below grab bars in the 1991 Standards
Toilet Compartments (Stalls) *(2010 Standards – 604)*				
3.41 Is the door opening width at least 32 inches clear, between the face of the door and the stop, when the door is open 90 degrees?	☒ Yes ☐ No Measurement: 35"

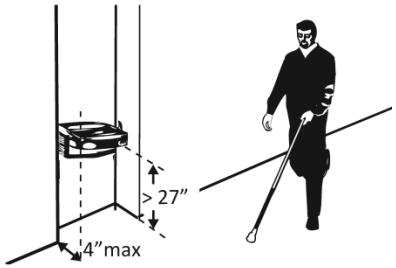
Priority 4 – Additional Access				Comments	Possible Solutions
Drinking Fountains *(2010 Standards – 602)*					
4.9	If the leading (bottom) edge of the fountain is higher than 27 inches above the floor, does the front of the fountain protrude no more than 4 inches into the circulation path?	☐ Yes ☒ No Measurement: 35" / 18"

Photo #: 	• Adjust drinking fountain • Replace drinking fountain • Add tactile warning such as permanent planter or partial walls

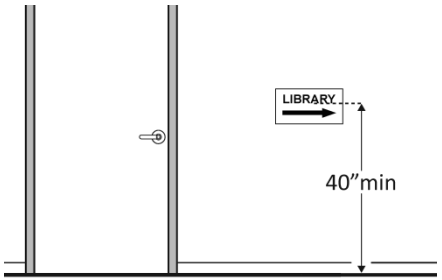
2.39	If there are signs that provide direction to or information about interior spaces: Do text characters contrast with their backgrounds? Is the sign mounted so that characters are at least 40 inches above the floor? 60" Max 1991 ADA	☒ Yes ☐ No ☐ Yes ☒ No Measurement: 62"

Photo #: See photo above	• Install signs with contrasting characters • Change sign height • Raised characters and Braille are not required

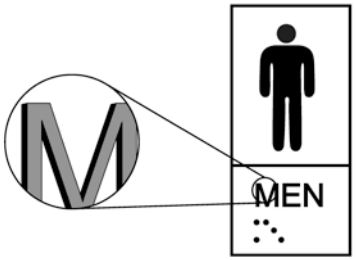
3.5 Is there Braille? Is the sign mounted: On the wall on the latch side of the door? Note: Signs are permitted on the push side of doors with closers and without hold-open devices. So the baseline of the lowest character is at least 48 inches above the floor and the baseline of the highest character is no more than 60 inches above the floor? *	☐ Yes ☒ No ☐ Yes ☒ No ☐ Yes ☒ No Measurement: 68"

Photo #:	• Install tactile sign • Relocate sign • *If constructed before 3/15/2010 and a person may approach within 3 inches of the sign without encountering protruding objects or standing within the door swing, relocation not required *If constructed before 3/15/2012 and mounted no higher than 60 inches to the centerline of the sign, relocation is not required
Entrance *(2010 Standards – 404)*

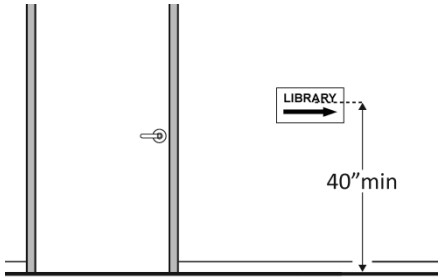
2.39 If there are signs that provide direction to or information about interior spaces: Do text characters contrast with their backgrounds? Is the sign mounted so that characters are at least 40 inches above the floor? 60" Max 1991 ADA	☒ Yes ☐ No ☐ Yes ☒ No Measurement: 72"

60" to center 1991 ADA Photo #: 	• Install signs with contrasting characters • Change sign height • Raised characters and Braille are not required
Sales & Service Counters – banks, stores, dry cleaners, auto repair shops, fitness clubs, etc. *(2010 Standards – 904)*

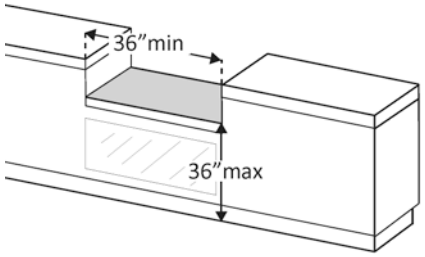
2.76 Is there a portion of at least one of each type of counter that is: No higher than 36 inches above the floor? At least 36 inches long?	☒ Yes ☐ No Measurement: 34" ☐ Yes ☒ No Measurement: 34"

Photo #: 	• Lower section of counter • Lengthen section of counter •

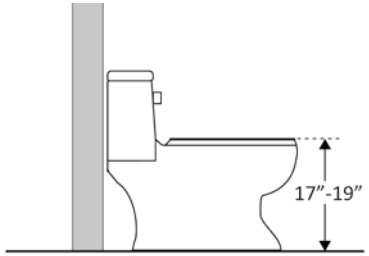
3.32	Is the height of the water closet no less than 17 inches and no greater than 19 inches above the floor measured to the top of the seat?	☐ Yes ☒ No Measurement: 20"

Photo #: 	• Adjust toilet height • Replace toilet •
3.33	Does it extend at least 54 inches from the rear wall?	☐ Yes ☒ No Measurement: 48"

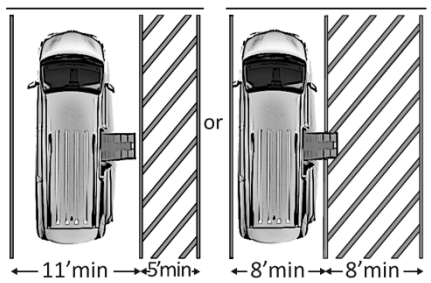
1.5	Is the van accessible space: At least 11 feet wide with an access aisle at least 5 feet wide? Or At least 8 feet wide with an access aisle at least 8 feet wide?	☐ Yes ☒ No Measurement: ☐ Yes ☒ No Measurement:

1991 on RT. 2010 on LT. Photo #: See above photo	• Reconfigure to provide van-accessible space(s) • •

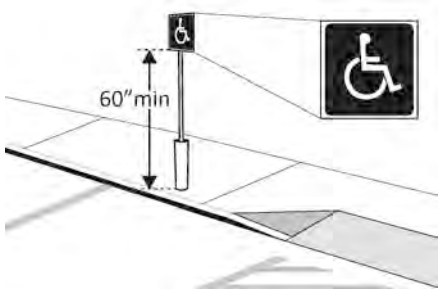
1.10	Are accessible spaces Identified with a sign that includes the International Symbol of Accessibility? Is the bottom of the sign at least 60 inches above the ground? MDOT say 7' to bottom of sign	☐ Yes ☒ No ☐ Yes ☒ No Measurement:

Photo #:	• Install signs • • The International Symbol of Accessibility is not required on the ground by the 2010 Standards

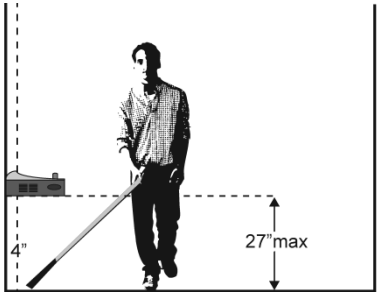
Priority 2 – Access to Goods & Services				Comments	Possible Solutions
Interior Accessible Route *(2010 Standards – Ch.4)*					
2.8	Do all objects on circulation paths through public areas, e.g. fire extinguishers, drinking fountains, signs, etc., protrude no more than 4 inches into the path? Or If an object protrudes more than 4 inches, is the bottom leading edge at 27 inches or lower above the floor?	☐ Yes ☒ No Measurement: ☒ Yes ☐ No Measurement: 20"

Photo #:	• Remove object • Add tactile warning such as permanent planter or partial walls •
Signs *(2010 Standards – 703)* **Note: "Tactile characters" are read using touch, i.e. raised characters and Braille.**

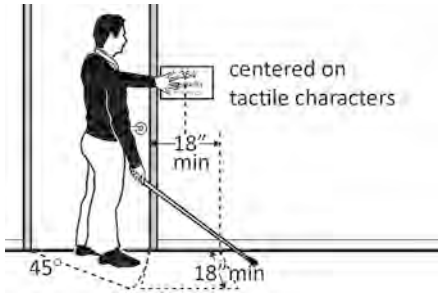
2.38	If there are signs designating permanent rooms and spaces not likely to change over time, e.g. room numbers and letters, room names, and exit signs: Do text characters contrast with their backgrounds? Are text characters raised? Is there Braille? Is the sign mounted: On the wall on the latch side of the door?	☐ Yes ☒ No ☐ Yes ☒ No ☐ Yes ☒ No ☐ Yes ☒ No

No Signage	• Install tactile sign • Relocate sign •

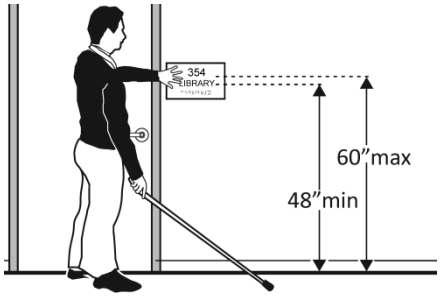
Note: Signs are permitted on the push side of doors with closers and without hold-open devices. With clear floor space beyond the arc of the door swing between the closed position and 45-degree open position, at least 18 x 18 inches centered on the tactile characters?* So the baseline of the lowest character is at least 48 inches above the floor and the baseline of the highest character is no more than 60 inches above the floor? * Note: If the sign is at double doors with one active leaf, the sign should be on the inactive leaf; if both leaves are active, the sign should be on the wall to the right of the right leaf.	☐ Yes ☒ No Measurement: ☐ Yes ☐ No Measurement:

60” to center 1991 ADA	Photo #:	*If constructed before 3/15/2010 and a person may approach within 3 inches of the sign without encountering protruding objects or standing within the door swing, relocation not required *If constructed before 3/15/2012 and mounted no higher than 60 inches to the centerline of the sign, relocation not required

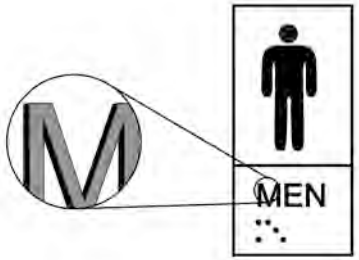
3.5 Do text characters contrast with their backgrounds?	☒ Yes ☐ No

• Install tactile sign • Relocate sign •
Are text characters raised?	☐ Yes ☒ No			
Is there Braille?	☐ Yes ☒ No			
Is the sign mounted: On the wall on the latch side of the door?	☐ Yes ☒ No			
Note: Signs are permitted on the push side of doors with closers and without hold-open devices.				
With clear floor space beyond	☐ Yes ☒ No			*If constructed before 3/15/2010 and a person

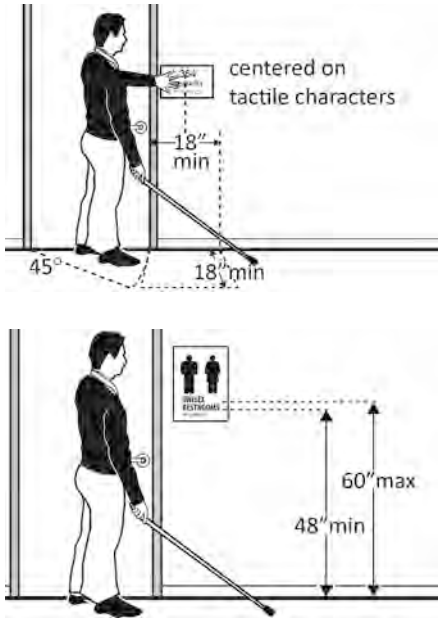
the arc of the door swing between the closed position and 45-degree open position, at least 18 x 18 inches centered on the tactile characters? * So the baseline of the lowest character is at least 48 inches above the floor and the baseline of the highest character is no more than 60 inches above the floor? * Note: If the sign is at double doors with one active leaf, the sign should be on the inactive leaf; if both leaves are active, the sign should be on the wall to the right of the right leaf.	Measurement: ☐ Yes ☒ No Measurement: 65"

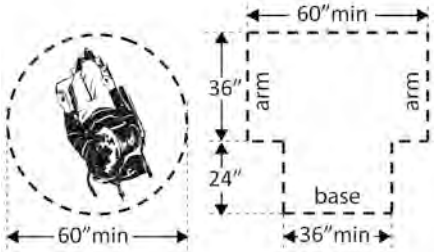
3.17	Is there clear floor space available for a person in a wheelchair to turn around, i.e. a circle at least 60 inches in diameter or a T-shaped space within a 60-inch square?*	☐ Yes ☒ No Measurement:

Photo #:	*The door to the toilet room may swing into the required turning space • Move or remove partitions, fixtures or objects such as trash cans • •

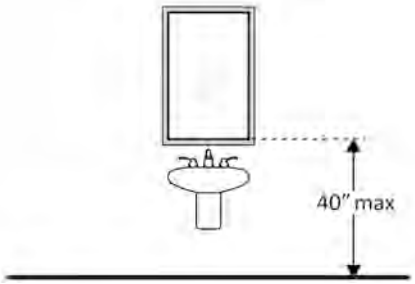
3.19	If the mirror is over a lavatory or countertop, is the bottom edge of the reflecting surface no higher than 40 inches above the floor? Or If the mirror is not over the lavatory or countertop, is the bottom edge of the reflecting surface no higher than 35 inches above the floor?*	☐ Yes ☒ No Measurement: 58" ☐ Yes ☐ No Measurement:

Photo #: See above photo	* If installed before 3/15/2012 and the bottom edge of the reflecting surface is no higher than 40 inches above the floor, lowering the mirror to 35 inches is not required • Lower the mirror • Add another mirror •

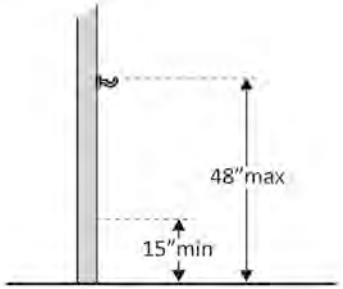
3.20	If there is a coat hook, is it no less than 15 inches and no greater than 48 inches above the floor? 54" for side reach 1991 ADA	☐ Yes ☒ No Measurement: 66"

Photo #:	• Adjust hook • Replace with or provide additional accessible hook •
Lavatories *(2010 Standards – 606)* **Note: 2010 Standards refer to sinks in toilet rooms as lavatories.**

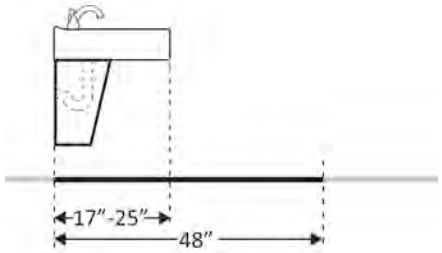
3.22	Do no less than 17 inches and no greater than 25 inches of the clear floor space extend under the lavatory so that a person using a wheelchair can get close enough to reach the faucet? 17” to 19” 1991 ADA	☐ Yes ☒ No Measurement: 16"

Photo #: 	• Alter lavatory • Replace lavatory •
3.26	Are pipes below the lavatory insulated or otherwise configured to protect against contact?	☐ Yes ☒ No

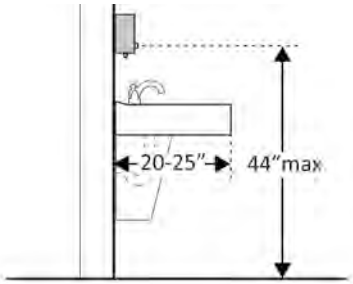
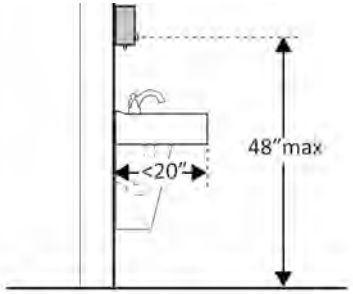
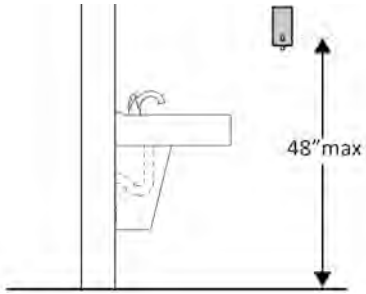
3.28	Are the operable parts of the soap dispenser within one of the following reach ranges: Above lavatories or counters no less than 20 inches and no greater than 25 inches deep: no higher than 44 inches above the floor? 48" not 44" 1991 ADA Above lavatories less than 20 inches deep: no higher than 48 inches above the floor? Not over an obstruction: no higher than 48 inches above the floor?	☐ Yes ☐ No Measurement: ☐ Yes ☐ No Measurement: ☒ Yes ☐ No Measurement: 51"

Photo #:	• Adjust dispensers • Replace with or provide additional accessible dispensers •
Water Closets in Single-User Toilet Rooms and Compartments (Stalls) *(2010 Standards – 603 & 609)* **Note: 2010 Standards refer to toilets as water closets.**

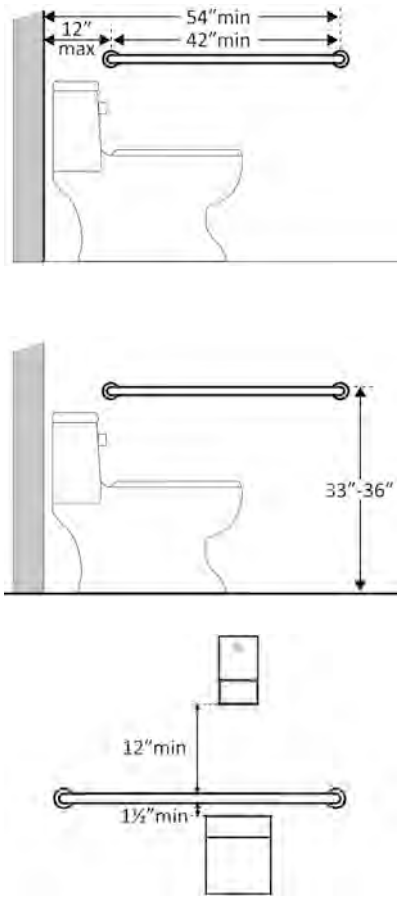
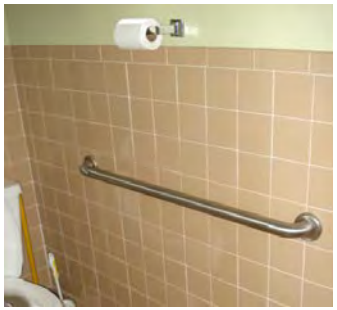
stall size.				
3.33	Is there a grab bar at least 42 inches long on the side wall? Is it located no more than 12 inches from the rear wall? Does it extend at least 54 inches from the rear wall? Is it mounted no less than 33 inches and no greater than 36 inches above the floor to the top of the gripping surface? Is there at least 12 inches clearance between the grab bar and protruding objects above?* Is there at least 1½ inches clearance between the grab bar and projecting objects below?* Is the space between the wall and the grab bar 1 ½ inches?	☐ Yes ☒ No Measurement: 36" ☐ Yes ☒ No Measurement: ☒ Yes ☐ No Measurement: ☐ Yes ☒ No Measurement: 32" ☒ Yes ☐ No Measurement: 18" ☒ Yes ☐ No Measurement: ☒ Yes ☐ No Measurement:

• Install grab bar • Relocate grab bar • Relocate objects • * If constructed before 3/15/2012 grab bars do not need to be relocated; there are no space requirements above and below grab bars in the 1991 Standards

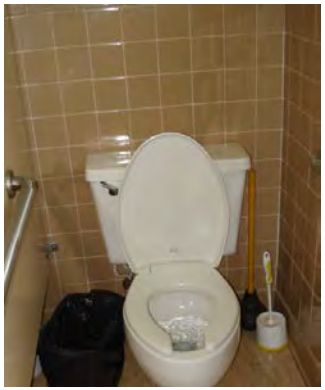
3.34	Is there a grab bar at least 36 inches long on the rear wall? Does it extend at least 12 inches from the centerline of the water closet on one side (side wall)? Does it extend at least 24 inches on the other (open) side? Is it mounted no less than 33 inches and no greater than 36 inches above the floor to the top of the gripping surface?	☐ Yes ☐ No Measurement: ☐ Yes ☐ No Measurement: ☐ Yes ☐ No Measurement: ☐ Yes ☐ No Measurement:

No Rear Wall Grab Bars Photo #:

• Install grab bar • Relocate grab bar • Relocate objects • * If constructed before 3/15/2012 grab bars do not need to be relocated; there are no space requirements above and below grab bars in the 1991 Standards
3.37	Is the flush control on the open side of the water closet?	☐ Yes ☒ No

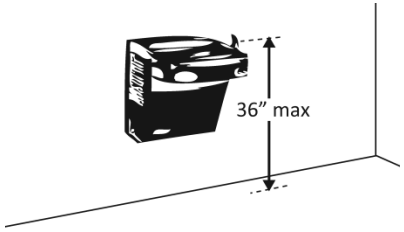
Priority 4 – Additional Access				Comments	Possible Solutions
Drinking Fountains *(2010 Standards – 602)*					
4.6	Is the spout outlet no higher than 36 inches above the floor?	☐ Yes ☒ No Measurement: 40"

Photo #:	• Adjust drinking fountain • Replace drinking fountain •
4.9	If the leading (bottom) edge of the fountain is higher than 27 inches above the floor, does the front of the fountain protrude no more than 4 inches into the circulation path?	☐ Yes ☒ No Measurement:

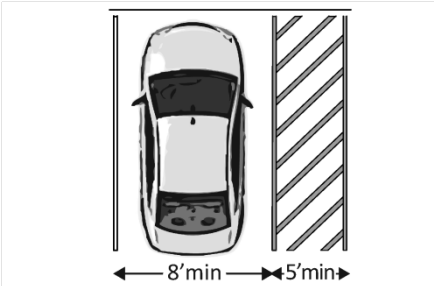
Proposed Solution Number of van accessible spaces will be addressed by district maintenance personnel
1.4	Are accessible spaces at least 8 feet wide with an access aisle at least 5 feet wide? 1991 ADA	☐ Yes ☒ No Measurement:

Photo #:	• Reconfigure by repainting lines Two spaces can share an access aisle **Proposed Solution** Dimensions of accessible spaces will be addressed by district maintenance personnel
1.5	Is the van accessible space: At least 11 feet wide with an access aisle at least 5 feet wide? Or At least 8 feet wide with an access aisle at least 8 feet wide?	☐ Yes ☒ No Measurement: ☐ Yes ☒ No Measurement:

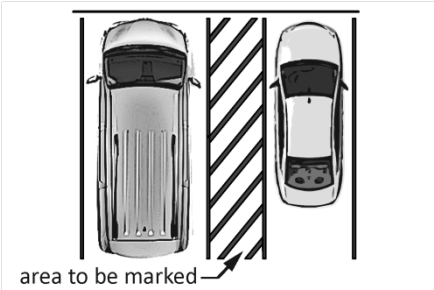
1.7	Are the access aisles marked so as to discourage parking in them?	☐ Yes ☒ No

Photo #:	• Mark access aisles • • The marking method and color may be addressed by state/local requirements **Proposed Solution** Access aisle pavement marking will be addressed by district maintenance personnel

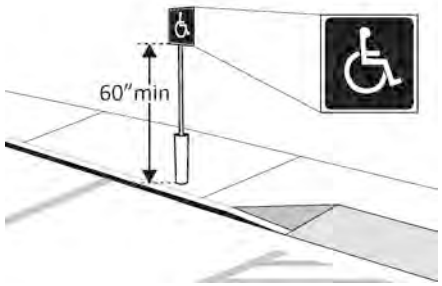
1.10	Are accessible spaces Identified with a sign that includes the International Symbol of Accessibility? Is the bottom of the sign at least 60 inches above the ground? MDOT say 7' to bottom of sign	☐ Yes ☒ No ☐ Yes ☐ No Measurement:

Photo #:	• Install signs • • The International Symbol of Accessibility is not required on the ground by the 2010 Standards **Proposed Solution**

Signage for accessible spaces will be addressed by district maintenance personnel
1.11	Are there signs reading "van accessible" at van accessible spaces?	☐ Yes ☒ No		Photo #:	• Install signs • • **Proposed Solution** Signage of van accessible spaces will be addressed by district maintenance personnel
1.12	Of the total parking spaces, are the accessible spaces located on the closest accessible route to the accessible entrance(s)?	☐ Yes ☒ No		Photo #:	• Reconfigure spaces • If parking lot serves multiple entrances, accessible parking should be dispersed **Proposed Solution** The District will review of the sites to see how the main entrances can be made accessible

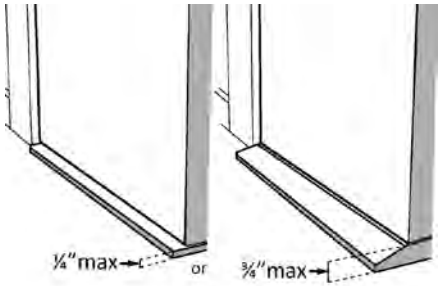
1.43	Is the door threshold edge no more than ¼ inch high? Or No more than ¾ inch high if slope is beveled no steeper than 1:2? Note: The first ¼ inch of the threshold may be vertical; the rest must be beveled.	☐ Yes ☒ No Measurement: 6" ☐ Yes ☐ No Measurement:

Photo #:	• Remove or replace threshold • • **Proposed Solution** Door threshold height will be addressed by district maintenance personnel
1.44	Is the door equipped with hardware, including locks, that is operable with one hand and does not require tight grasping, pinching, or twisting of the wrist?	☐ Yes ☒ No		Photo #:	• Replace inaccessible knob with lever, loop or push hardware • Add automatic door opener • **Proposed Solution** The door handware will be addressed by district maintenance personnel

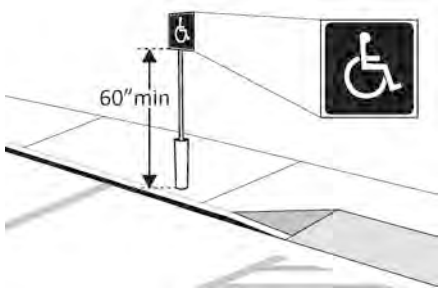
Priority 1 – Approach & Entrance			**Comments**	**Possible Solutions**
Parking *(2010 Standards – 208 & 502)* **Note: Accessible parking spaces should be identified by size, access aisle and signage.**				
1.10 Are accessible spaces Identified with a sign that includes the International Symbol of Accessibility? Is the bottom of the sign at least 60 inches above the ground? MDOT say 7' to bottom of sign	☒ Yes ☐ No ☐ Yes ☒ No Measurement: 48"

Photo #: 	• Install signs • • The International Symbol of Accessibility is not required on the ground by the 2010 Standards **Proposed Solution** Height off accessibility signs will be adjusted by district maintenance personnel

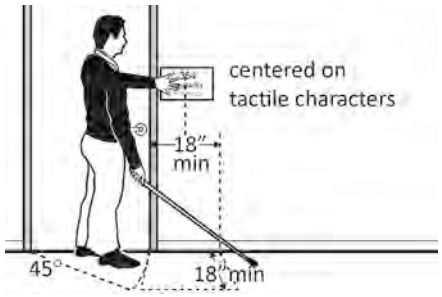
2.38 If there are signs designating permanent rooms and spaces not likely to change over time, e.g. room numbers and letters, room names, and exit signs: Do text characters contrast with their backgrounds? Are text characters raised? Is there Braille?	☒ Yes ☐ No ☐ Yes ☒ No ☐ Yes ☒ No

Photo #:	• Install tactile sign • Relocate sign • *If constructed before 3/15/2010 and a person may approach within 3 inches of the sign without encountering protruding objects or standing within the door swing, relocation not required *If constructed before 3/15/2012 and mounted no higher than 60 inches to the centerline of the sign, relocation not required **Proposed Solution** Signage will be reviewed by district personnel and corrected as needed.

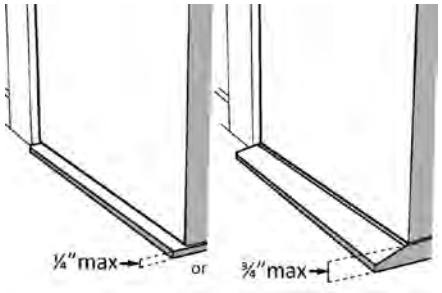
Priority 1 – Approach & Entrance				**Comments**	**Possible Solutions**
Entrance *(2010 Standards – 404)*					
1.43	Is the door threshold edge no more than ¼ inch high? Or No more than ¾ inch high if slope is beveled no steeper than 1:2? Note: The first ¼ inch of the threshold may be vertical; the rest must be beveled.	☐ Yes ☒ No Measurement: ☐ Yes ☐ No Measurement:

Photo #:	• Remove or replace threshold • • **Proposed Solution** Door threshold height will be addressed by district maintenance personnel
1.49	Are edges of carpets or mats securely attached to minimize tripping hazards?	☐ Yes ☒ No		Photo #:	• Secure carpeting or mats at edges • • **Proposed Solution** Securing mats will be addressed by district maintenance personnel

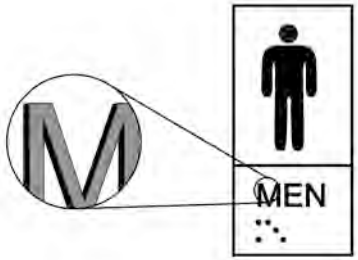
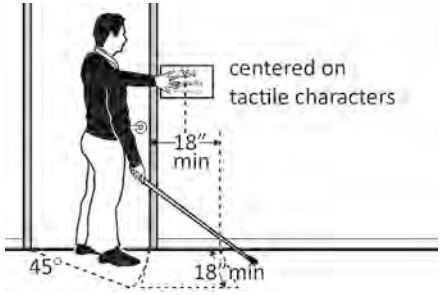
Signs at Toilet Rooms *(2010 Standards – 703)*					
3.5	Do text characters contrast with their backgrounds? Are text characters raised? Is there Braille? Is the sign mounted: On the wall on the latch side of the door? Note: Signs are permitted on the push side of doors with closers and without hold-open devices. With clear floor space beyond the arc of the door swing between the closed position and 45-degree open position, at least 18 x 18 inches centered on the tactile characters? * So the baseline of the lowest character is at least 48 inches	☒ Yes ☐ No ☐ Yes ☒ No ☐ Yes ☒ No ☐ Yes ☒ No ☐ Yes ☒ No Measurement: ☐ Yes ☒ No

above the floor and the baseline of the highest character is no more than 60 inches above the floor? *	Measurement: 64"

Photo #: 	• Install tactile sign • Relocate sign • *If constructed before 3/15/2010 and a person may approach within 3 inches of the sign without encountering protruding objects or standing within the door swing, relocation not required *If constructed before 3/15/2012 and mounted no higher than 60 inches to the centerline of the

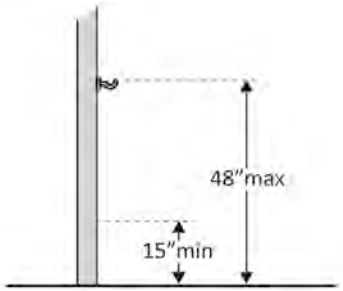
3.20	If there is a coat hook, is it no less than 15 inches and no greater than 48 inches above the floor? 54" for side reach 1991 ADA	☐ Yes ☒ No Measurement: 59"

Photo #:	• Adjust hook • Replace with or provide additional accessible hook • **Proposed Solution** Coat Hook in Toilet Room will be adjusted by district maintenance
