Mississippi Department of Transportation

ADA TRANSITION PLAN

October 1, 2014

UPDATE

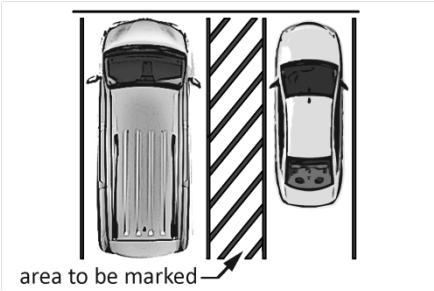
1.7	Are the access aisles marked so as to discourage parking in them?	☐ Yes ☒ No

Photo #: See photo above	• Mark access aisles • • The marking method and color may be addressed by state/local requirements **Proposed Solution** Access aisle pavement marking will be addressed by district maintenance personnel

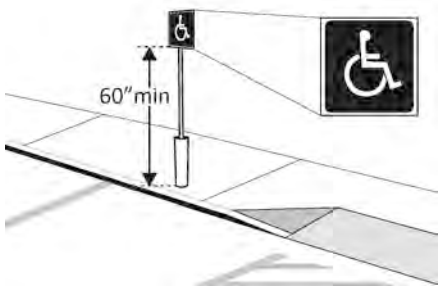
1.10	Are accessible spaces Identified with a sign that includes the International Symbol of Accessibility? Is the bottom of the sign at least 60 inches above the ground? MDOT say 7' to bottom of sign	☐ Yes ☒ No ☐ Yes ☐ No Measurement:

No signs Photo #: See photo above	• Install signs • • The International Symbol of Accessibility is not required on the ground by the 2010 Standards **Proposed Solution** Signage for accessible spaces will be addressed by district maintenance personnel
1.11	Are there signs reading "van accessible" at van accessible spaces?	☐ Yes ☒ No		No signs Photo #:	• Install signs • • **Proposed Solution** Signage of van accessible spaces will be addressed by district maintenance personnel

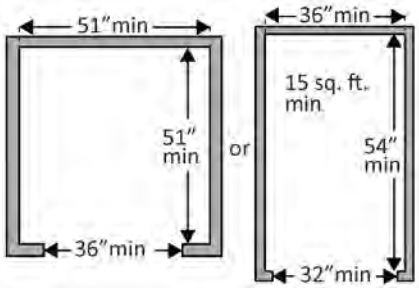
Photo #:	• Replace elevator • •
2.26	If there is a LULA elevator, is the interior: At least 51 x 51 inches with a door opening width of at least 36 inches? Or At least 54 inches deep by at least 36 inches wide with at least 15 sq. ft. of clear floor	☐ Yes ☐ No Measurement: ☐ Yes ☐ No Measurement:

80"W not 51"W 1991 ADA	• Replace elevator • •

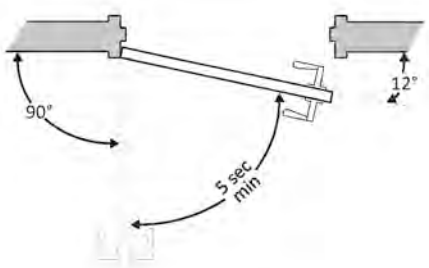
2.46	If the door has a closer, does it take at least 5 seconds to close from an open position of 90 degrees to a position of 12 degrees from the latch? 70 degrees and 3 min. 1991 ADA	☐ Yes ☒ No Measurement:

Photo #:	• Adjust closer • •
Rooms and Spaces – stores, supermarkets, libraries, etc. *(2010 Standards – 302, 304, & 402)*

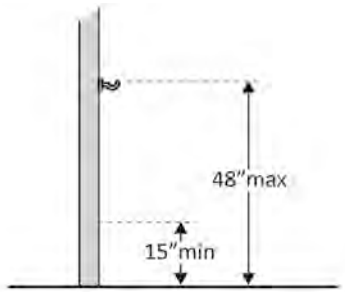
Priority 3 – Toilet Rooms				**Comments**	**Possible Solutions**
In the Toilet Room					
3.20	If there is a coat hook, is it no less than 15 inches and no greater than 48 inches above the floor? 54” for side reach 1991 ADA	☐ Yes ☒ No Measurement: 63"

Photo #:	• Adjust hook • Replace with or provide additional accessible hook • **Proposed Solution** Coat Hook in toilet room will be adjusted by district maintenance personnel
Water Closets in Single-User Toilet Rooms and Compartments (Stalls) *(2010 Standards – 603 & 609)* **Note: 2010 Standards refer to toilets as water closets.**

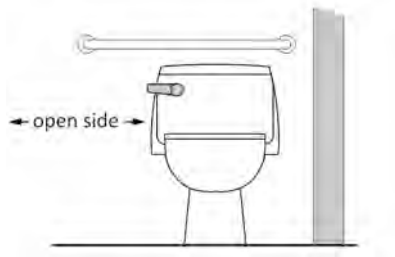
3.37	Is the flush control on the open side of the water closet?	☐ Yes ☒ No

Photo #:	• Move control • • **Proposed Solution** Flush control will be addressed when toilet is replaced.
3.38	Is the toilet paper dispenser located no less than 7 inches and no greater than 9 inches from the front of the water closet to the centerline of the dispenser?*	☐ Yes ☒ No Measurement: 2"

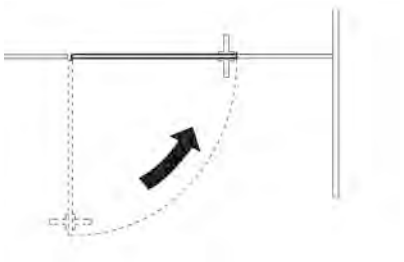
3.43 Is the door self-closing?	☐ Yes ☒ No

Photo #:	• Add closer • Replace door Or Provide Continuous spring hinges • **Proposed Solution** Toilet room door being self-closed will be addressed by district maintenance personnel

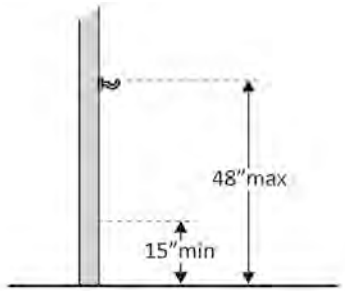
Priority 3 – Toilet Rooms			**Comments**	**Possible Solutions**
3.20 If there is a coat hook, is it no less than 15 inches and no greater than 48 inches above the floor? 54" for side reach 1991 ADA	☐ Yes ☒ No Measurement: 66 1/2"

• Adjust hook • Replace with or provide additional accessible hook • **Proposed Solution** Coat Hook in Toilet Room will be adjusted by district maintenance personnel
Water Closets in Single-User Toilet Rooms and Compartments (Stalls) *(2010 Standards – 603 & 609)* **Note: 2010 Standards refer to toilets as water closets.**				
3.37 Is the flush control on the open side of the water closet?	☐ Yes ☒ No

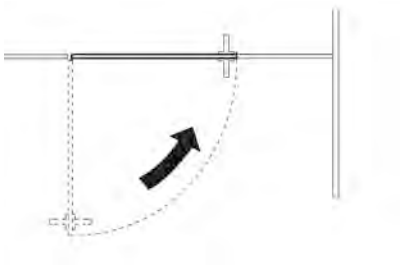
3.43 Is the door self-closing?	☐ Yes ☒ No

Photo #:	• Add closer • Replace door Or Provide Continuous spring hinges • **Proposed Solution** Toilet room door being self-closed will be addressed by district maintenance personnel

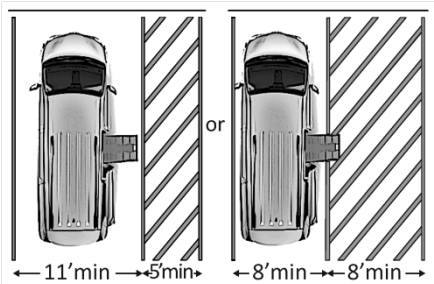
1.5	Is the van accessible space: At least 11 feet wide with an access aisle at least 5 feet wide? Or At least 8 feet wide with an access aisle at least 8 feet wide?	☐ Yes ☒ No Measurement: 9'/4' ☐ Yes ☒ No Measurement:

Photo #: See photo above	• Reconfigure to provide van-accessible space(s) • • **Proposed Solution** Configuration of van accessible spaces will be addressed by district maintenance personnel

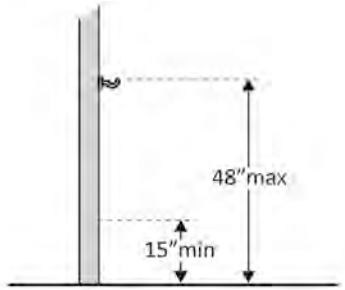
3.20	If there is a coat hook, is it no less than 15 inches and no greater than 48 inches above the floor? 54" for side reach 1991 ADA	☐ Yes ☒ No Measurement: 58"

Photo #:	• Adjust hook • Replace with or provide additional accessible hook • **Proposed Solution** Coat hook in toilet room will be adjusted by district maintenance personnel
Water Closets in Single-User Toilet Rooms and Compartments (Stalls) *(2010 Standards – 603 & 609)* **Note: 2010 Standards refer to toilets as water closets.**

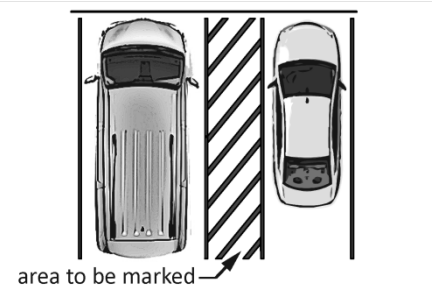
1.7	Are the access aisles marked so as to discourage parking in them?	☐ Yes ☒ No

Photo #:	• Mark access aisles • • The marking method and color may be addressed by state/local requirements

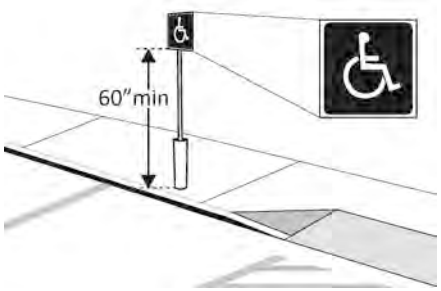
1.9	Do the access aisles adjoin an accessible route?	☐ Yes ☒ No		Photo #:	• Create accessible route • Relocate accessible space •
1.10	Are accessible spaces Identified with a sign that includes the International Symbol of Accessibility? Is the bottom of the sign at least 60 inches above the ground? MDOT say 7' to bottom of sign	☐ Yes ☒ No ☐ Yes ☐ No Measurement:

Photo #:	• Install signs • • The International Symbol of Accessibility is not required on the ground by the 2010 Standards

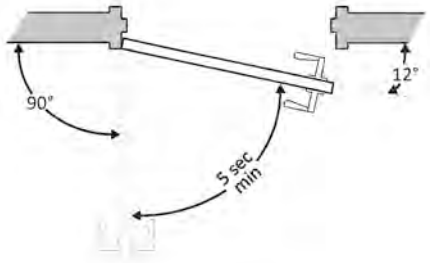
1.46	If the door has a closer, does it take at least 5 seconds to close from an open position of 90 degrees to a position of 12 degrees from the latch? 70 Degrees and 3 min 1991 ADA	☐ Yes ☒ No Measurement: 2

Photo #:	• Adjust closer • •

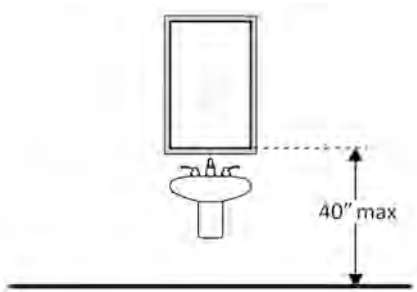
Priority 3 – Toilet Rooms				**Comments**	**Possible Solutions**
Signs at Toilet Rooms *(2010 Standards – 703)*					
3.19	If the mirror is over a lavatory or countertop, is the bottom edge of the reflecting surface no higher than 40 inches above the floor?	☐ Yes ☒ No Measurement: 42"

* If installed before 3/15/2012 and the bottom edge of the reflecting surface is no higher than 40 inches above the floor, lowering the mirror to 35 inches is not required • Lower the mirror • Add another mirror •
Water Closets in Single-User Toilet Rooms and Compartments (Stalls) *(2010 Standards – 603 & 609)* **Note: 2010 Standards refer to toilets as water closets.**

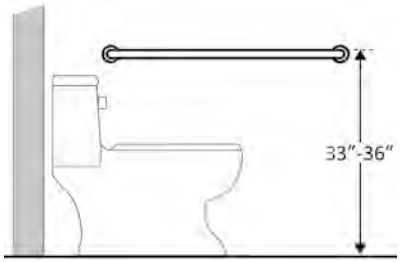
3.33	Is it mounted no less than 33 inches and no greater than 36 inches above the floor to the top of the gripping surface?	☐ Yes ☒ No Measurement: 38"

Photo #: 	• Install grab bar • Relocate grab bar • Relocate objects • * If constructed before 3/15/2012 grab bars do not need to be relocated; there are no space requirements above and below grab bars in the 1991 Standards

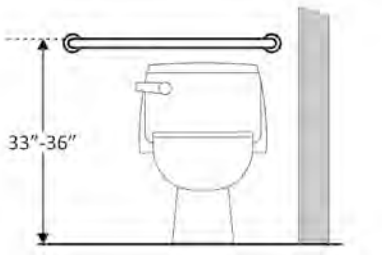
3.34	Is it mounted no less than 33 inches and no greater than 36 inches above the floor to the top of the gripping surface?	☐ Yes ☒ No Measurement: 38"

Photo #: See photo above	• Install grab bar • Relocate grab bar • Relocate objects • * If constructed before 3/15/2012 grab bars do not need to be relocated; there are no space requirements above and below grab bars in the 1991 Standards

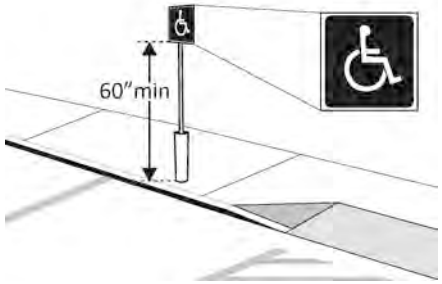
1.10	Are accessible spaces Identified with a sign that includes the International Symbol of Accessibility? Is the bottom of the sign at least 60 inches above the ground? MDOT say 7' to bottom of sign	☒ Yes ☐ No ☐ Yes ☒ No Measurement: 51"

Photo #: 	• Install signs • • The International Symbol of Accessibility is not required on the ground by the 2010 Standards **Proposed Solution** All signs have been raised to 7' to the bottom of the sign. 8/28/2013

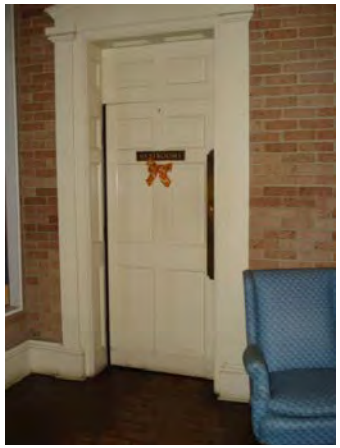
Lobby signs don't meet standards. Most signs meet this standard. The signs in the lobby area doesn not Photo #:

• Install tactile sign • Relocate sign • *If constructed before 3/15/2010 and a person may approach within 3 inches of the sign without encountering protruding objects or standing within the door swing, relocation not required *If constructed before 3/15/2012 and mounted no higher than 60 inches to the centerline of the sign, relocation not required **Proposed Solution** A sign with braille has been added to correct this. 8/28/2013 Sign has been mounted on the latch side of the door. 8/28/2013 The obstacle has been

moved away from the door. 8/28/2013

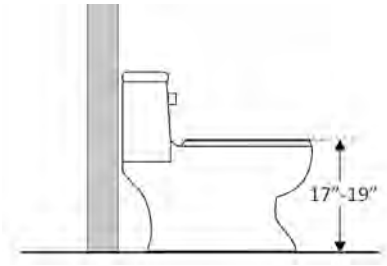
3.32	Is the height of the water closet no less than 17 inches and no greater than 19 inches above the floor measured to the top of the seat?	☐ Yes ☒ No Measurement: 21"

The water closet is on platform. Photo #: See photo above	• Adjust toilet height • Replace toilet • **Proposed Solution** NO action taken, this will be addressed during the next major facility renovation.

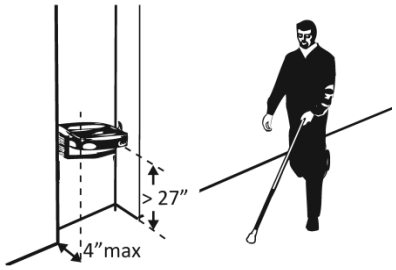
Priority 4 – Additional Access				Comments	Possible Solutions
Drinking Fountains *(2010 Standards – 602)*					
4.9	If the leading (bottom) edge of the fountain is higher than 27 inches above the floor, does the front of the fountain protrude no more than 4 inches into the circulation path?	☐ Yes ☒ No Measurement: 32”

The fountains are in the flow of walking traffic. Photo #: 	• Adjust drinking fountain • Replace drinking fountain • Add tactile warning such as permanent planter or partial walls **Proposed Solution** No action taken, this will be addressed during the next major facility renovation.

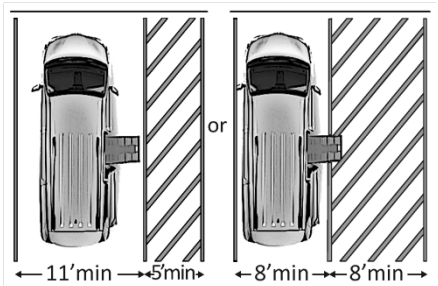
1.5	Is the van accessible space: At least 11 feet wide with an access aisle at least 5 feet wide? Or At least 8 feet wide with an access aisle at least 8 feet wide?	☒ Yes ☐ No Measurement: ☐ Yes ☐ No Measurement:

1991 on RT. 2010 on LT. Photo #:	• Reconfigure to provide van-accessible space(s) • •
1.6	Is at least 98 inches of vertical clearance provided for the van accessible space?	☒ Yes ☐ No Measurement:

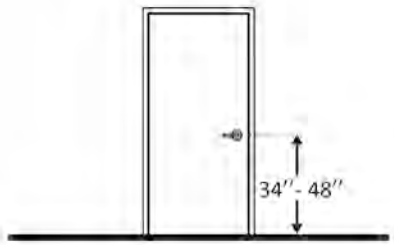
1.45	Are the operable parts of the door hardware no less than 34 inches and no greater than 48 inches above the floor or ground surface? 48” high 1991 ADA	☒ Yes ☐ No Measurement: 33"

Photo #:	• Change hardware height • •

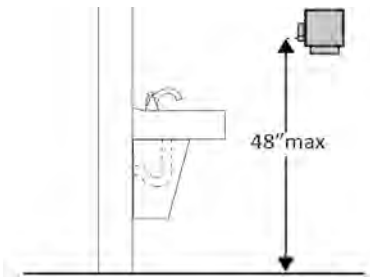
Priority 3 – Toilet Rooms				**Comments**	**Possible Solutions**
Soap Dispensers and Hand Dryers *(2010 Standards – 603)*					
3.29	Are the operable parts of the hand dryer or towel dispenser within one of the following reach ranges: Not over an obstruction: no higher than 48 inches above the floor?	☐ Yes ☒ No Measurement: 53"

Photo #:	• Adjust dispensers • Replace with or provide additional accessible dispensers •
Water Closets in Single-User Toilet Rooms and Compartments (Stalls) *(2010 Standards – 603 & 609)* **Note: 2010 Standards refer to toilets as water closets.**

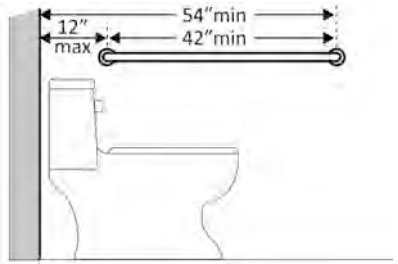
3.33	Does it extend at least 54 inches from the rear wall?	☐ Yes ☒ No Measurement: 49"

Photo #:	• Install grab bar • Relocate grab bar • Relocate objects * If constructed before 3/15/2012 grab bars do not need to be relocated; there are no space requirements above and below grab bars in the 1991 Standards
Toilet Compartments (Stalls) *(2010 Standards – 604)*

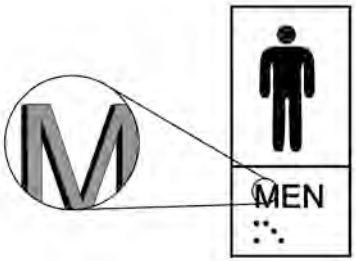
3.5	Do text characters contrast with their backgrounds? Are text characters raised? Is there Braille? Is the sign mounted:	☒ Yes ☐ No ☐ Yes ☒ No ☐ Yes ☒ No

• Install tactile sign • Relocate sign •

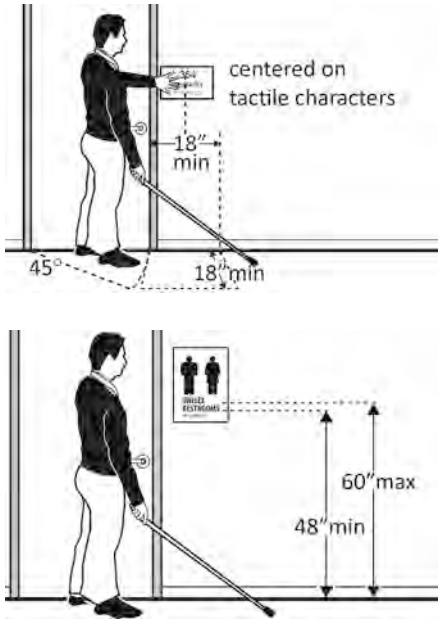
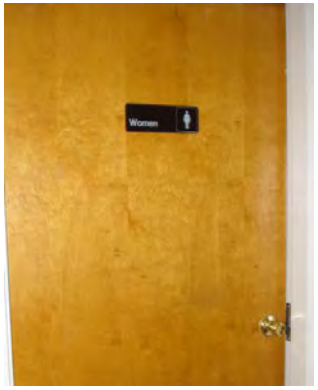
On the wall on the latch side of the door? Note: Signs are permitted on the push side of doors with closers and without hold-open devices. With clear floor space beyond the arc of the door swing between the closed position and 45-degree open position, at least 18 x 18 inches centered on the tactile characters? * So the baseline of the lowest character is at least 48 inches above the floor and the baseline of the highest character is no more than 60 inches above the floor? *	☐ Yes ☒ No ☐ Yes ☒ No Measurement: ☐ Yes ☒ No Measurement: 64"

60" max to center 1991 ADA	Photo #:

*If constructed before 3/15/2010 and a person may approach within 3 inches of the sign without encountering protruding objects or standing within the door swing, relocation not required *If constructed before 3/15/2012 and mounted no higher than 60 inches to the centerline of the sign, relocation is not required

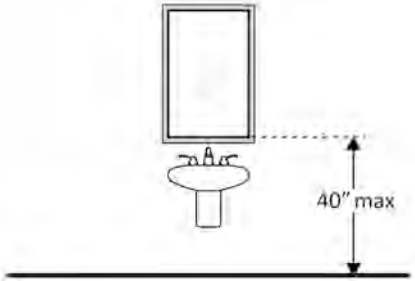
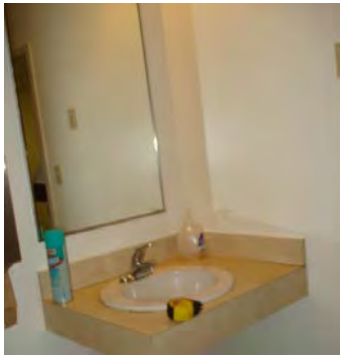
3.19	If the mirror is over a lavatory or countertop, is the bottom edge of the reflecting surface no higher than 40 inches above the floor? Or If the mirror is not over the lavatory or countertop, is the bottom edge of the reflecting surface no higher than 35 inches above the floor?*	☐ Yes ☒ No Measurement: 43" ☐ Yes ☐ No Measurement:

* If installed before 3/15/2012 and the bottom edge of the reflecting surface is no higher than 40 inches above the floor, lowering the mirror to 35 inches is not required • Lower the mirror • Add another mirror •

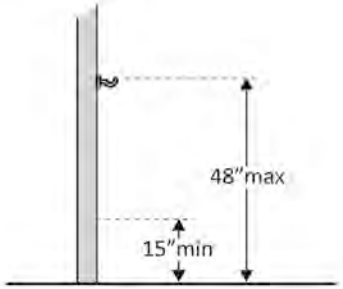
3.20	If there is a coat hook, is it no less than 15 inches and no greater than 48 inches above the floor? 54" for side reach 1991 ADA	☐ Yes ☒ No Measurement:

No hook. Photo #:	• Adjust hook • Replace with or provide additional accessible hook •

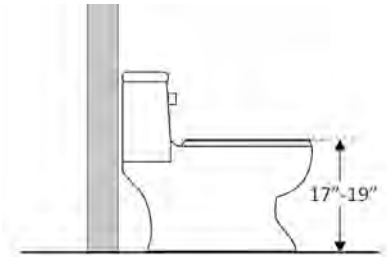
3.32	Is the height of the water closet no less than 17 inches and no greater than 19 inches above the floor measured to the top of the seat?	☐ Yes ☒ No Measurement: 15.5"

Photo #:	• Adjust toilet height • Replace toilet •
3.34	Is there a grab bar at least 36 inches long on the rear wall? Does it extend at least 12 inches from the centerline of the water closet on one side (side wall)? Does it extend at least 24 inches on the other (open) side?	☐ Yes ☒ No Measurement: 21" ☒ Yes ☐ No Measurement: ☐ Yes ☒ No Measurement:

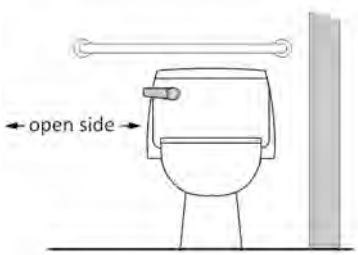
Photo #: 	• Install grab bar • Relocate grab bar • Relocate objects • * If constructed before 3/15/2012 grab bars do not need to be relocated; there are no space requirements above and below grab bars in the 1991 Standards
3.37	Is the flush control on the open side of the water closet?	☐ Yes ☒ No

Photo #:	• Move control • •

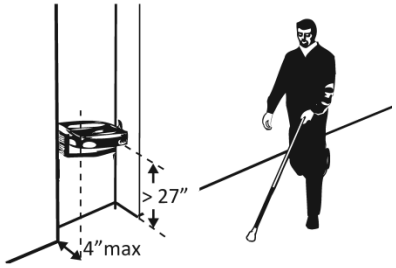
Priority 4 – Additional Access				Comments	Possible Solutions
Drinking Fountains *(2010 Standards – 602)*					
4.9	If the leading (bottom) edge of the fountain is higher than 27 inches above the floor, does the front of the fountain protrude no more than 4 inches into the circulation path?	☐ Yes ☒ No Measurement:

Photo #:	• Adjust drinking fountain • Replace drinking fountain • Add tactile warning such as permanent planter or partial walls

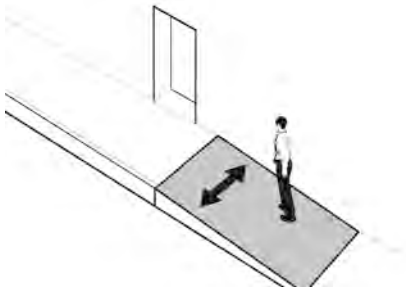
Priority 1 – Approach & Entrance			**Comments**	**Possible Solutions**
Exterior Accessible Route *(2010 Standards – Ch.4)*				
1.18 Is the cross slope no steeper than 1:48? Or 2%	☐ Yes ☒ No Measurement: 2.7 / 2.4 / 3.4

Photo #: 	• Regrade or Reconstruct to 1:48 max. • • **Proposed Solution** No action taken, this will be address during the next major facility renovation
Entrance *(2010 Standards – 404)*				
1.49 Are edges of carpets or mats securely attached to minimize tripping hazards?	☐ Yes ☒ No		Photo #:	• Secure carpeting or mats at edges • • **Proposed Solution** The mats edges have been secured with "double sided' adhesive tape.

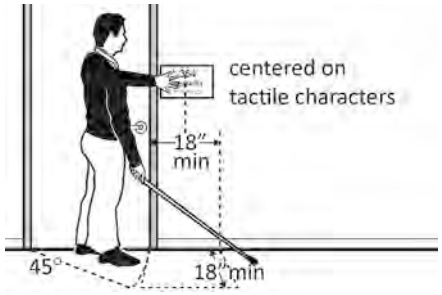
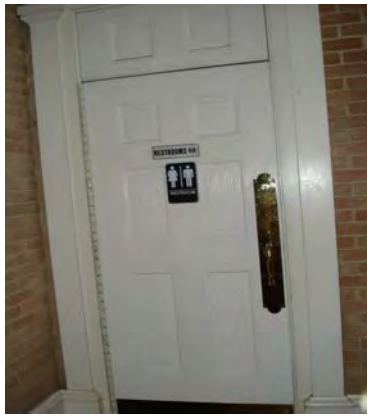
Interior signs are mounted on the doors.	• Install tactile sign • Relocate sign • *If constructed before

Are text characters raised? Is there Braille? Is the sign mounted: On the wall on the latch side of the door? Note: Signs are permitted on the push side of doors with closers and without hold-open devices.	☐Yes ☒No ☐Yes ☒No

3/15/2010 and a person may approach within 3 inches of the sign without encountering protruding objects or standing within the door swing, relocation not required *If constructed before 3/15/2012 and mounted no higher than 60 inches to the centerline of the sign, relocation not required **Proposed Solution** Signs have been added or relocated to the latch sides of the doors.
Sales & Service Counters – banks, stores, dry cleaners, auto repair shops, fitness clubs, etc. *(2010 Standards – 904)*

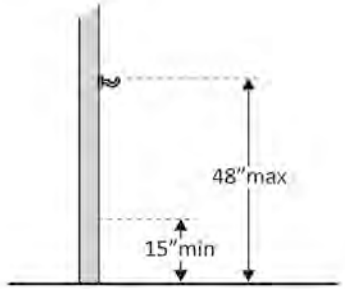
Priority 3 – Toilet Rooms				**Comments**	**Possible Solutions**
In the Toilet Room					
3.20	If there is a coat hook, is it no less than 15 inches and no greater than 48 inches above the floor? 54" for side reach 1991 ADA	☐ Yes ☒ No Measurement: 55"

Photo #: 6201	• Adjust hook • Replace with or provide additional accessible hook • **Proposed solution** An additional coat hook has been added at the ADA height standard.
Soap Dispensers and Hand Dryers *(2010 Standards – 603)*

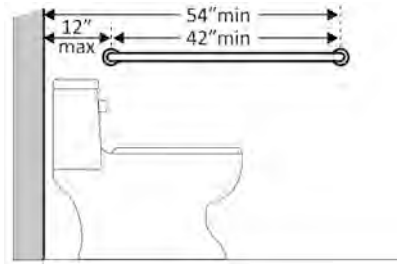
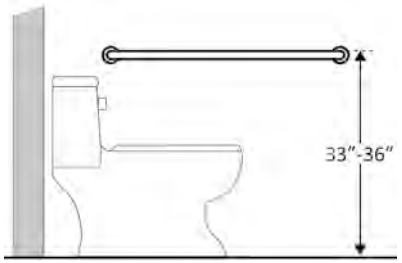
3.33	Is there a grab bar at least 42 inches long on the side wall? Is it located no more than 12 inches from the rear wall? Does it extend at least 54 inches from the rear wall? Is it mounted no less than 33 inches and no greater than 36 inches above the floor to the top of the gripping surface?	☐ Yes ☒ No Measurement: 36" ☒ Yes ☐ No Measurement: ☐ Yes ☒ No Measurement: 42" ☐ Yes ☒ No Measurement: 38"

Photo #: 	• Install grab bar • Relocate grab bar • Relocate objects • * If constructed before 3/15/2012 grab bars do not need to be relocated; there are no space requirements above and below grab bars in the 1991 Standards **Proposed Solution** No action taken, this will be addressed during the next major facility renovation.

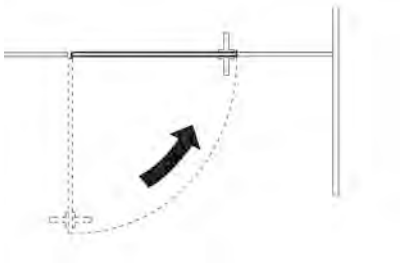
Proposed Solution No action taken, this will be addressed during the next major facility renovation.
Toilet Compartments (Stalls) *(2010 Standards – 604)*				
3.43 Is the door self-closing?	☐ Yes ☒ No

Photo #: 	• Add closer • Replace door Or Provide Continuous spring hinges • **Proposed Solution** We added self closing hinges to correct this.

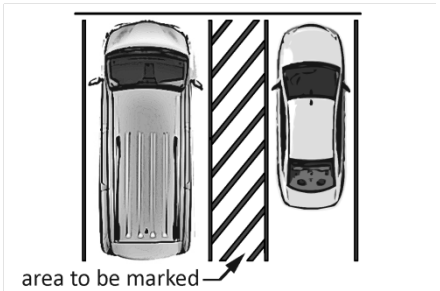
1.7	Are the access aisles marked so as to discourage parking in them?	☐ Yes ☒ No

Photo #:	• Mark access aisles • • The marking method and color may be addressed by state/local requirements

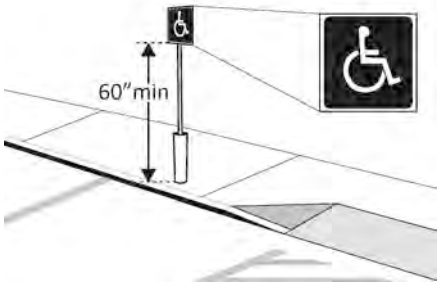
1.10	Are accessible spaces Identified with a sign that includes the International Symbol of Accessibility? Is the bottom of the sign at least 60 inches above the ground? MDOT say 7' to bottom of sign	☐ Yes ☒ No ☐ Yes ☒ No Measurement:

No signs. Photo #:	• Install signs • • The International Symbol of Accessibility is not required on the ground by the 2010 Standards

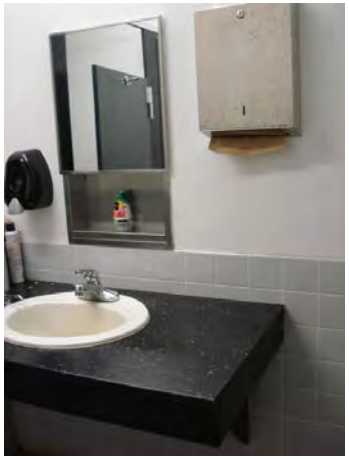
Priority 3 – Toilet Rooms				**Comments**	**Possible Solutions**
Entrance *(2010 Standards – 404)*					
3.11	Can the door be opened easily (5 pounds maximum force)?	☐ Yes ☒ No Measurement: 6lb		Photo #:	• Adjust or replace closers • Install lighter doors • Install power-assisted or automatic door openers
3.19	If the mirror is over a lavatory or countertop, is the bottom edge of the reflecting surface no higher than 40 inches above the floor? Or If the mirror is not over the lavatory or countertop, is the bottom edge of the reflecting surface no higher than 35 inches above the floor?*	☐ Yes ☒ No Measurement: 50" ☐ Yes ☐ No Measurement:

* If installed before 3/15/2012 and the bottom edge of the reflecting surface is no higher than 40 inches above the floor, lowering the mirror to 35 inches is not required • Lower the mirror • Add another mirror •

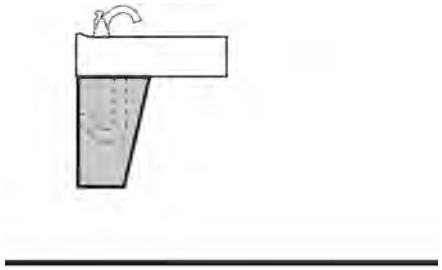
3.26	Are pipes below the lavatory insulated or otherwise configured to protect against contact?	☐ Yes ☒ No

Photo #:	• Install insulation • Install cover panel •
Soap Dispensers and Hand Dryers *(2010 Standards – 603)*

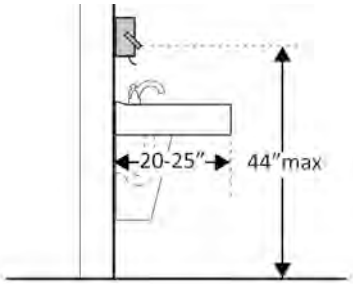
3.29	Are the operable parts of the hand dryer or towel dispenser within one of the following reach ranges: Above lavatories or counters no less than 20 inches and no greater than 25 inches deep: no higher than 44 inches above the floor?	☐ Yes ☒ No Measurement: 54"

• Adjust dispensers • Replace with or provide additional accessible dispensers •

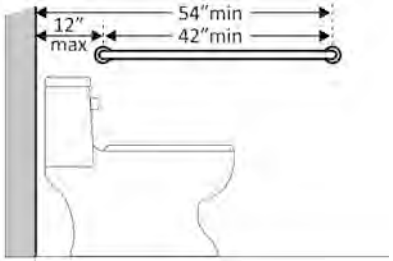
3.33 Is there a grab bar at least 42 inches long on the side wall? Is it located no more than 12 inches from the rear wall? Does it extend at least 54 inches from the rear wall?	☐ Yes ☒ No Measurement: 19" ☐ Yes ☒ No Measurement: ☐ Yes ☒ No Measurement: 42"

Photo #: See photo above	• Install grab bar • Relocate grab bar • Relocate objects • * If constructed before 3/15/2012 grab bars do not need to be relocated; there are no space requirements above and below grab bars in the 1991 Standards

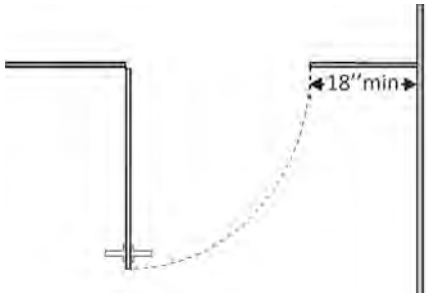
1991 Standards
Toilet Compartments (Stalls) *(2010 Standards – 604)*				
3.42 If there is a front approach to the pull side of the door, is there at least 18 inches of maneuvering clearance beyond the latch side plus 60 inches clear depth?*	☐ Yes ☒ No Measurement: 5"

Photo #: 	*See 2010 Standards 604.8.1.2 Doors for maneuvering clearance requirements on the push side of the door and side approaches to the pull side of the door • Remove obstructions •
3.44 Are there door pulls on both sides of the door that are operable with one hand and do not require tight grasping pinching or twisting of the wrist?*	☐ Yes ☒ No		Photo #:	* If constructed before 3/15/2012 door pulls do not need to be added; door pulls are not required in the 1991 Standards • Replace hardware • •

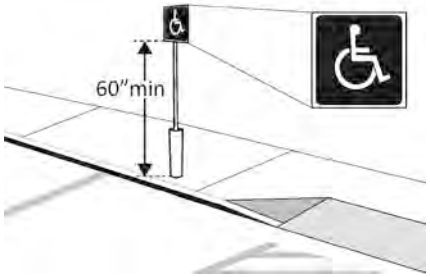
1.10	Are accessible spaces Identified with a sign that includes the International Symbol of Accessibility? Is the bottom of the sign at least 60 inches above the ground? MDOT say 7' to bottom of sign	☐ Yes ☒ No ☐ Yes ☒ No Measurement:

Photo #: See photo above	• Install signs • • The International Symbol of Accessibility is not required on the ground by the 2010 Standards

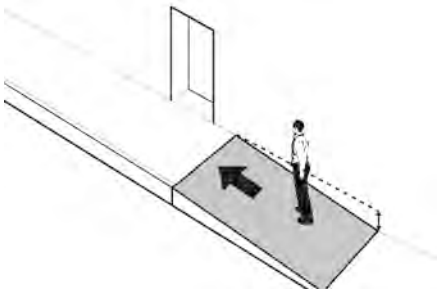
1.17	Is the running slope no steeper than 1:20, i.e. for every inch of height change there are at least 20 inches of route run? Or 5%	☐ Yes ☒ No Measurement: 6%

The sidewalk infront of intence Photo #: 	• Regrade to 1:20 max. • If steeper than 1:20 and no steeper than 1:12, treat as a ramp and add other features such as edge protection and handrails •
1.18	Is the cross slope no steeper than 1:48? Or 2%	☐ Yes ☒ No Measurement: 12%

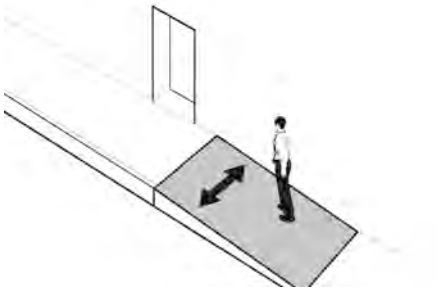
The sidewalk infront of intence Photo #: 	• Regrade or Reconstruct to 1:48 max. • •

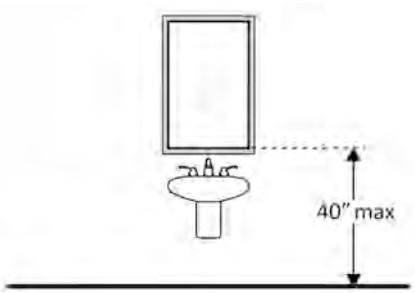
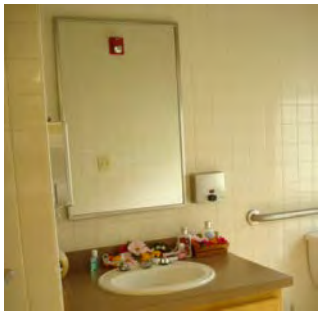
3.19	If the mirror is over a lavatory or countertop, is the bottom edge of the reflecting surface no higher than 40 inches above the floor? Or If the mirror is not over the lavatory or countertop, is the bottom edge of the reflecting surface no higher than 35 inches above the floor?*	☒ Yes ☐ No Measurement: 41" ☐ Yes ☐ No Measurement:

* If installed before 3/15/2012 and the bottom edge of the reflecting surface is no higher than 40 inches above the floor, lowering the mirror to 35 inches is not required • Lower the mirror • Add another mirror •
Lavatories *(2010 Standards – 606)* **Note: 2010 Standards refer to sinks in toilet rooms as lavatories.**

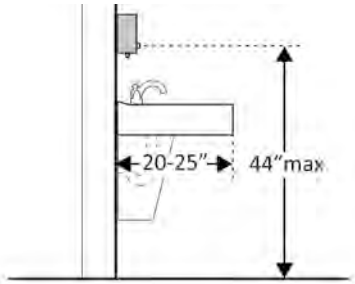
3.28	Are the operable parts of the soap dispenser within one of the following reach ranges: Above lavatories or counters no less than 20 inches and no greater than 25 inches deep: no higher than 44 inches above the floor?	☐ Yes ☒ No Measurement: 52"

Photo #:	• Adjust dispensers • Replace with or provide additional accessible dispensers •

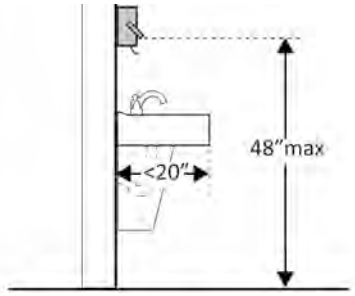
3.29	Are the operable parts of the hand dryer or towel dispenser within one of the following reach ranges: Above lavatories less than 20 inches deep: no higher than 48 inches above the floor?	☐ Yes ☒ No Measurement: 51"

Photo #:	• Adjust dispensers • Replace with or provide additional accessible dispensers •

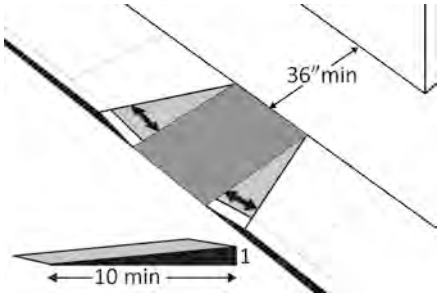
Priority 1 – Approach & Entrance			**Comments**	**Possible Solutions**
Curb Ramps *(2010 Standards – 406)*				
1.23 At the top of the curb ramp is there a level landing (slope no steeper than 1:48 in all directions) that is at least 36 inches long and at least as wide as the curb ramp?	☐ Yes ☒ No Measurement: 5.6 / 7

The ramps at the East B. RA do not level landing. Photo #: 	• Reconfigure • Add ramp flares •
Ramps *(2010 Standards – 405 & 505)* **Note: If any portion of the accessible route is steeper than 1:20, it should be treated as a ramp.**

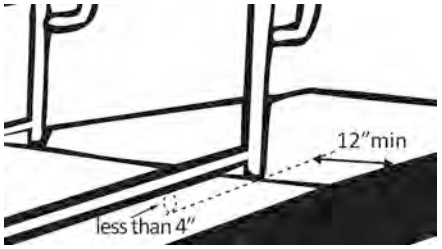
1.36 To prevent wheelchair casters and crutch tips from falling off: Does the surface of the ramp extend at least 12 inches beyond the inside face of the handrail? Or Is there a curb or barrier that prevents the passage of a 4-inch diameter sphere?	☐ Yes ☒ No Measurement: ☐ Yes ☒ No Measurement:

Photo #: 	• Add curb • Add barrier • Extend ramp width • **Proposed Solution** No action taken, this will be addressed on the next major facility renovation.

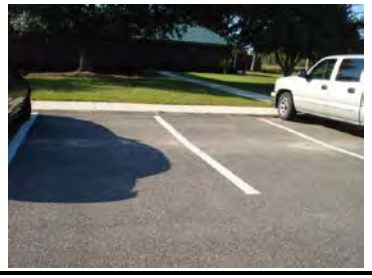
Comments	Possible Solutions
1.2	If parking is provided for the public, are an adequate number of accessible spaces provided?	☐ Yes ☒ No Total #:6 Accessible #: 0	**otal Spaces** / **Accessible Spaces** 1 - 25 / 1 26 - 50 / 2 51 - 75 / 3 76 - 100 / 4 100+ see 2010 Standards 208.2	Photo #:

• Reconfigure by repainting lines • •

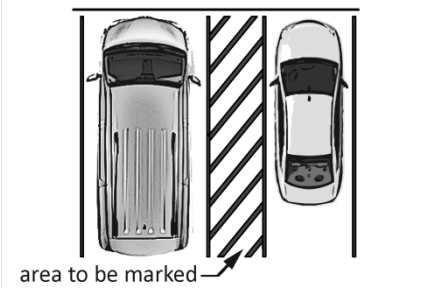
1.7	Are the access aisles marked so as to discourage parking in them?	☐ Yes ☒ No

Photo #: See photo above	• Mark access aisles • • The marking method and color may be addressed by state/local requirements

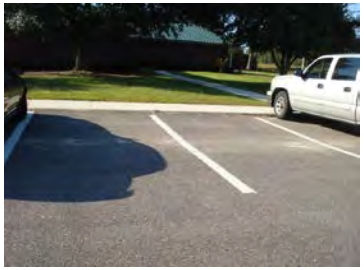
No signs Photo #:

• Install signs • • The International Symbol of Accessibility is not required on the ground by the 2010 Standards
1.11	Are there signs reading "van accessible" at van accessible spaces?	☐ Yes ☐ No		No signs Photo #: See photo above	• Install signs • •

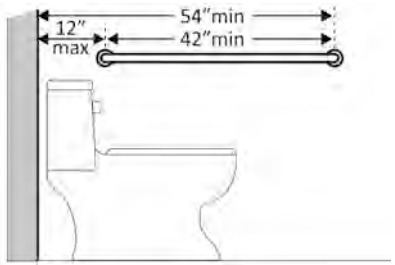
Priority 3 – Toilet Rooms			**Comments**	**Possible Solutions**
3.2 Are there signs at inaccessible toilet rooms that give directions to accessible toilet rooms?	☐ Yes ☒ No		Photo #:	• Install signs • •
Water Closets in Single-User Toilet Rooms and Compartments (Stalls) *(2010 Standards – 603 & 609)* **Note: 2010 Standards refer to toilets as water closets.**				
3.33 Does it extend at least 54 inches from the rear wall?	☐ Yes ☒ No Measurement: 51"

Photo #: 	• Install grab bar • Relocate grab bar • Relocate objects • * If constructed before 3/15/2012 grab bars do not need to be relocated; there are no space requirements above and below grab bars in the 1991 Standards

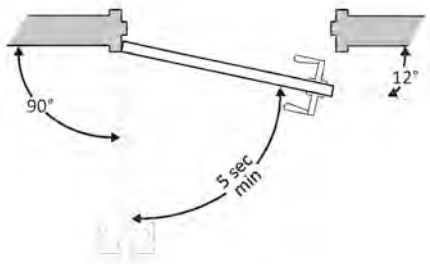
1.46	If the door has a closer, does it take at least 5 seconds to close from an open position of 90 degrees to a position of 12 degrees from the latch? 70 Degrees and 3 min 1991 ADA	☐ Yes ☒ No Measurement: 2

Photo #:	• Adjust closer • • **Proposed Solution** Door closure has been adjusted to meet ADA time requirements.

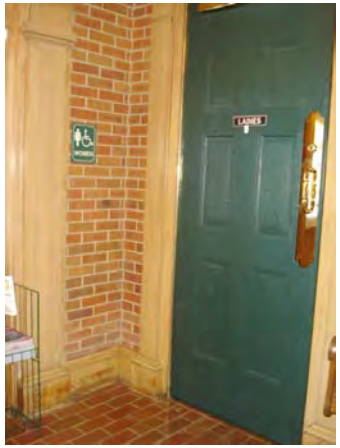
Not all signs are mounted on the latch side of the door. Photo #:

• Install tactile sign • Relocate sign • *If constructed before 3/15/2010 and a person may approach within 3 inches of the sign without encountering protruding objects or standing within the door swing, relocation not required **Proposed Solution** An additional Braille sign has been added on the latch side of the door.

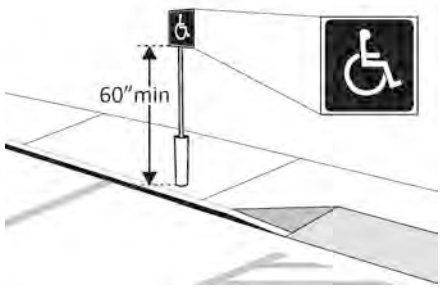
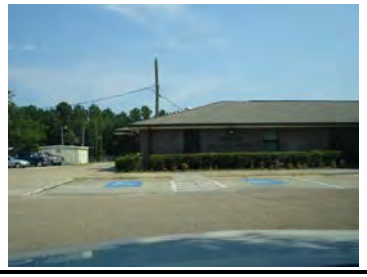
1.10	Are accessible spaces Identified with a sign that includes the International Symbol of Accessibility? Is the bottom of the sign at least 60 inches above the ground? MDOT say 7' to bottom of sign	☐ Yes ☒ No ☐ Yes ☐ No Measurement:

No Signs Photo #:

The International Symbol of Accessibility is not required on the ground by the 2010 Standards	• Install signs • •

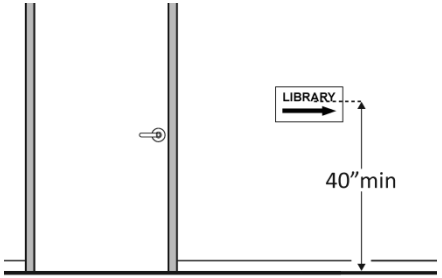
2.39	If there are signs that provide direction to or information about interior spaces: Do text characters contrast with their backgrounds? Is the sign mounted so that characters are at least 40 inches above the floor? 60" Max 1991 ADA	☒ Yes ☐ No ☐ Yes ☒ No Measurement: 62"

Photo #: See photo above	• Install signs with contrasting characters • Change sign height • Raised characters and Braille are not required

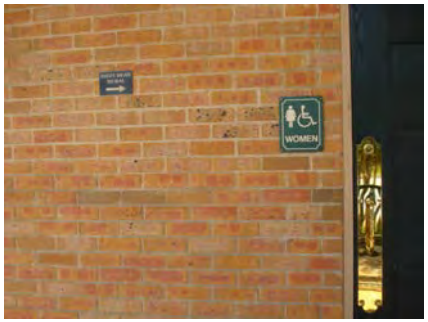
60" to center 1991 ADA Photo #:

• Install signs with contrasting characters • Change sign height • Raised characters and Braille are not required **Proposed Solutions** Signs have been lowered to ADA standards.
Sales & Service Counters – banks, stores, dry cleaners, auto repair shops, fitness clubs, etc. *(2010 Standards – 904)*

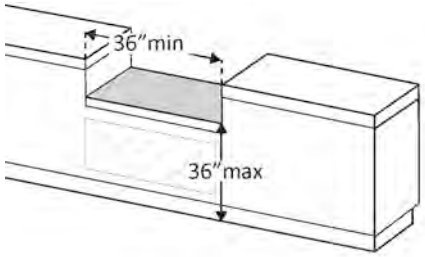
2.76	Is there a portion of at least one of each type of counter that is: No higher than 36 inches above the floor? At least 36 inches long?	☒ Yes ☐ No Measurement: 34" ☐ Yes ☒ No Measurement: 34"

Photo #: 	• Lower section of counter • Lengthen section of counter • **Proposed Solution** No action taken, this will be addressed at the next major facility renovation.

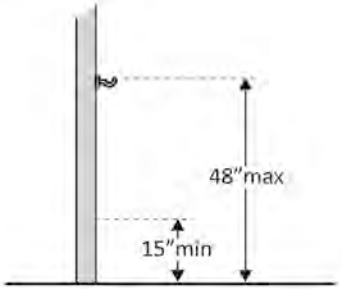
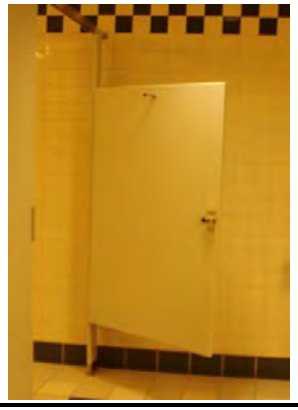
3.20	If there is a coat hook, is it no less than 15 inches and no greater than 48 inches above the floor? 54" for side reach 1991 ADA	☐ Yes ☒ No Measurement: 67"

• Adjust hook • Replace with or provide additional accessible hook • **Proposed Solution** An additional coat hook has been added and set at ADA standards.

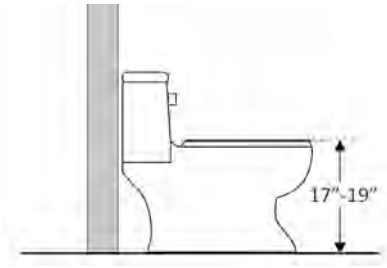
3.32 Is the height of the water closet no less than 17 inches and no greater than 19 inches above the floor measured to the top of the seat?	☐ Yes ☒ No Measurement: 20"

Photo #: 	• Adjust toilet height • Replace toilet • **Proposed Solution** No action taken, this will be addressed at the next major facility renovation.

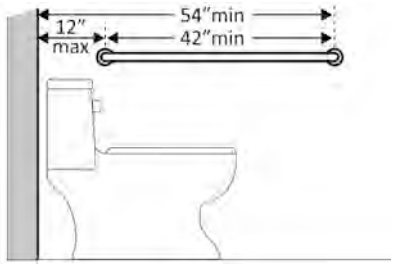
3.33 Does it extend at least 54 inches from the rear wall?	☐ Yes ☒ No Measurement: 48"

Photo #: See above photo	• Install grab bar • Relocate grab bar • Relocate objects • * If constructed before 3/15/2012 grab bars do not need to be relocated; there are no space requirements above and below grab bars in the 1991 Standards **Proposed Solution** No action taken, this will be addressed at the next major facility renovation.
Toilet Compartments (Stalls) *(2010 Standards – 604)*

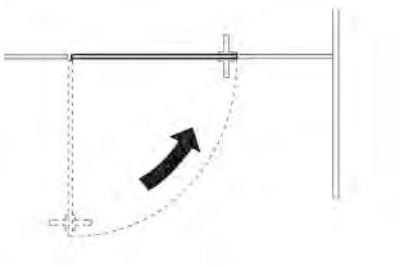
3.43 Is the door self-closing?	☐ Yes ☒ No

Photo #:	• Add closer • Replace door Or Provide Continuous spring hinges • **Proposed Solution** This has been corrected by adding a self closing hinge to the door.

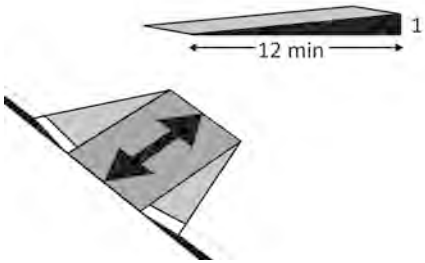
Exterior Accessible Route *(2010 Standards – Ch.4)*					
Curb Ramps *(2010 Standards – 406)*					
1.20	Is the running slope of the curb ramp no steeper than 1:12, i.e. for every inch of height change there are at least 12 inches of curb ramp run?	☐ Yes ☒ No Measurement: 9.2%

Photo #:	• Regrade or Reconstruct curb ramp • • **Proposed Solutions** Not feasible at this time adjust. Looking at the possibility of installing hand rails during the 2013 calendar year.

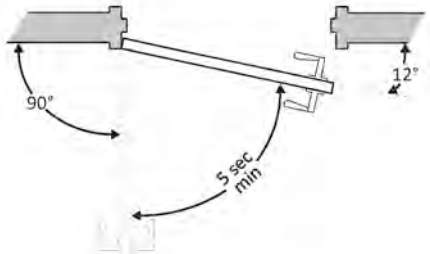
Priority 3 – Toilet Rooms				**Comments**	**Possible Solutions**
Entrance *(2010 Standards – 404)*					
3.12	If the door has a closer, does it take at least 5 seconds to close from an open position of 90 degrees to a position of 12 degrees from the latch? 70 degrees and 3 min. 1991 ADA	☐ Yes ☒ No Measurement:

Photo #:	• Adjust closer • • **Proposed Solutions** Door closures will be adjusted during 2013 calendar year.
In the Toilet Room					
3.20	If there is a coat hook, is it no less than 15 inches and no greater than 48 inches above the floor? 54" for side reach 1991 ADA	☐ Yes ☒ No Measurement: 55"

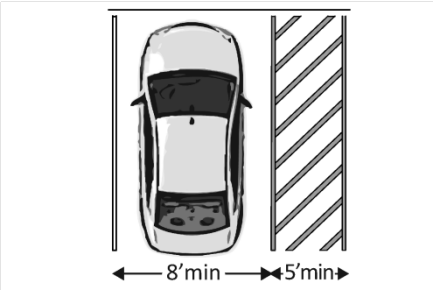
1.4	Are accessible spaces at least 8 feet wide with an access aisle at least 5 feet wide? 1991 ADA	☐ Yes ☒ No Measurement:

No aisle markings, space is wide enough for 11' space with 5' aisle. Photo #: See above photo.	• Reconfigure by repainting lines Two spaces can share an access aisle **Proposed Solutions** Striping will be modified to be in compliance with this standard. Work should be performed during 2013 calendar year.

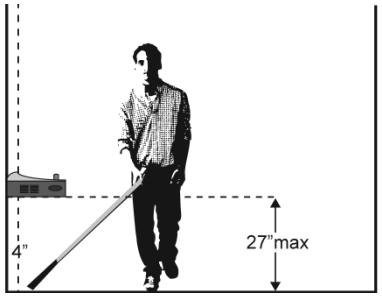
Priority 2 – Access to Goods & Services				Comments	Possible Solutions
Interior Accessible Route *(2010 Standards – Ch.4)*					
2.8	Do all objects on circulation paths through public areas, e.g. fire extinguishers, drinking fountains, signs, etc., protrude no more than 4 inches into the path?	☐ Yes ☒ No Measurement: 19"

Photo #:	• Remove object • Add tactile warning such as permanent planter or partial walls • **Proposed Solutions** Obstruction appears to be in corner of room and not on the circulation path. Suggest to monitor for access issues related to this location.
Interior Doors – to classrooms, medical exam rooms, conference rooms, etc. *(2010 Standards – 404)*

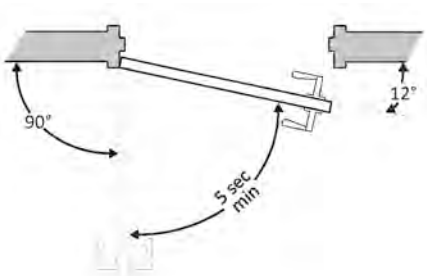
2.46	If the door has a closer, does it take at least 5 seconds to close from an open position of 90 degrees to a position of 12 degrees from the latch? 70 degrees and 3 min. 1991 ADA	☐ Yes ☒ No Measurement:

Photo #:	• Adjust closer • • **Proposed Solutions** Door closer will be adjusted within the 2013 calendar year.
Rooms and Spaces – stores, supermarkets, libraries, etc. *(2010 Standards – 302, 304, & 402)*

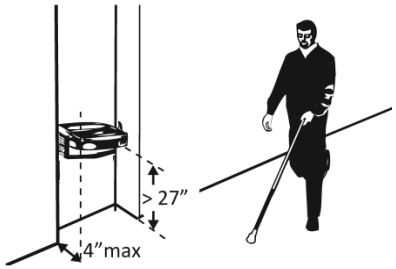
Priority 4 – Additional Access				Comments	Possible Solutions
Drinking Fountains *(2010 Standards – 602)*					
4.9	If the leading (bottom) edge of the fountain is higher than 27 inches above the floor, does the front of the fountain protrude no more than 4 inches into the circulation path?	☐ Yes ☒ No Measurement: 32"

Photo #: 	• Adjust drinking fountain • Replace drinking fountain • Add tactile warning such as permanent planter or partial walls

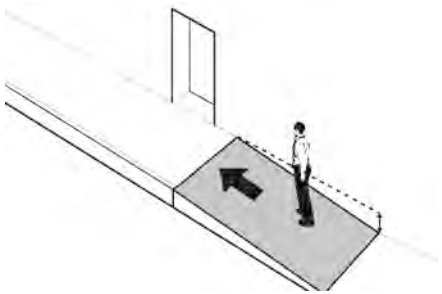
1.11	Are there signs reading "van accessible" at van accessible spaces?	☐ Yes ☒ No		Photo #:	• Install signs • • **Proposed Solutions** Van accessible signs will be installed within 2013
Exterior Accessible Route *(2010 Standards – Ch.4)*					
1.17	Is the running slope no steeper than 1:20, i.e. for every inch of height change there are at least 20 inches of route run? Or 5%	☐ Yes ☒ No Measurement: 6.4

Photo #:	• Regrade to 1:20 max. • If steeper than 1:20 and no steeper than 1:12, treat as a ramp and add other features such as edge protection and handrails • **Proposed Solutions** Handrails will be installed within the 2014 calendar year.
Entrance *(2010 Standards – 404)*					
1.49	Are edges of carpets or mats securely attached to minimize tripping hazards?	☐ Yes ☒ No		Photo #:	• Secure carpeting or mats at edges • • **Proposed Solutions** Replace carpet as

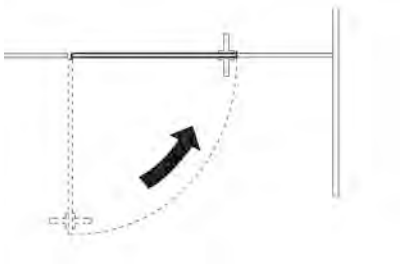
3.43 Is the door self-closing?	☐ Yes ☒ No

Photo #:	• Add closer • Replace door Or Provide Continuous spring hinges • **Proposed Solutions** Continuous spring hinges will be installed during the 2013 calendar year.

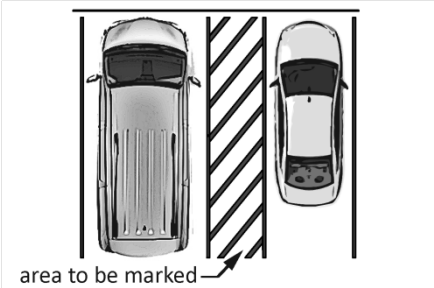
performed during 2013 calendar year.
1.7	Are the access aisles marked so as to discourage parking in them?	☐ Yes ☒ No

Photo #:	• Mark access aisles • • The marking method and color may be addressed by state/local requirements **Proposed Solutions** Same comment as above.
1.10	Are accessible spaces Identified with a sign that includes the International Symbol of Accessibility? Is the bottom of the sign at least 60 inches above the ground? MDOT say 7' to bottom of sign	☐ Yes ☒ No ☐ Yes ☒ No Measurement:

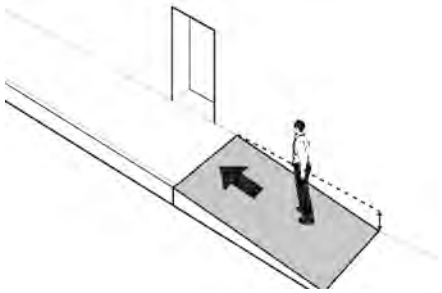
1.11	Are there signs reading "van accessible" at van accessible spaces?	☐ Yes ☒ No		Photo #: See above photo	• Install signs • • **Proposed Solutions** Same comments as above.
Exterior Accessible Route *(2010 Standards – Ch.4)*					
1.17	Is the running slope no steeper than 1:20, i.e. for every inch of height change there are at least 20 inches of route run? Or 5%	☐ Yes ☒ No Measurement: 6.4

Photo #: See above photo	• Regrade to 1:20 max. • If steeper than 1:20 and no steeper than 1:12, treat as a ramp and add other features such as edge protection and handrails • **Proposed Solutions** Not feasible to regrade running slope. We will install handrails. This work is anticipated to be complete within the 2014 calendar year.

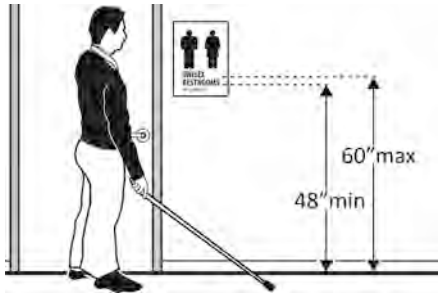
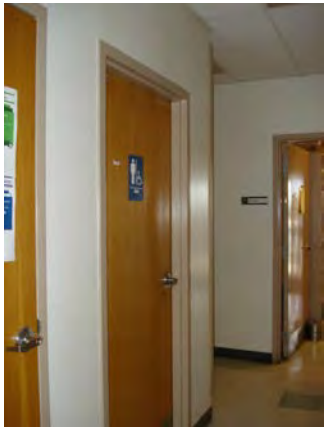
Priority 3 – Toilet Rooms			**Comments**	**Possible Solutions**
Signs at Toilet Rooms *(2010 Standards – 703)*				
3.5 Is the sign mounted: On the wall on the latch side of the door?	☐ Yes ☒ No

• Install tactile sign • Relocate sign • **Proposed Solutions** This sign will be relocated to the wall on the latch side of the door. This will be completed within 2013 calendar year.
Entrance *(2010 Standards – 404)*

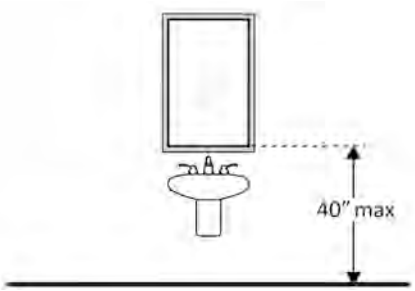
3.19	If the mirror is over a lavatory or countertop, is the bottom edge of the reflecting surface no higher than 40 inches above the floor? Or If the mirror is not over the lavatory or countertop, is the bottom edge of the reflecting surface no higher than 35 inches above the floor?*	☒ Yes ☐ No Measurement: 41" ☐ Yes ☐ No Measurement:

Photo #: 	* If installed before 3/15/2012 and the bottom edge of the reflecting surface is no higher than 40 inches above the floor, lowering the mirror to 35 inches is not required • Lower the mirror • Add another mirror • **Proposed Solutions**

Mirror will be lowered to 40” during 2013 calendar year.
Toilet Compartments (Stalls) *(2010 Standards – 604)*				
3.43 Is the door self-closing?	☐ Yes ☒ No		Photo #:	• Add closer • Replace door Or Provide Continuous spring hinges • **Proposed Solutions** Continuous spring hinges will be installed during 2013 calendar year.

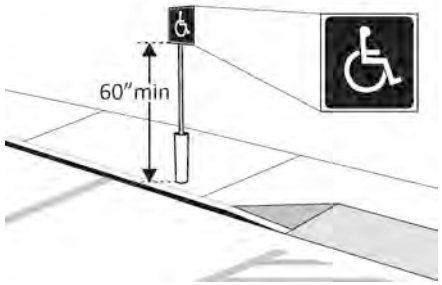
1.10	Are accessible spaces Identified with a sign that includes the International Symbol of Accessibility? Is the bottom of the sign at least 60 inches above the ground? MDOT say 7' to bottom of sign	☐ Yes ☒ No ☐ Yes ☒ No Measurement:

No signs Photo #: See above photo	• Install signs • • The International Symbol of Accessibility is not required on the ground by the 2010 Standards **Proposed Solutions** A sign will be installed within the 2013 calendar

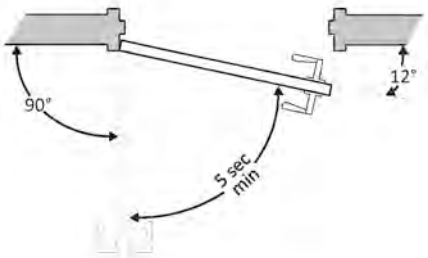
1.46	If the door has a closer, does it take at least 5 seconds to close from an open position of 90 degrees to a position of 12 degrees from the latch? 70 Degrees and 3 min 1991 ADA	☐ Yes ☒ No Measurement: 2

Photo #:	• Adjust closer • • **Proposed Solutions** The door closure will be adjusted within the 2013 calendar year.

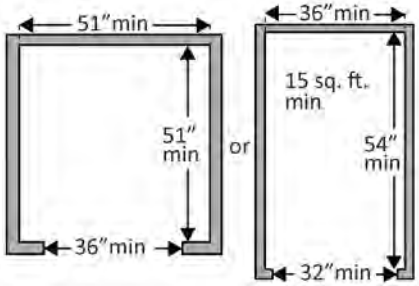
least 32 inches?	Measurement:		Photo #:	
2.26	If there is a LULA elevator, is the interior: At least 51 x 51 inches with a door opening width of at least 36 inches? Or At least 54 inches deep by at least 36 inches wide with at least 15 sq. ft. of clear floor area and a door opening width of at least 32 inches?	☐ Yes ☐ No Measurement: ☐ Yes ☐ No Measurement:

80"W not 51"W 1991 ADA Photo #:	• Replace elevator • •
2.27	If there is a full size or LULA elevator, are the in-car controls: No less than 15 inches and no greater 48 inches above the floor? Or Up to 54 inches above the floor for a parallel approach? 42" Max 1991 ADA	☐ Yes ☐ No Measurement: ☐ Yes ☐ No Measurement:

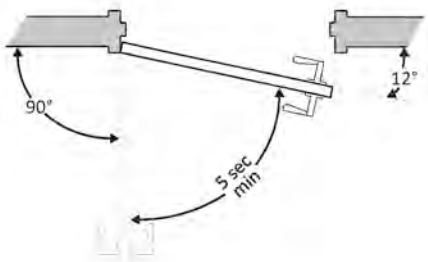
2.46	If the door has a closer, does it take at least 5 seconds to close from an open position of 90 degrees to a position of 12 degrees from the latch? 70 degrees and 3 min. 1991 ADA	☐ Yes ☒ No Measurement:

No closer Photo #:	• Adjust closer • • **Proposed Solutions** Again not sure what door is this referred to. The District Headquarters is a large facility with numerous doors.
Rooms and Spaces – stores, supermarkets, libraries, etc. *(2010 Standards – 302, 304, & 402)*

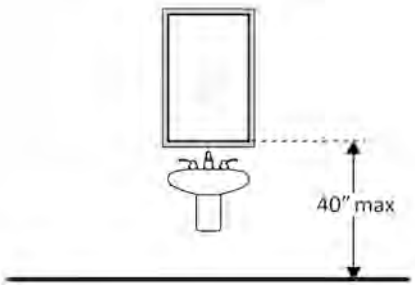
3.19	If the mirror is over a lavatory or countertop, is the bottom edge of the reflecting surface no higher than 40 inches above the floor?	☐ Yes ☒ No Measurement: 41"

Photo #:	* If installed before 3/15/2012 and the bottom edge of the reflecting surface is no higher than 40 inches above the floor, lowering the mirror to 35 inches is not required • Lower the mirror • Add another mirror **Proposed Solutions** We have measured all mirrors within the District Headquarters rest rooms and our measurements are below 40".
3.20	If there is a coat hook, is it no less than 15 inches and no greater than 48 inches above the floor? 54" for side reach 1991 ADA	☐ Yes ☒ No Measurement: 66"

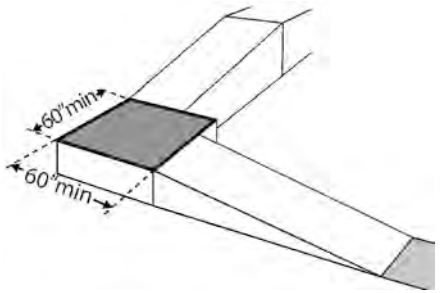
1.29	Is there a level landing where the ramp changes direction that is at least 60 x 60 inches?	☐ Yes ☒ No Measurement:

Photo #:	• Alter ramp • • **Proposed Solutions** Modifications will be made to ramps on the next renovation project..

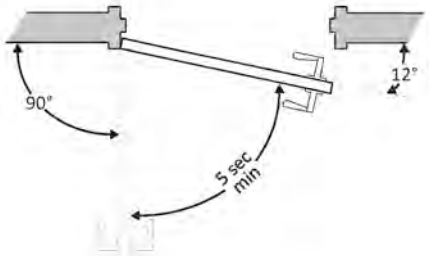
2.46	If the door has a closer, does it take at least 5 seconds to close from an open position of 90 degrees to a position of 12 degrees from the latch? 70 degrees and 3 min. 1991 ADA	☐ Yes ☒ No Measurement:

Photo #:	• Adjust closer • • **Proposed Solutions** Door closure will be adjusted

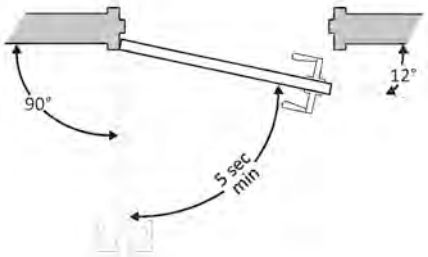
Priority 3 – Toilet Rooms				**Comments**	**Possible Solutions**
Entrance *(2010 Standards – 404)*					
3.12	If the door has a closer, does it take at least 5 seconds to close from an open position of 90 degrees to a position of 12 degrees from the latch? 70 degrees and 3 min. 1991 ADA	☐ Yes ☒ No Measurement:

Photo #:	• Adjust closer • • **Proposed Solutions** Door closure will be adjusted

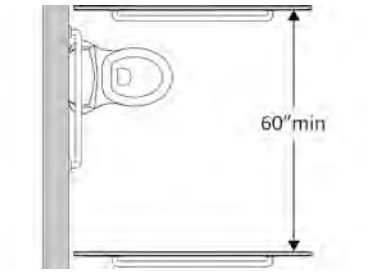
3.47	Is the compartment at least 60 inches wide?	☐ Yes ☒ No Measurement: 41"

Photo #:	• Widen compartment • • **Proposed solutions** This will be addressed during next renovations.
