Mississippi Department of Transportation

ADA TRANSITION PLAN

October 1, 2014

UPDATE

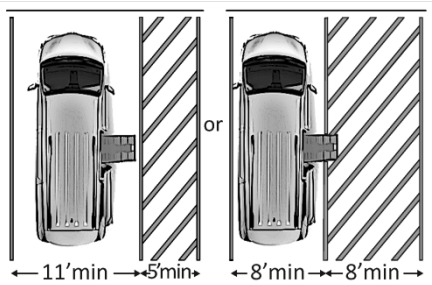
1.5	Is the van accessible space: At least 11 feet wide with an access aisle at least 5 feet wide? Or At least 8 feet wide with an access aisle at least 8 feet wide?	☐ Yes ☒ No Measurement: ☐ Yes ☒ No Measurement:

1991 on RT. 2010 on LT. No define space Photo #:	• Reconfigure to provide van-accessible space(s) • • **Proposed Solutions** Same comment as above.

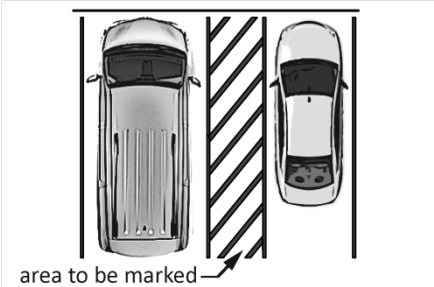
1.7	Are the access aisles marked so as to discourage parking in them?	☐ Yes ☒ No

Photo #:	• Mark access aisles • • The marking method and color may be addressed by state/local requirements **Proposed Solutions** Same comment as above.

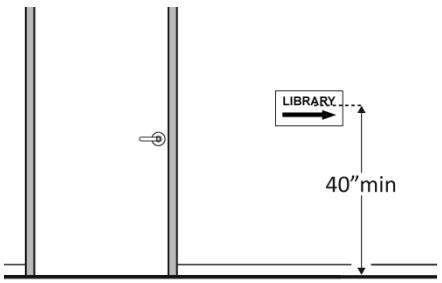
2.39	If there are signs that provide direction to or information about interior spaces: Do text characters contrast with their backgrounds? Is the sign mounted so that characters are at least 40 inches above the floor? 60" Max 1991 ADA	☐ Yes ☒ No ☐ Yes ☒ No Measurement:

60" to center 1991 ADA Photo #:	• Install signs with contrasting characters • Change sign height • Raised characters and Braille are not required **Proposed Solutions** We have reviewed this building and can't identify the signs this is referring to.
Interior Doors – to classrooms, medical exam rooms, conference rooms, etc. *(2010 Standards – 404)*

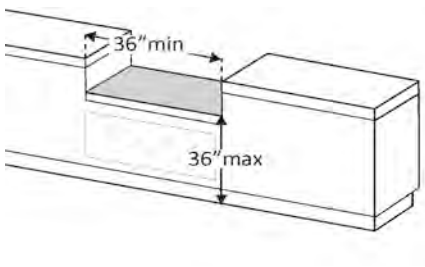
2.76	Is there a portion of at least one of each type of counter that is: No higher than 36 inches above the floor? At least 36 inches long?	☐ Yes ☒ No Measurement: ☐ Yes ☒ No Measurement:

Photo #:	• Lower section of counter • Lengthen section of counter • **Proposed Solutions** Existing sale or service counter is not present???

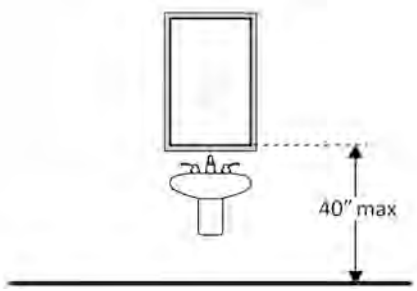
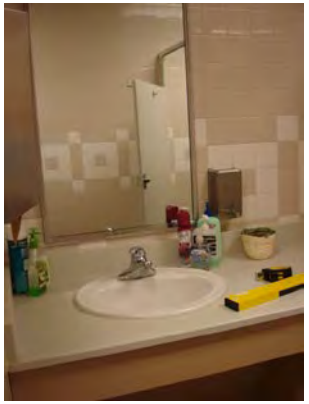
3.19 If the mirror is over a lavatory or countertop, is the bottom edge of the reflecting surface no higher than 40 inches above the floor? Or If the mirror is not over the lavatory or countertop, is the bottom edge of the reflecting surface no higher than 35 inches above the floor?*	☐ Yes ☒ No Measurement: 38" ☐ Yes ☐ No Measurement:

Photo #:	* If installed before 3/15/2012 and the bottom edge of the reflecting surface is no higher than 40 inches above the floor, lowering the mirror to 35 inches is not required • Lower the mirror • Add another mirror

• **Proposed Solutions** Mirror was installed before 3/15/2012 and is not required to be lowered.
3.20	If there is a coat hook, is it no less than 15 inches and no greater than 48 inches above the floor? 54” for side reach 1991 ADA	☐ Yes ☒ No Measurement: 66"

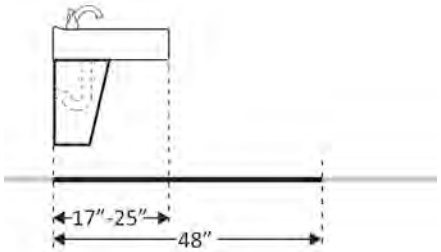
3.22	Do no less than 17 inches and no greater than 25 inches of the clear floor space extend under the lavatory so that a person using a wheelchair can get close enough to reach the faucet? 17” to 19” 1991 ADA	☐ Yes ☒ No Measurement: 26"

Photo #:	• Alter lavatory • Replace lavatory • **Proposed Solutions** At this time it is not feasible to address this issue. However, will be

address during next renovation to the facility.

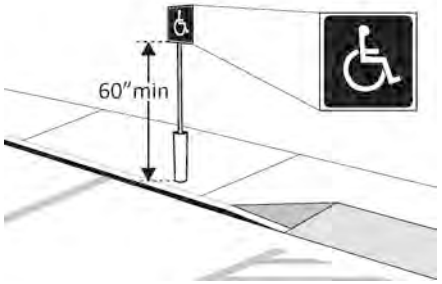
Priority 1 – Approach & Entrance			**Comments**	**Possible Solutions**
Parking *(2010 Standards – 208 & 502)* **Note: Accessible parking spaces should be identified by size, access aisle and signage.**				
1.10 Are accessible spaces Identified with a sign that includes the International Symbol of Accessibility? Is the bottom of the sign at least 60 inches above the ground? MDOT say 7' to bottom of sign	☐ Yes ☒ No ☐ Yes ☐ No Measurement:

Photo #: 	• Install signs • • The International Symbol of Accessibility is not required on the ground by the 2010 Standards **Proposed Solutions** Signs will be installed within the 2013 calendar year.
1.11 Are there signs reading "van accessible" at van accessible spaces?	☐ Yes ☒ No		Photo #: See above photo	• Install signs • • **Proposed Solutions** Same comment as above.
Curb Ramps *(2010 Standards – 406)*

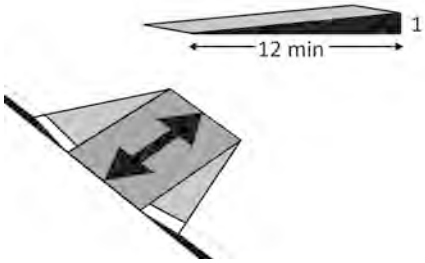
1.20	Is the running slope of the curb ramp no steeper than 1:12, i.e. for every inch of height change there are at least 12 inches of curb ramp run?	☐ Yes ☒ No Measurement: 8.7

Photo #:	• Regrade or Reconstruct curb ramp • • **Proposed Solutions** Not feasible to re-grade curb ramp. 8.7 translates to 1:11.49. Will continue to monitor to see if any issues arises to the access of this facility.

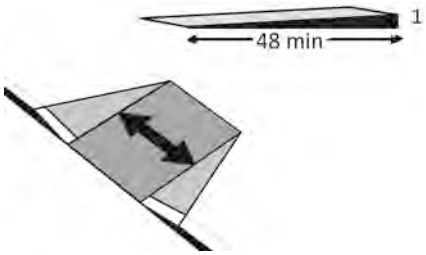
1.21	Is the cross slope of the curb ramp, excluding flares, no steeper than 1:48? Or 2%	☐ Yes ☒ No Measurement: 2.5

Photo #:	• Regrade or Reconstruct curb ramp • • **Proposed Solutions** See comments above.
Entrance *(2010 Standards – 404)*

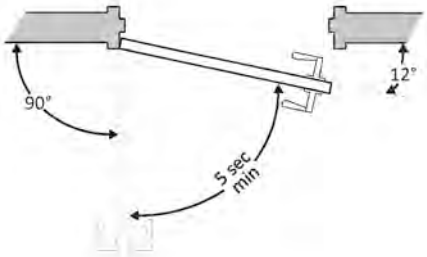
1.46	If the door has a closer, does it take at least 5 seconds to close from an open position of 90 degrees to a position of 12 degrees from the latch? 70 Degrees and 3 min 1991 ADA	☐ Yes ☒ No Measurement: 5

Photo #:	• Adjust closer • • **Proposed Solutions** We will adjust closer as needed. Actual measurement references that it takes 5 seconds for door to close. This

already meets requirements??

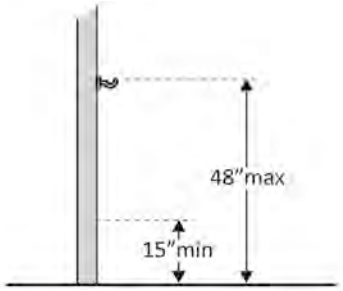
Priority 3 – Toilet Rooms			**Comments**	**Possible Solutions**
Entrance *(2010 Standards – 404)*				
3.11 Can the door be opened easily (5 pounds maximum force)?	☐ Yes ☒ No Measurement: 7		Photo #:	• Adjust or replace closers • Install lighter doors • Install power-assisted or automatic door openers **Proposed Solutions** Door closer will be adjusted during the 2013 calendar year.
In the Toilet Room				
3.20 If there is a coat hook, is it no less than 15 inches and no greater than 48 inches above the floor? 54" for side reach 1991 ADA	☐ Yes ☒ No Measurement: 68

Photo #:	• Adjust hook • Replace with or provide additional accessible hook • **Proposed Solutions** An Additional coat hook will be installed within the 2013 calendar year.
Soap Dispensers and Hand Dryers *(2010 Standards – 603)*

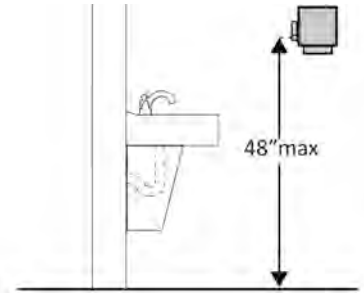
3.29	Can the operable parts of the hand dryer or towel dispenser be operated without tight grasping, pinching or twisting of the wrist?	☐ Yes ☒ No

Photo #:	• Adjust dispensers • Replace with or provide additional accessible dispensers • **Proposed Solutions** Dispenser will be replaced with in the 2013 calendar year.
Toilet Compartments (Stalls) *(2010 Standards – 604)*					
3.43	Is the door self-closing?	☐ Yes ☒ No		Photo #:	• Add closer • Replace door Or Provide Continuous spring hinges • **Proposed Solutions** Continuous spring hinges will be installed within the 2013 calendar year.

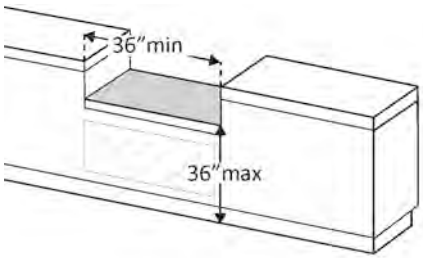
Priority 2 – Access to Goods & Services			Comments	Possible Solutions
Sales & Service Counters – banks, stores, dry cleaners, auto repair shops, fitness clubs, etc. *(2010 Standards – 904)*				
2.76 Is there a portion of at least one of each type of counter that is: No higher than 36 inches above the floor? At least 36 inches long?	☒ Yes ☐ No Measurement: 33 1/2" ☐ Yes ☒ No Measurement: 34 3/4"

Photo #: 	• Lower section of counter • Lengthen section of counter • **Proposed Solutions** This area is not available to the public.

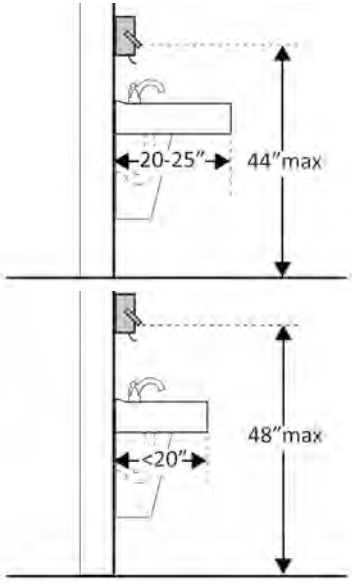
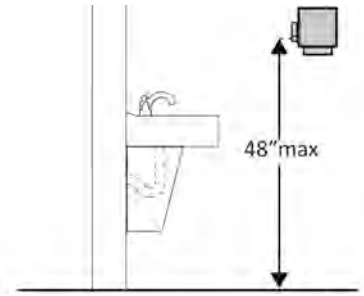
higher than 48 inches above the floor? Can the operable parts of the hand dryer or towel dispenser be operated without tight grasping, pinching or twisting of the wrist? Is the force required to activate the hand dryer or towel dispenser no greater than 5 pounds?	Measurement: 52" ☒ Yes ☐ No ☒ Yes ☐ No Measurement:

• Adjust dispensers • Replace with or provide additional accessible dispensers • **Proposed Solutions** Adjust the dispenser during 2013 calendar year.

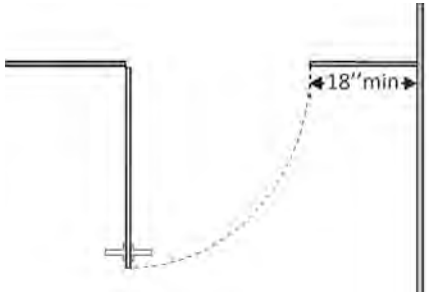
3.42	If there is a front approach to the pull side of the door, is there at least 18 inches of maneuvering clearance beyond the latch side plus 60 inches clear depth?*	☐ Yes ☒ No Measurement:

Photo #:	*See 2010 Standards 604.8.1.2 Doors for maneuvering clearance requirements on the push side of the door and side approaches to the pull side of the door • Remove obstructions • **Proposed Solutions** We are looking at the possibility of removing the door and making a single occupancy restroom. Not feasible to reconfigure walls.
3.43	Is the door self-closing?	☐ Yes ☒ No		Photo #:	• Add closer • Replace door Or Provide Continuous spring hinges • **Proposed Solutions** Provide continuous spring hinges during the 2013 calendar year.

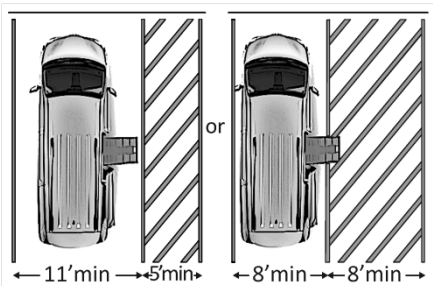
Priority 1 – Approach & Entrance				**Comments**	**Possible Solutions**
Parking *(2010 Standards – 208 & 502)* **Note: Accessible parking spaces should be identified by size, access aisle and signage.**					
1.5	Is the van accessible space: At least 11 feet wide with an access aisle at least 5 feet wide? Or At least 8 feet wide with an access aisle at least 8 feet wide?	☐ Yes ☐ No Measurement: ☒ Yes ☐ No Measurement:

1991 on RT. 2010 on LT. Photo #: 	• Reconfigure to provide van-accessible space(s) • • **Proposed Solutions** Action – Striping, Date – 12/31/2014

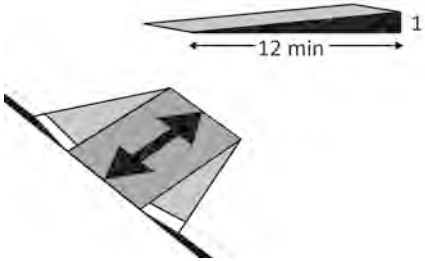
Curb Ramps *(2010 Standards – 406)*					
1.20	Is the running slope of the curb ramp no steeper than 1:12, i.e. for every inch of height change there are at least 12 inches of curb ramp run?	☒ Yes ☐ No Measurement: 9.5%

Photo #: 	• Regrade or Reconstruct curb ramp • • **Proposed Solutions** Action – Reconstruct Curb Ramp, Date – Beyond 2014 To be done with next remodel project

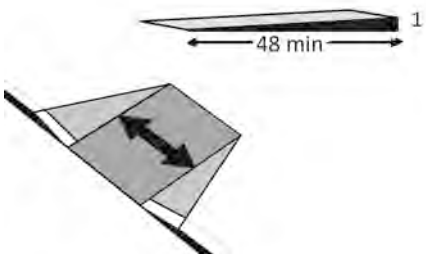
1.21	Is the cross slope of the curb ramp, excluding flares, no steeper than 1:48? Or 2%	☒ Yes ☐ No Measurement: 3.6%

Photo #:	• Regrade or Reconstruct curb ramp • • **Proposed Solution** Action – Reconstruct Landing, Date – Beyond 2014 To be done with next remodel project
1.23	At the top of the curb ramp is there a level landing (slope no steeper than 1:48 in all directions) that is at least 36 inches long and at least as wide as the curb ramp? If there are curb ramp flares, are the slopes of the flares no steeper than 1:10, i.e. for every inch of height change there are at least 10 inches of flare run?	☐ Yes ☒ No Measurement: ☒ Yes ☐ No Measurement: 6.9%

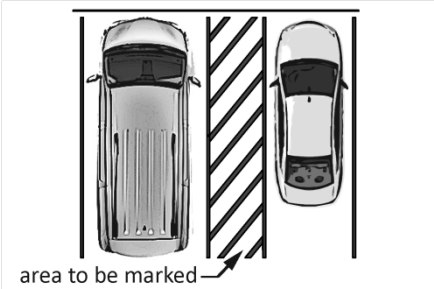
1.7	Are the access aisles marked so as to discourage parking in them?	☐ Yes ☒ No

Photo #:	• Mark access aisles • • The marking method and color may be addressed by state/local requirements **Proposed Solution** Action – Striping Date – 12/31/2014
1.10	Are accessible spaces Identified with a sign that includes the International Symbol of Accessibility? Is the bottom of the sign at least 60 inches above the ground? MDOT say 7' to bottom of sign	☐ Yes ☒ No ☐ Yes ☐ No Measurement:

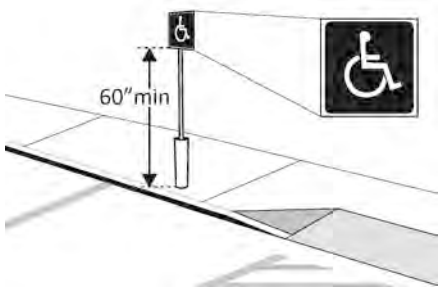
No Signs Photo #:	• Install signs • • The International Symbol of Accessibility is not required on the ground by the 2010 Standards **Proposed Solution** Action – Signs Date – 12/31/2013
1.11	Are there signs reading "van accessible" at van accessible spaces?	☐ Yes ☒ No		Photo #:	• Install signs • • **Proposed Solution** Action – Signs Date – 12/31/2013

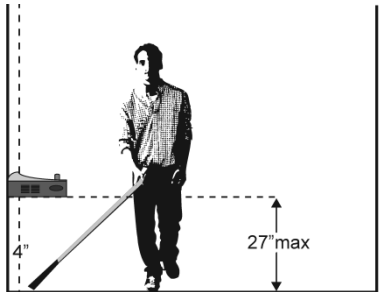
Priority 2 – Access to Goods & Services			**Comments**	**Possible Solutions**
Interior Accessible Route *(2010 Standards – Ch.4)*				
2.8 Do all objects on circulation paths through public areas, e.g. fire extinguishers, drinking fountains, signs, etc., protrude no more than 4 inches into the path? Or If an object protrudes more than 4 inches, is the bottom leading edge at 27 inches or lower above the floor? Or Is the bottom leading edge at 80 inches or higher above the floor?	☐ Yes ☒ No Measurement: ☐ Yes ☐ No Measurement: ☐ Yes ☐ No Measurement:	 Or

Photo #: 	• Remove object • Add tactile warning such as permanent planter or partial walls • **Proposed Solution** Action – Permanent Planter Date – 12/31/2013
Signs *(2010 Standards – 703)* **Note: "Tactile characters" are read using touch, i.e. raised characters and Braille.**

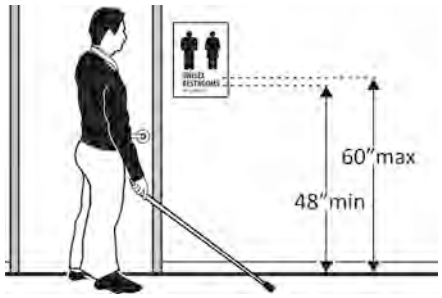
Signs at Toilet Rooms *(2010 Standards – 703)*					
3.5	Do text characters contrast with their backgrounds? Are text characters raised? Is there Braille? Is the sign mounted: On the wall on the latch side of the door? Note: Signs are permitted on the push side of doors with closers and without hold-open devices. With clear floor space beyond the arc of the door swing between the closed position and 45-degree open position, at least 18 x 18 inches centered on the tactile characters? * So the baseline of the lowest	☒ Yes ☐ No ☐ Yes ☒ No ☐ Yes ☒ No ☐ Yes ☒ No ☐ Yes ☒ No Measurement:

character is at least 48 inches above the floor and the baseline of the highest character is no more than 60 inches above the floor? *	☐ Yes ☒ No Measurement: 64"

Photo #:	• Install tactile sign • Relocate sign • *If constructed before 3/15/2010 and a person may approach within 3 inches of the sign without encountering protruding objects or standing within the door swing, relocation not required *If constructed before 3/15/2012 and mounted no higher than 60 inches to the centerline of the

60" max to center 1991 ADA		sign, relocation is not required **Proposed Solution** Action – Tactile Signs Date – 12/31/2014
Lavatories *(2010 Standards – 606)* **Note: 2010 Standards refer to sinks in toilet rooms as lavatories.**

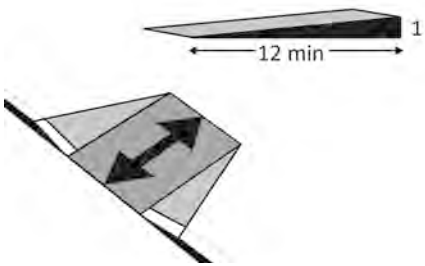
Exterior Accessible Route *(2010 Standards – Ch.4)*				
1.20 Is the running slope of the curb ramp no steeper than 1:12, i.e. for every inch of height change there are at least 12 inches of curb ramp run?	☒ Yes ☐ No Measurement: 8.1%

• Regrade or Reconstruct curb ramp • •
1.23 At the top of the curb ramp is there a level landing (slope no steeper than 1:48 in all directions) that is at least 36 inches long and at least as wide as the curb ramp? If there are curb ramp flares, are the slopes of the flares no steeper than 1:10, i.e. for every inch of height change there are at least 10 inches of flare run?	☒ Yes ☐ No Measurement: 1.7% ☐ Yes ☒ No Measurement: 7.6%

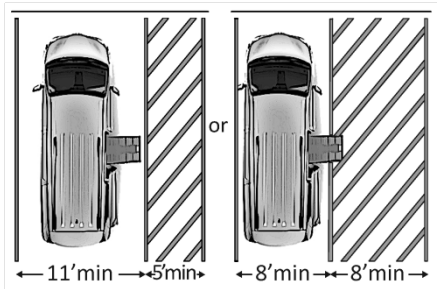
Priority 1 – Approach & Entrance			**Comments**	**Possible Solutions**
Parking *(2010 Standards – 208 & 502)* **Note: Accessible parking spaces should be identified by size, access aisle and signage.**				
1.5 Is the van accessible space: At least 11 feet wide with an access aisle at least 5 feet wide? Or At least 8 feet wide with an access aisle at least 8 feet wide?	☐ Yes ☐ No Measurement: ☐ Yes ☒ No Measurement: 10' & 12"

1991 on RT. 2010 on LT. Photo #: 	• Reconfigure to provide van-accessible space(s) • • **Proposed Solution** Action – Striping Date – No Action Required, Field Checked
1.11 Are there signs reading "van accessible" at van accessible spaces?	☐ Yes ☒ No		Photo #: 	• Install signs • • **Proposed Solution** Action – Signs Date – 12/31/2013

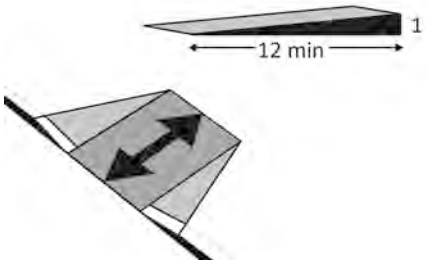
Curb Ramps *(2010 Standards – 406)*					
1.20	Is the running slope of the curb ramp no steeper than 1:12, i.e. for every inch of height change there are at least 12 inches of curb ramp run?	☒ Yes ☐ No Measurement: 13.3%

Photo #: 	• Regrade or Reconstruct curb ramp • • **Proposed Solution** Action – Reconstruct Curb Ramp Date – Beyond 2014 To be done with next remodel project
1.23	At the top of the curb ramp is there a level landing (slope no steeper than 1:48 in all directions) that is at least 36 inches long and at least as wide as the curb ramp? If there are curb ramp flares, are the slopes of the flares no steeper than 1:10, i.e. for every inch of height change there are at least 10 inches of flare run?	☐ Yes ☒ No Measurement: 8.2% ☒ Yes ☐ No Measurement: 6.3%

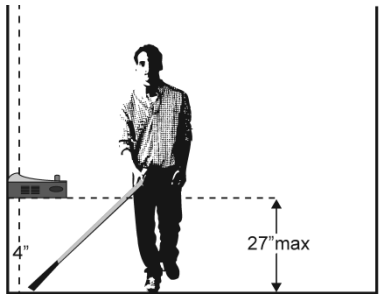
Priority 2 – Access to Goods & Services			Comments	Possible Solutions
Interior Accessible Route *(2010 Standards – Ch.4)*				
2.8 Do all objects on circulation paths through public areas, e.g. fire extinguishers, drinking fountains, signs, etc., protrude no more than 4 inches into the path? Or If an object protrudes more than 4 inches, is the bottom leading edge at 27 inches or lower above the floor?	☐ Yes ☒ No Measurement: 19" drinking fountains ☐ Yes ☒ No Measurement: 27" & 33" to bottom	 Or

Photo #: 	• Remove object • Add tactile warning such as permanent planter or partial walls • **Proposed Solution** Action – Permanent Planter Date – 12/31/2013

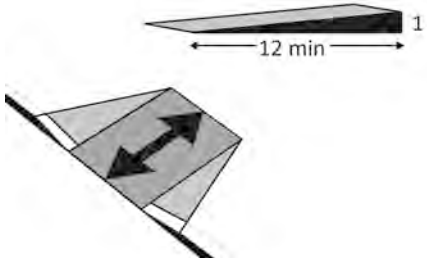
Curb Ramps *(2010 Standards – 406)*					
1.20	Is the running slope of the curb ramp no steeper than 1:12, i.e. for every inch of height change there are at least 12 inches of curb ramp run?	☒ Yes ☐ No Measurement: 11.4%

Photo #: 	• Regrade or Reconstruct curb ramp • • **Proposed Solution** Action – Reconstruct Curb Ramp Date – Beyond 2014 To be done with next remodel project

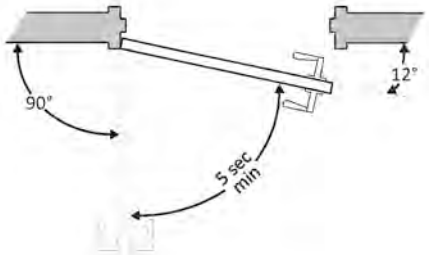
Entrance *(2010 Standards – 404)*				
1.39 Do all inaccessible entrances have signs indicating the location of the nearest accessible entrance?	☐ Yes ☒ No		Photo #:	• Install signs • Install signs on route before people get to inaccessible entrances so that people do not have to turn around and retrace route •
1.46 If the door has a closer, does it take at least 5 seconds to close from an open position of 90 degrees to a position of 12 degrees from the latch? 70 Degrees and 3 min 1991 ADA	☐ Yes ☒ No Measurement: 4sec

Photo #:	• Adjust closer • •

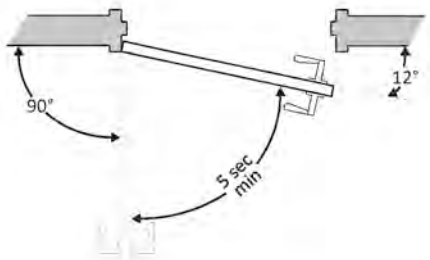
Priority 3 – Toilet Rooms			**Comments**	**Possible Solutions**
Entrance *(2010 Standards – 404)*				
3.12 If the door has a closer, does it take at least 5 seconds to close from an open position of 90 degrees to a position of 12 degrees from the latch? 70 degrees and 3 min. 1991 ADA	☐ Yes ☒ No Measurement: 3 Sec.

Photo #:	• Adjust closer • •
In the Toilet Room				
3.20 If there is a coat hook, is it no less than 15 inches and no greater than 48 inches above the floor? 54" for side reach 1991 ADA	☐ Yes ☒ No Measurement: 67"

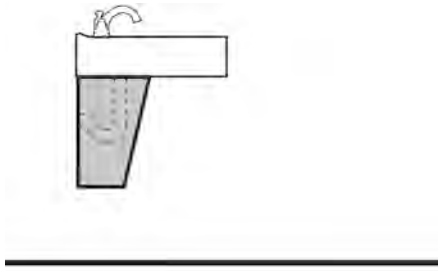
3.26	Are pipes below the lavatory insulated or otherwise configured to protect against contact?	☐ Yes ☒ No

Photo #:	• Install insulation • Install cover panel •
Water Closets in Single-User Toilet Rooms and Compartments (Stalls) *(2010 Standards – 603 & 609)* **Note: 2010 Standards refer to toilets as water closets.**				
3.37	Is the flush control on the open side of the water closet?	☐ Yes ☒ No

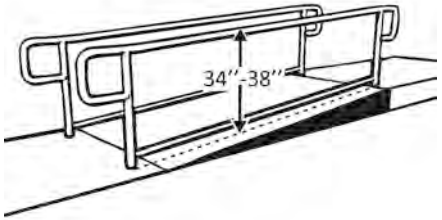
Priority 1 – Approach & Entrance			**Comments**	**Possible Solutions**
Ramps *(2010 Standards – 405 & 505)* **Note: If any portion of the accessible route is steeper than 1:20, it should be treated as a ramp.**				
1.31	Is the top of the handrail gripping surface no less than 34 inches and no greater than 38 inches above the ramp surface?	☐ Yes ☒ No Measurement: 31"

Photo #: 	• Reconfigure or replace handrails • • **Proposed Solution** Action – Replace Handrails Date – 12/31/2014
1.33	If the handrail gripping surface is circular, is it no less than 1 ¼ inches and no greater than 2 inches in diameter? No greater than 1'1/2" and 1'1/2" from wall 1991 ADA	☐ Yes ☒ No Measurement: 2" x 4"

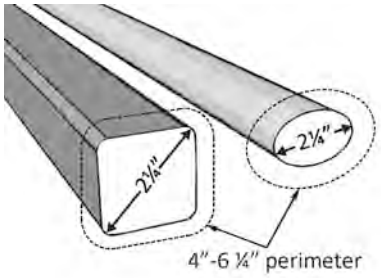
1.34	If the handrail gripping surface is non-circular, is it no less than 4 inches and no greater than 6 ½ inches in perimeter and no more than 2 ¼ inches in cross section?	☐ Yes ☒ No Measurement:

Photo #: 	• Replace handrails • • **Proposed Solution** Action – Replace Handrails Date – 12/31/2014

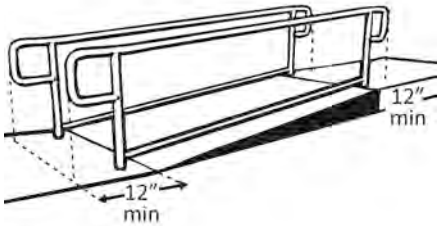
1.35	Does the handrail: Extend at least 12 inches horizontally beyond the top and bottom of the ramp? Return to a wall, guard, or landing surface?	☐ Yes ☒ No Measurement: ☐ Yes ☐ No

Photo #: 	• Add extensions • Reconfigure handrails • **Proposed Solution** Action – Replace Handrails Date – 12/31/2014

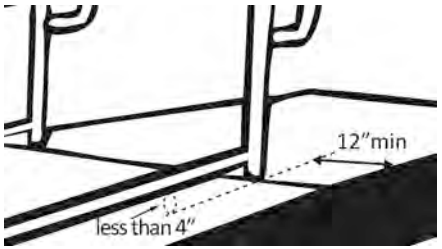
1.36	To prevent wheelchair casters and crutch tips from falling off: Does the surface of the ramp extend at least 12 inches beyond the inside face of the handrail? Or Is there a curb or barrier that prevents the passage of a 4-inch diameter sphere?	☐ Yes ☒ No Measurement: ☐ Yes ☒ No Measurement:

Photo #: 	• Add curb • Add barrier • Extend ramp width • **Proposed Solution** Action – Add Barrier Date – No Action Required Constructed before 3/15/2012

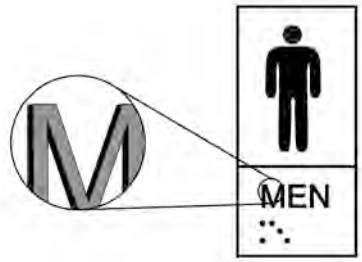
Priority 3 – Toilet Rooms			Comments	Possible Solutions
Signs at Toilet Rooms *(2010 Standards – 703)*				
3.5 Do text characters contrast with their backgrounds?	☐ Yes ☒ No

• Install tactile sign • Relocate sign •
Are text characters raised?	☐ Yes ☒ No			
Is there Braille?	☐ Yes ☒ No			
Is the sign mounted: On the wall on the latch side of the door?	☐ Yes ☒ No			
Note: Signs are permitted on the push side of doors with closers and without hold-open devices.

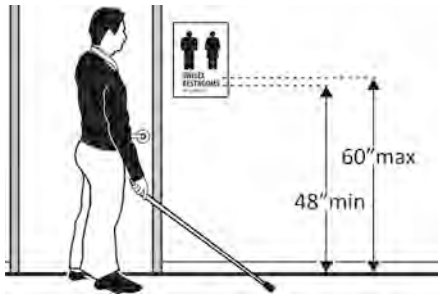
With clear floor space beyond the arc of the door swing between the closed position and 45-degree open position, at least 18 x 18 inches centered on the tactile characters? *	☐ Yes ☒ No Measurement:			*If constructed before 3/15/2010 and a person may approach within 3 inches of the sign without encountering protruding objects or standing within the door swing, relocation not required
So the baseline of the lowest character is at least 48 inches above the floor and the baseline of the highest character is no more than 60 inches above the floor? *	☐ Yes ☒ No Measurement:

60" max to center 1991 ADA		*If constructed before 3/15/2012 and mounted no higher than 60 inches to the centerline of the sign, relocation is not required

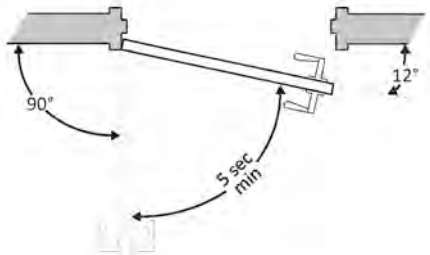
3.12	If the door has a closer, does it take at least 5 seconds to close from an open position of 90 degrees to a position of 12 degrees from the latch? 70 degrees and 3 min. 1991 ADA	☐ Yes ☒ No Measurement: 3 sec

Photo #: 	• Adjust closer • • **Proposed Solution** Action – Adjust Closure Date – 12/31/2013
In the Toilet Room					
3.20	If there is a coat hook, is it no less than 15 inches and no greater than 48 inches above the floor? 54" for side reach 1991 ADA	☐ Yes ☒ No Measurement: 67"

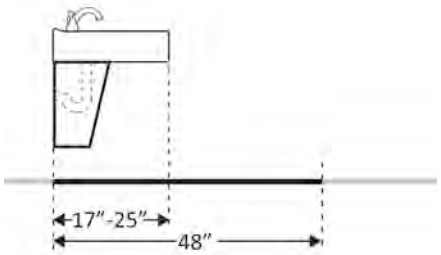
3.22	Do no less than 17 inches and no greater than 25 inches of the clear floor space extend under the lavatory so that a person using a wheelchair can get close enough to reach the faucet? 17" to 19" 1991 ADA	☐ Yes ☒ No Measurement:

Photo #: 	• Alter lavatory • Replace lavatory • **Proposed Solution** Action – Alter Lavatory, Date – Beyond 2014, To be done with next remodel project

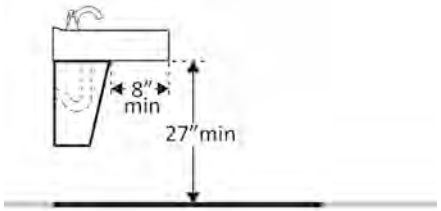
3.24	Is there at least 27 inches clearance from the floor to the bottom of the lavatory that extends at least 8 inches under the lav for knee clearance?	☐ Yes ☒ No Measurement:

Photo #: 	• Alter lavatory • Replace lavatory • **Proposed Solution** Action – Alter Lavatory, Date – Beyond 2014, To be done with next remodel project

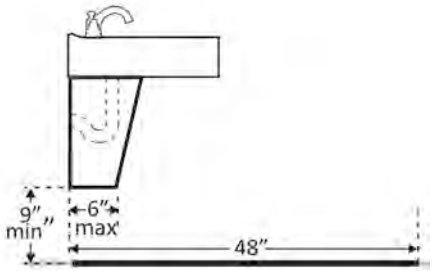
3.25	Is there toe clearance at least 9 inches high? (Space extending greater than 6 inches beyond the available toe clearance at 9 inches above the floor is not considered toe clearance.)	☐ Yes ☒ No

Photo #: 	• Alter lavatory • Replace lavatory • **Proposed Solution** Action – Alter Lavatory, Date – Beyond 2014, To be done with next remodel project

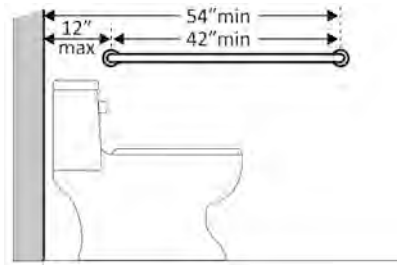
closets.					
3.33	Is there a grab bar at least 42 inches long on the side wall?	☐ Yes ☒ No Measurement: 48"			• Install grab bar • Relocate grab bar • Relocate objects •
	Is it located no more than 12 inches from the rear wall?	☐ Yes ☒ No Measurement:6 6"

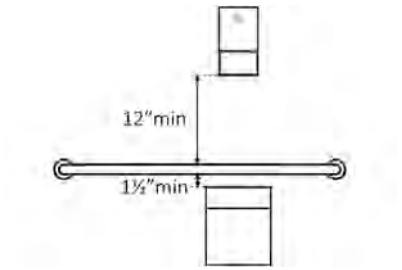
Is there at least 12 inches clearance between the grab bar and protruding objects above?*	☐ Yes ☒ No Measurement: 9"			* If constructed before 3/15/2012 grab bars do not need to be relocated; there are no space requirements above and below grab bars in the 1991 Standards
	Is there at least 1½ inches clearance between the grab bar and projecting objects below?*	☒ Yes ☐ No Measurement:

Is the space between the wall and the grab bar 1 ½ inches?	☒ Yes ☐ No Measurement:		Photo #: 	Action – Relocate Grab Bar Date – No Action Required, Constructed before 3/15/2012

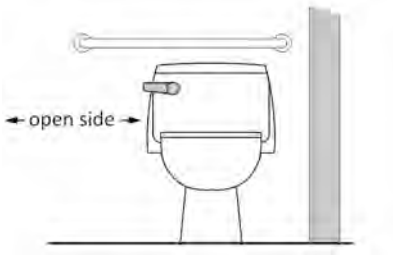
Constructed before 3/15/2012
3.37	Is the flush control on the open side of the water closet?	☐ Yes ☒ No

Photo #:	• Move control • • **Proposed Solution** Action – Move Control, Date – Beyond 2014, To be done with next remodel project
Toilet Compartments (Stalls) *(2010 Standards – 604)*					
3.41	Is the door opening width at least 32 inches clear, between the face of the door and the stop, when the door is open 90 degrees?	☐ Yes ☒ No Measurement: 30"

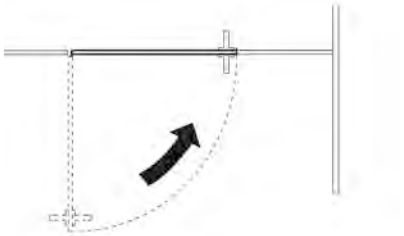
3.43	Is the door self-closing?	☐ Yes ☒ No

Photo #:	• Add closer • Replace door Or Provide Continuous spring hinges • **Proposed Solution** Action – Add Closer Date – 12/31/2014
3.45	Is the lock operable with one hand and without tight grasping, pinching or twisting of the wrist?	☐ Yes ☒ No

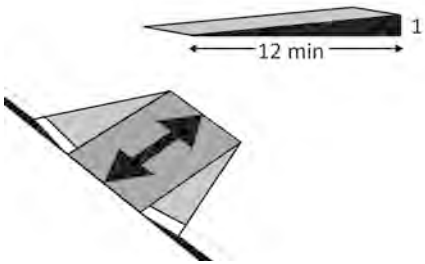
Priority 1 – Approach & Entrance				**Comments**	**Possible Solutions**
Curb Ramps *(2010 Standards – 406)*					
1.20	Is the running slope of the curb ramp no steeper than 1:12, i.e. for every inch of height change there are at least 12 inches of curb ramp run?	☐ Yes ☒ No Measurement: 6.5%

Photo #: 	• Regrade or Reconstruct curb ramp • • **Proposed Solution** Action – Reconstruct Curb Ramp Date – No Action Required, Field Checked

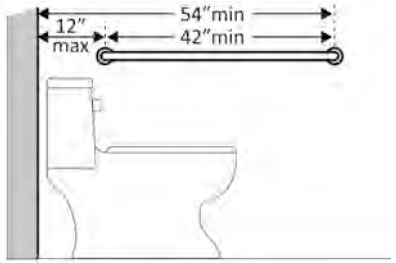
Water Closets in Single-User Toilet Rooms and Compartments (Stalls) *(2010 Standards – 603 & 609)* **Note: 2010 Standards refer to toilets as water closets.**				
3.33 Is there a grab bar at least 42 inches long on the side wall? Is it located no more than 12 inches from the rear wall?	☒ Yes ☐ No Measurement: ☐ Yes ☒ No Measurement:

• Install grab bar • Relocate grab bar • Relocate objects • **Proposed Solution**

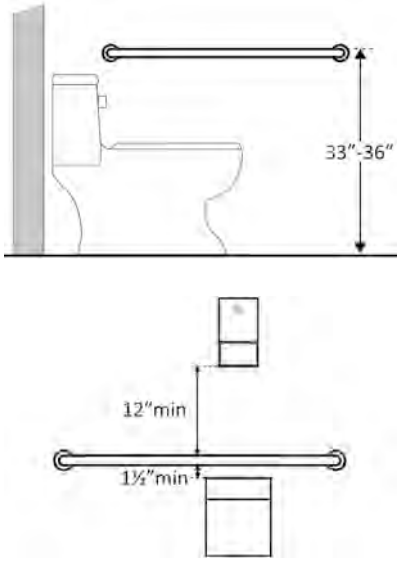
Does it extend at least 54 inches from the rear wall?	7" ☐ Yes ☒ No Measurement: 49"

Photo #: 	Action – Relocate Grab Bar Date – Beyond 2014 To be done with next remodel project * If constructed before 3/15/2012 grab bars do not need to be relocated; there are no space requirements above and below grab bars in the 1991 Standards
3.34	Is there a grab bar at least 36 inches long on the rear wall? Does it extend at least 12 inches from the centerline of the water closet on one side (side wall)? Does it extend at least 24 inches on the other (open) side?	☒ Yes ☐ No Measurement: ☐ Yes ☒ No Measurement: 6" ☒ Yes ☐ No Measurement:

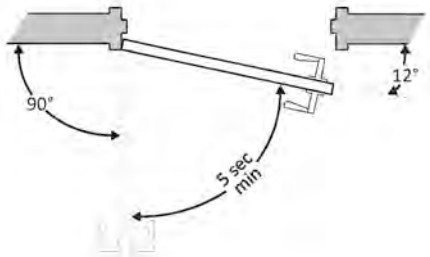
1.46	If the door has a closer, does it take at least 5 seconds to close from an open position of 90 degrees to a position of 12 degrees from the latch? 70 Degrees and 3 sec. 1991 ADA	☐ Yes ☒ No Measurement: 3 sec.

Photo #: 	• Adjust closer • • **Proposed Solutions** Maintenance forces could adjust the door closer to meet the ADA requirements. Time Frame - Immediate

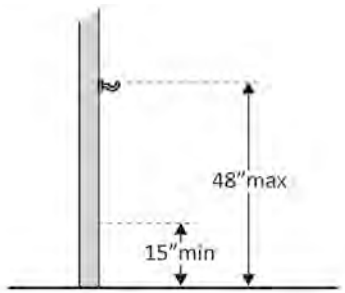
Priority 3 – Toilet Rooms			Comments	Possible Solutions
In the Toilet Room				
3.20 If there is a coat hook, is it no less than 15 inches and no greater than 48 inches above the floor? 54" for side reach 1991 ADA	☐ Yes ☒ No Measurement: 64"

Photo #:	• Adjust hook • Replace with or provide additional accessible hook • **Proposed Solutions** Maintenance forces could reinstall the coat hook to meet ADA requirements. Time Frame - Immediate

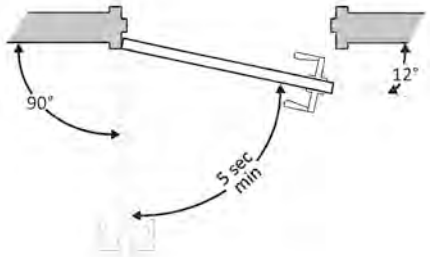
1.46	If the door has a closer, does it take at least 5 seconds to close from an open position of 90 degrees to a position of 12 degrees from the latch? 70 Degrees and 3 min 1991 ADA	☒ Yes ☐ No Measurement: 4 Sec.

Photo #:	• Adjust closer • • **Proposed Solutions** Maintenance forces could adjust the door closer to meet the ADA requirements. Time Frame - Immediate

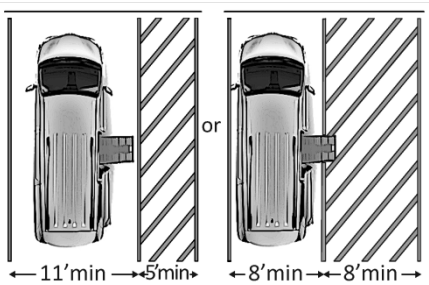
1.5	Is the van accessible space: At least 11 feet wide with an access aisle at least 5 feet wide? Or At least 8 feet wide with an access aisle at least 8 feet wide?	☐ Yes ☒ No Measurement: ☐ Yes ☒ No Measurement:

1991 on RT. 2010 on LT. Photo #:	• Reconfigure to provide van-accessible space(s) • •

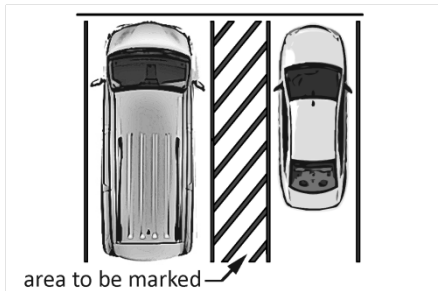
Photo #:	• Reconfigure to provide van-accessible space(s) • •
1.7	Are the access aisles marked so as to discourage parking in them?	☐ Yes ☒ No

Photo #:	• Mark access aisles • • The marking method and color may be addressed by state/local requirements
1.8	Is the slope of the accessible parking spaces and access aisles no steeper than 1:48 in all directions?	☐ Yes ☒ No Measurement:		Photo #:	• Regrade surface or Modify grade • •
1.9	Do the access aisles adjoin an accessible route?	☐ Yes ☒ No		Photo #:	• Create accessible route • Relocate accessible space •

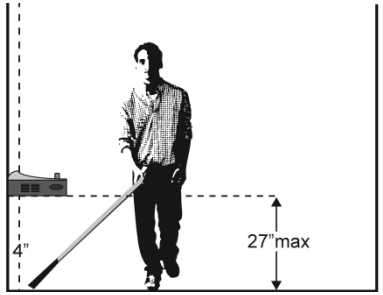
Priority 2 – Access to Goods & Services				Comments	Possible Solutions
Interior Accessible Route *(2010 Standards – Ch.4)*					
2.8	Do all objects on circulation paths through public areas, e.g. fire extinguishers, drinking fountains, signs, etc., protrude no more than 4 inches into the path? Or If an object protrudes more than 4 inches, is the bottom leading edge at 27 inches or lower above the floor? Or	☒ Yes ☐ No Measurement: 9" ☒ Yes ☐ No Measurement: 19"	 Or

Photo #: 	• Remove object • Add tactile warning such as permanent planter or partial walls • **Proposed Solutions** Drinking fountain could be recessed into wall or a partial wall constructed around the fountain. Time Frame – 1 year.

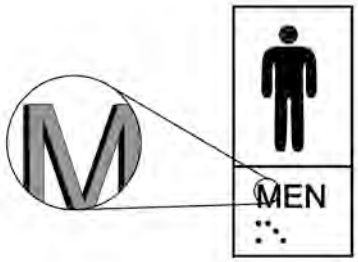
Signs at Toilet Rooms *(2010 Standards – 703)*				
3.5 Do text characters contrast with their backgrounds?	☐ Yes ☒ No

• Install tactile sign • Relocate sign •
Are text characters raised?	☐ Yes ☒ No			
Is there Braille?	☐ Yes ☒ No			
Is the sign mounted: On the wall on the latch side of the door?	☐ Yes ☒ No			
Note: Signs are permitted on the push side of doors with closers and without hold-open devices.

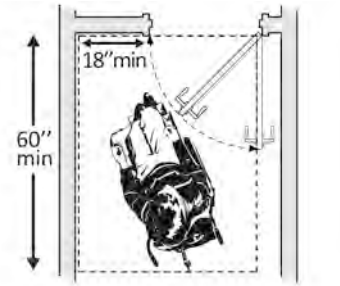
3.7	If there is a front approach to the pull side of the door is there at least 18 inches of maneuvering clearance beyond the latch side plus 60 inches clear depth?	☐ Yes ☒ No Measurement: 6"

Photo #:	• Remove obstructions • Reconfigure walls • Add automatic door opener See 2010 Standards 404.2.4 for maneuvering clearance requirements on the push side of the door and side approaches to the pull side of the door **Proposed Solutions** To correct this problem would involve major reconstruction of the

building. Funding would have to be secured before this activity could be done.
3.9	Is the door equipped with hardware that is operable with one hand and does not require tight grasping, pinching, or twisting of the wrist? Check door handle and lock (if provided).	☐ Yes ☒ No Measurement:		Photo #:	• Replace knobs or latches with lever or loop handles • Install power-assisted or automatic door openers • **Proposed Solutions** Maintenance forces can install new door handles that meet ADA requirements. Time Frame - Immediate
In the Toilet Room

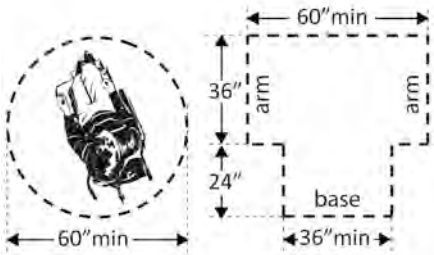
3.17	Is there clear floor space available for a person in a wheelchair to turn around, i.e. a circle at least 60 inches in diameter or a T-shaped space within a 60-inch square?*	☐ Yes ☒ No Measurement:

Photo #:	*The door to the toilet room may swing into the required turning space • Move or remove partitions, fixtures or objects such as trash cans •

• **Proposed Solutions** To correct this problem would involve major reconstruction of the building. Funding would have to be secured before this activity could be done.
3.20 If there is a coat hook, is it no less than 15 inches and no greater than 48 inches above the floor? 54" for side reach 1991 ADA	☐ Yes ☒ No Measurement: 66"

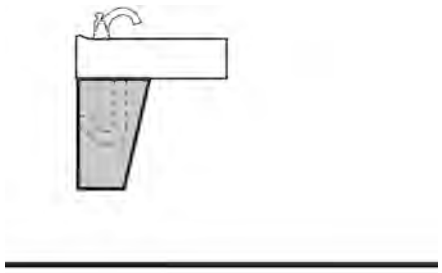
3.26	Are pipes below the lavatory insulated or otherwise configured to protect against contact?	☐ Yes ☒ No

Photo #:	• Install insulation • Install cover panel • **Proposed Solutions** Maintenance forces can install cover panel under lavatory. Time Frame – Immediate.

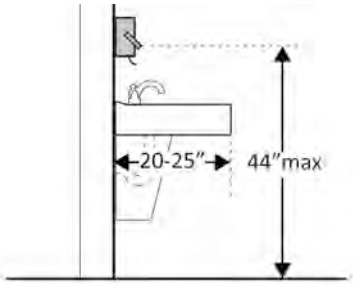
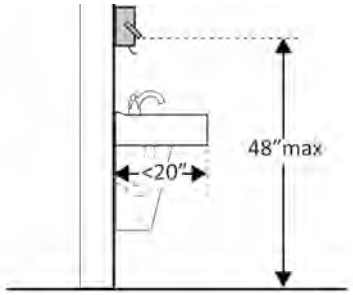
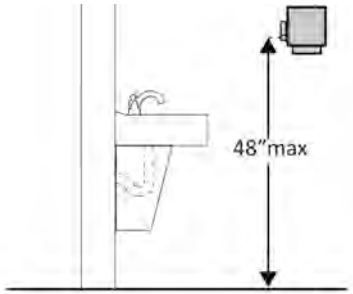
3.29	Are the operable parts of the hand dryer or towel dispenser within one of the following reach ranges: Above lavatories or counters no less than 20 inches and no greater than 25 inches deep: no higher than 44 inches above the floor? Above lavatories less than 20 inches deep: no higher than 48	☐ Yes ☐ No Measurement: ☐ Yes ☐ No

inches above the floor? Not over an obstruction: no higher than 48 inches above the floor? Can the operable parts of the hand dryer or towel dispenser be operated without tight grasping, pinching or twisting of the wrist?	Measurement: ☐ Yes ☐ No Measurement: ☐ Yes ☒ No

• Adjust dispensers • Replace with or provide additional accessible dispensers • **Proposed Solutions** Maintenance forces can remove and reset towel dispenser to meet ADA

Photo #:	requirements. Time Frame - Immediate
Water Closets in Single-User Toilet Rooms and Compartments (Stalls) *(2010 Standards – 603 & 609)* **Note: 2010 Standards refer to toilets as water closets.**					
3.32	Is the height of the water closet no less than 17 inches and no greater than 19 inches above the floor measured to the top of the seat?	☐ Yes ☒ No Measurement: 14"

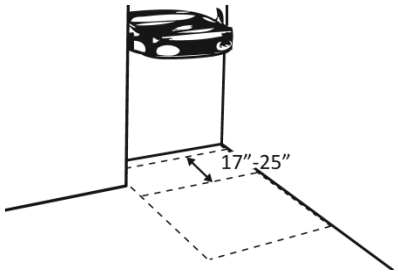
Priority 4 – Additional Access				Comments	Possible Solutions
Drinking Fountains *(2010 Standards – 602)*					
4.2	If there is a forward approach, do no less than 17 inches and no greater than 25 inches of the clear floor space extend under the drinking fountain? 17” to 19” 1991 ADA	☐ Yes ☒ No Measurement: 8"

Photo #: 	• Alter space • Replace drinking fountain •
4.6	Is the spout outlet no higher than 36 inches above the floor?	☒ Yes ☐ No Measurement: 42"

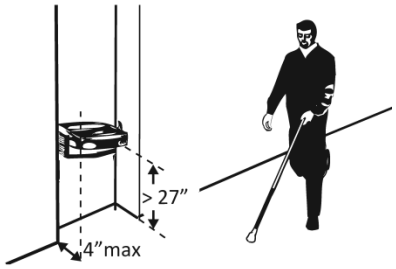
4.9	If the leading (bottom) edge of the fountain is higher than 27 inches above the floor, does the front of the fountain protrude no more than 4 inches into the circulation path?	☒ Yes ☐ No Measurement:

Photo #: 	• Adjust drinking fountain • Replace drinking fountain • Add tactile warning such as permanent planter or partial walls

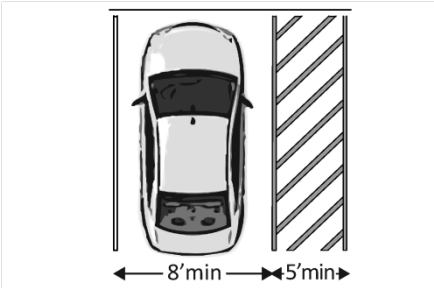
1.4	Are accessible spaces at least 8 feet wide with an access aisle at least 5 feet wide? 1991 ADA	☐ Yes ☒ No Measurement:

Photo #:	• Reconfigure by repainting lines Two spaces can share an access aisle **Proposed Solutions** Maintenance forces can strip parking lot to provide an accessible parking space.

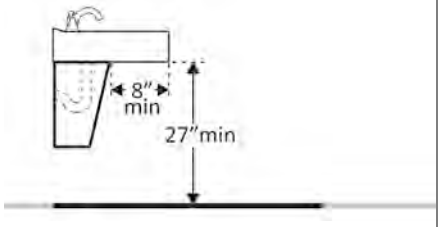
3.24	Is there at least 27 inches clearance from the floor to the bottom of the lavatory that extends at least 8 inches under the lav for knee clearance?	☐ Yes ☒ No Measurement: 28" x 2'

Photo #: 	• Alter lavatory • Replace lavatory •

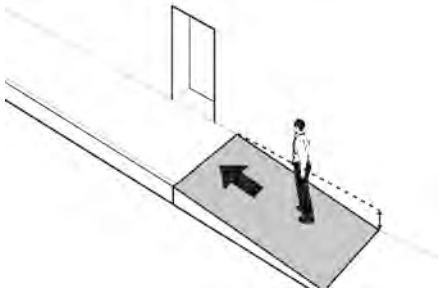
Exterior Accessible Route *(2010 Standards – Ch.4)*					
1.17	Is the running slope no steeper than 1:20, i.e. for every inch of height change there are at least 20 inches of route run? Or 5%	☐ Yes ☒ No Measurement: 9.3%

• Regrade to 1:20 max. • If steeper than 1:20 and no steeper than 1:12, treat as a ramp and add other features such as edge protection and handrails •

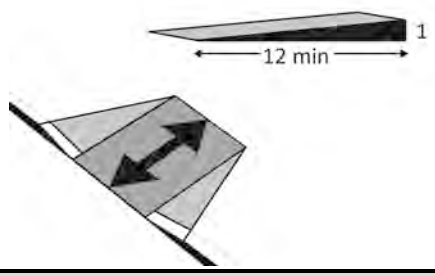
Photo #:	
1.18 Is the cross slope no steeper than 1:48? Or 2%	☐ Yes ☒ No Measurement: 4.5%		Photo #:	• Regrade or Reconstruct to 1:48 max. • •
Curb Ramps *(2010 Standards – 406)*				
1.20 Is the running slope of the curb ramp no steeper than 1:12, i.e. for every inch of height change there are at least 12 inches of curb ramp run?	☒ Yes ☐ No Measurement: 9.6%

Photo #:	• Regrade or Reconstruct curb ramp • •
Ramps *(2010 Standards – 405 & 505)* **Note: If any portion of the accessible route is steeper than 1:20, it should be treated as a ramp.**				
1.28 Is there a level landing that is at least 60 inches long and at least as wide as the ramp: At the top of the ramp?	☐ Yes ☒ No Measurement:

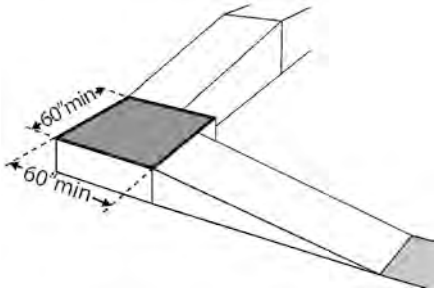
At the bottom of the ramp?	☐ Yes ☒ No Measurement:		Photo #:	
1.29	Is there a level landing where the ramp changes direction that is at least 60 x 60 inches?	☐ Yes ☒ No Measurement:

Photo #:	• Alter ramp • •
1.30	If the ramp has a rise higher than 6 inches, are there handrails on both sides? Or if the ramp is 72" longer hand rails on both side 1991ADA	☐ Yes ☒ No Measurement:

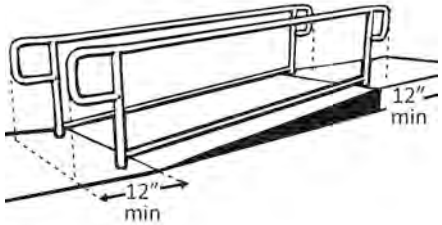
Photo #: 	• Add handrails • • Curb ramps are not required to have handrails
1.35	Does the handrail: Extend at least 12 inches horizontally beyond the top and bottom of the ramp? Return to a wall, guard, or landing surface?	☐ Yes ☒ No Measurement: ☐ Yes ☐ No

Photo #: 	• Add extensions • Reconfigure handrails •

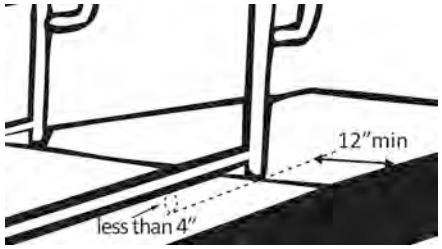
1.36	To prevent wheelchair casters and crutch tips from falling off: Does the surface of the ramp extend at least 12 inches beyond the inside face of the handrail? Or Is there a curb or barrier that prevents the passage of a 4-inch diameter sphere?	☐ Yes ☒ No Measurement: ☐ Yes ☒ No Measurement:

Photo #: 	• Add curb • Add barrier • Extend ramp width •
Entrance *(2010 Standards – 404)*					
1.37	Is the main entrance accessible?	☐ Yes ☒ No		Photo #: 	• Redesign to make it accessible • •
1.38	If the main entrance is not accessible, is there an alternative accessible entrance? Can the alternative accessible entrance be used independently and during the same hours as the main entrance?	☐ Yes ☒ No ☐ Yes ☒ No			• Designate an entrance and make it accessible • Ensure that accessible entrance can be used independently and during the same hours as the main entrance •

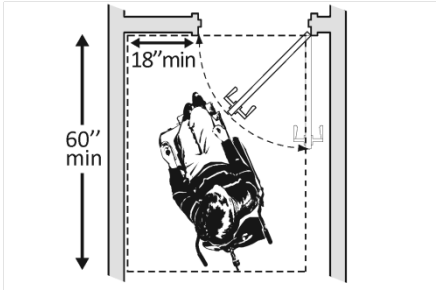
Photo #:	
1.42	If there is a front approach to the pull side of the door, is there at least 18 inches of maneuvering clearance beyond the latch side plus at least 60 inches clear depth? On both sides of the door, is the ground or floor surface of the maneuvering clearance level (no steeper than 1:48)?	☒ Yes ☐ No Measurement: ☐ Yes ☒ No Measurement: 4.4% outside 1.0% inside

Photo #:	See 2010 Standards 404.2.4 for maneuvering clearance requirements on the push side of the door and side approaches to the pull side of the door • Remove obstructions • Reconfigure walls • Add automatic door opener

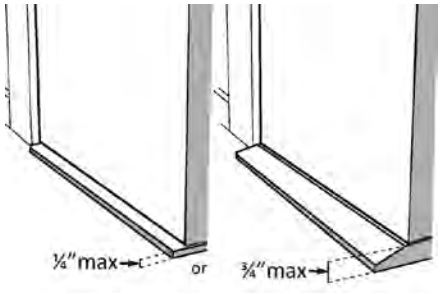
1.43	Is the door threshold edge no more than ¼ inch high? Or No more than ¾ inch high if slope is beveled no steeper than 1:2? Note: The first ¼ inch of the threshold may be vertical; the rest must be beveled.	☐ Yes ☒ No Measurement: ☐ Yes ☐ No Measurement:

Photo #:	• Remove or replace threshold • •

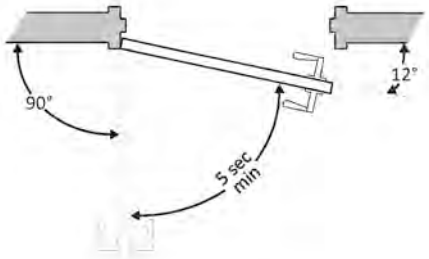
2.46	If the door has a closer, does it take at least 5 seconds to close from an open position of 90 degrees to a position of 12 degrees from the latch? 70 degrees and 3 min. 1991 ADA	☐ Yes ☒ No Measurement: 4 sec

Photo #:	• Adjust closer • •

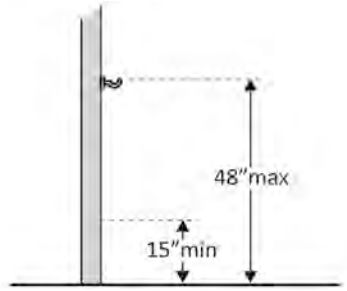
Priority 3 – Toilet Rooms			**Comments**	**Possible Solutions**
In the Toilet Room				
3.20 If there is a coat hook, is it no less than 15 inches and no greater than 48 inches above the floor? 54" for side reach 1991 ADA	☐ Yes ☒ No Measurement: 63"

Photo #:	• Adjust hook • Replace with or provide additional accessible hook • **Proposed Solution** Maintenance forces could reinstall the coat hook to meet ADA requirements. Time Frame - Immediate

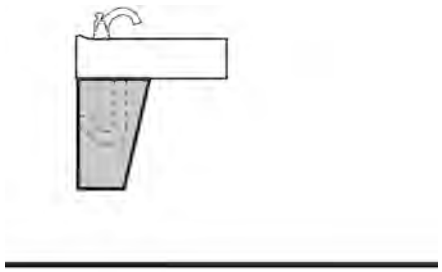
Lavatories *(2010 Standards – 606)* **Note: 2010 Standards refer to sinks in toilet rooms as lavatories.**				
3.26 Are pipes below the lavatory insulated or otherwise configured to protect against contact?	☐ Yes ☒ No

Photo #:	• Install insulation • Install cover panel • **Proposed Solution** Maintenance forces can install cover panel under lavatory. Time Frame - Immediate

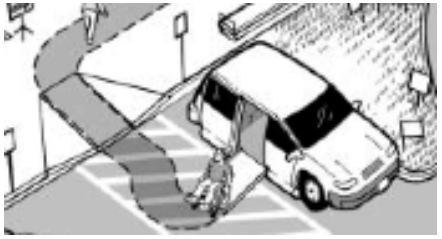
before this activity could be done.
1.9	Do the access aisles adjoin an accessible route?	☐ Yes ☒ No

Photo #:	• Create accessible route • Relocate accessible space • **Proposed Solutions** The existing sidewalk and parking area do not meet ADA requirements. Major reconstruction would have to take place fix the problem. Funding would have to be secured before this activity could be done.

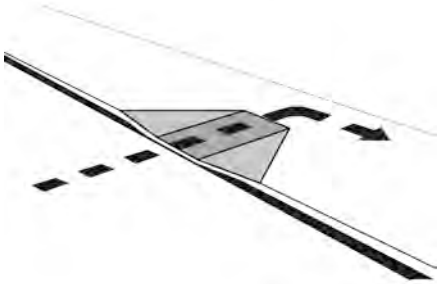
Curb Ramps *(2010 Standards – 406)*				
1.19 If the accessible route crosses a curb, is there a curb ramp?	☐ Yes ☒ No

Photo #:	• Install curb ramp • • **Proposed Solutions** The existing sidewalk and parking area do not meet ADA requirements. Major reconstruction would

have to take place fix the problem. Funding would have to be secured before this activity could be done.
Ramps *(2010 Standards – 405 & 505)* **Note: If any portion of the accessible route is steeper than 1:20, it should be treated as a ramp.**

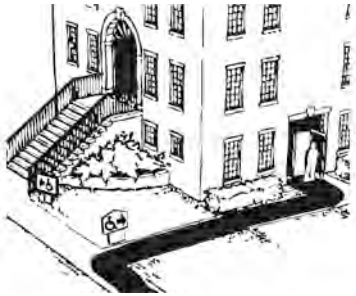
1.38	If the main entrance is not accessible, is there an alternative accessible entrance? Can the alternative accessible entrance be used independently and during the same hours as the main entrance?	☐ Yes ☒ No ☐ Yes ☒ No

Photo #:	• Designate an entrance and make it accessible • Ensure that accessible entrance can be used independently and during the same hours as the main entrance •
1.39	Do all inaccessible entrances have signs indicating the location of the nearest accessible entrance?	☐ Yes ☒ No		Photo #:	• Install signs • Install signs on route before people get to inaccessible entrances so that people do not have to turn around and retrace route •
1.40	If not all entrances are accessible, is there a sign at the accessible entrance with the International Symbol of Accessibility?	☐ Yes ☒ No		Photo #:	• Install sign • • **Proposed Solutions** Maintenance forces can install sign.

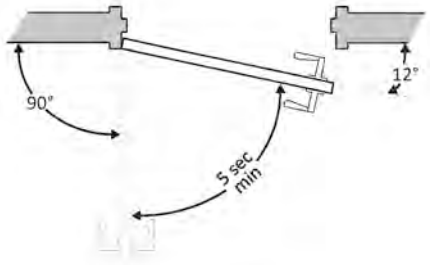
1.46	If the door has a closer, does it take at least 5 seconds to close from an open position of 90 degrees to a position of 12 degrees from the latch? 70 Degrees and 3 min 1991 ADA	☐ Yes ☒ No Measurement: 4 Sec.

Photo #:	• Adjust closer • • **Proposed Solutions** Maintenance forces could adjust the door closer to meet the ADA requirements. Time Frame – Immediate.

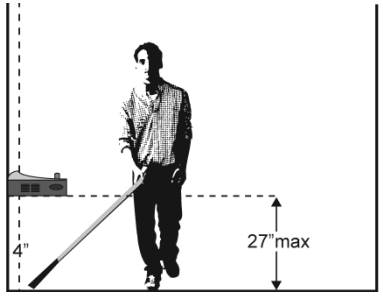
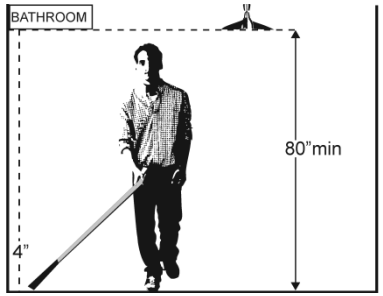
Priority 2 – Access to Goods & Services			Comments	Possible Solutions
Interior Accessible Route *(2010 Standards – Ch.4)*				
2.8 Do all objects on circulation paths through public areas, e.g. fire extinguishers, drinking fountains, signs, etc., protrude no more than 4 inches into the path? Or If an object protrudes more than 4 inches, is the bottom leading edge at 27 inches or lower above the floor? Or Is the bottom leading edge at 80 inches or higher above the floor?	☐ Yes ☒ No Measurement: 19" ☐ Yes ☒ No Measurement: 27" and 35" ☐ Yes ☐ No Measurement:	 Or

Photo #:	• Remove object • Add tactile warning such as permanent planter or partial walls • **Proposed Solutions** Drinking fountain could be recessed into wall or a partial wall constructed around the fountain. Time Frame – 1 year
Ramps *(2010 Standards 404 & 505)*

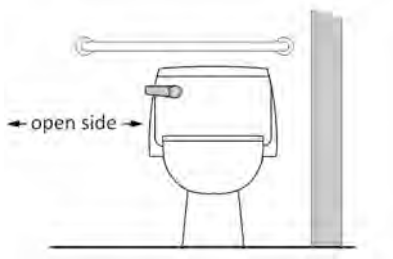
3.37	Is the flush control on the open side of the water closet?	☐ Yes ☒ No

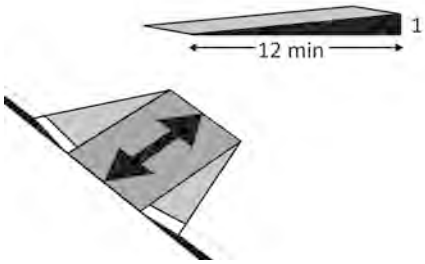
Curb Ramps *(2010 Standards – 406)*					
1.20	Is the running slope of the curb ramp no steeper than 1:12, i.e. for every inch of height change there are at least 12 inches of curb ramp run?	☐ Yes ☒ No Measurement: 10.4%

Photo #: 	• Regrade or Reconstruct curb ramp • •

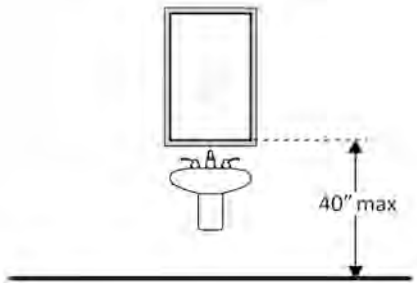
3.19	If the mirror is over a lavatory or countertop, is the bottom edge of the reflecting surface no higher than 40 inches above the floor? Or	☐ Yes ☒ No Measurement: 58"

Photo #:	• Lower the mirror • Add another mirror •
3.20 If there is a coat hook, is it no less than 15 inches and no greater than 48 inches above the floor? 54" for side reach 1991 ADA	☐ Yes ☒ No Measurement:

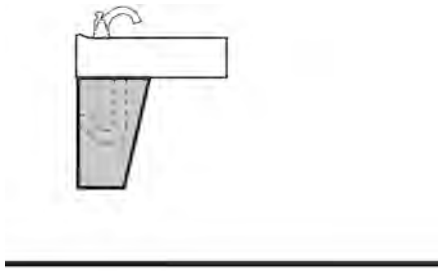
Lavatories *(2010 Standards – 606)* **Note: 2010 Standards refer to sinks in toilet rooms as lavatories.**				
3.26 Are pipes below the lavatory insulated or otherwise configured to protect against contact?	☐ Yes ☒ No

Photo #:	• Install insulation • Install cover panel •

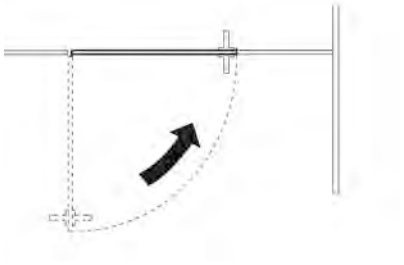
Photo #:	• Widen door width • •
3.43 Is the door self-closing?	☐ Yes ☒ No

Photo #:	• Add closer • Replace door Or Provide Continuous spring hinges •

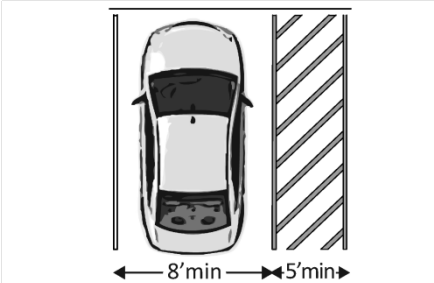
repainting lines
1.4	Are accessible spaces at least 8 feet wide with an access aisle at least 5 feet wide? 1991 ADA	☐ Yes ☒ No Measurement:

Photo #: 	• Reconfigure by repainting lines Two spaces can share an access aisle

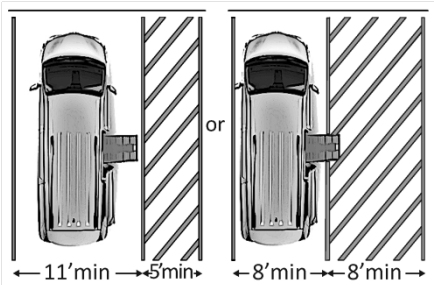
1.5	Is the van accessible space: At least 11 feet wide with an access aisle at least 5 feet wide? Or At least 8 feet wide with an access aisle at least 8 feet wide?	☐ Yes ☒ No Measurement: ☐ Yes ☒ No Measurement:

1991 on RT. 2010 on LT. Photo #: 	• Reconfigure to provide van-accessible space(s) • •

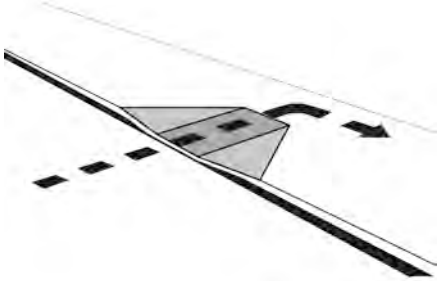
Curb Ramps *(2010 Standards – 406)*					
1.19	If the accessible route crosses a curb, is there a curb ramp?	☐ Yes ☒ No

Photo #:	• Install curb ramp • •
