Mississippi Department of Transportation

ADA TRANSITION PLAN

October 1, 2014

UPDATE

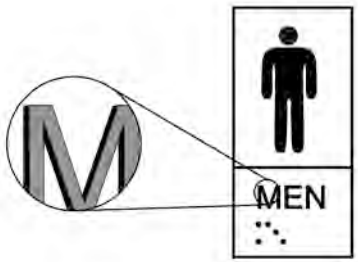
Signs at Toilet Rooms *(2010 Standards – 703)*				
3.5 Do text characters contrast with their backgrounds?	☐ Yes ☒ No

• Install tactile sign • Relocate sign •
Are text characters raised?	☐ Yes ☒ No			
Is there Braille?	☐ Yes ☒ No			
Is the sign mounted: On the wall on the latch side of the door?	☐ Yes ☒ No			
Note: Signs are permitted on the push side of doors with closers and without hold-open devices.

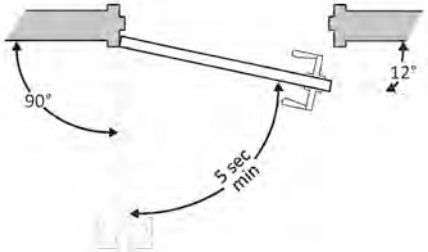
3.9	Is the door equipped with hardware that is operable with one hand and does not require tight grasping, pinching, or twisting of the wrist? Check door handle and lock (if provided).	☐ Yes ☒ No Measurement:		Photo #: 	• Replace knobs or latches with lever or loop handles • Install power-assisted or automatic door openers •
3.12	If the door has a closer, does it take at least 5 seconds to close from an open position of 90 degrees to a position of 12 degrees from the latch? 70 degrees and 3 min. 1991 ADA	☐ Yes ☒ No Measurement:

Photo #: 	• Adjust closer • •
3.13	If there are two doors in a series, e.g. vestibule, is the distance between the doors at least 48 inches plus the width of the doors when swinging into the space?	☐ Yes ☒ No Measurement: 6"

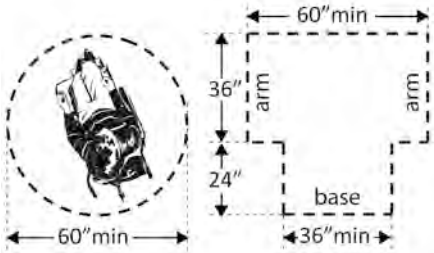
In the Toilet Room					
3.16	Is there a clear path to at least one of each type of fixture, e.g. lavatory, hand dryer, etc., that is at least 36 inches wide?	☐ Yes ☒ No Measurement:		Photo #: 	• Remove obstructions • •
3.17	Is there clear floor space available for a person in a wheelchair to turn around, i.e. a circle at least 60 inches in diameter or a T-shaped space within a 60-inch square?*	☐ Yes ☒ No Measurement:

Photo #: 	*The door to the toilet room may swing into the required turning space • Move or remove partitions, fixtures or objects such as trash cans • •
3.20	If there is a coat hook, is it no less than 15 inches and no greater than 48 inches above the floor? 54” for side reach 1991 ADA	☐ Yes ☒ No Measurement: 63”

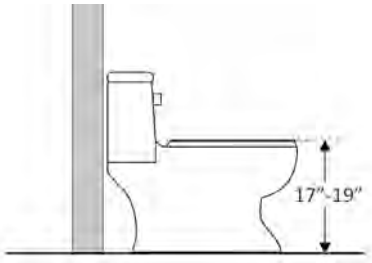
3.32	Is the height of the water closet no less than 17 inches and no greater than 19 inches above the floor measured to the top of the seat?	☐ Yes ☒ No Measurement: 14"

• Adjust toilet height • Replace toilet •

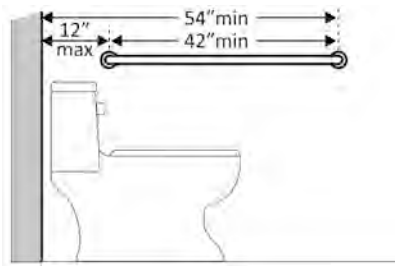
3.33	Is there a grab bar at least 42 inches long on the side wall?	☒ Yes ☐ No Measurement:			• Install grab bar • Relocate grab bar • Relocate objects •
	Is it located no more than 12 inches from the rear wall?	☐ Yes ☒ No Measurement: 10”

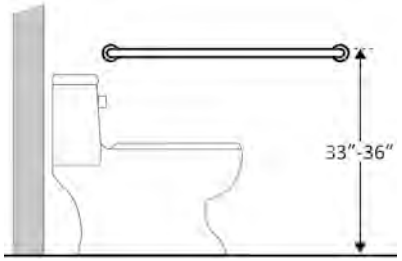
Does it extend at least 54 inches from the rear wall?	☐ Yes ☒ No Measurement: 52"			
	Is it mounted no less than 33 inches and no greater than 36 inches above the floor to the top of the gripping surface?	☐ Yes ☒ No Measurement: 30"

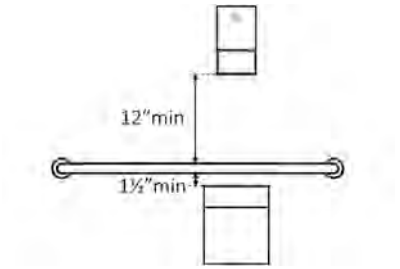
Is there at least 12 inches clearance between the grab bar and protruding objects above?*	☐ Yes ☒ No Measurement: 3"			* If constructed before 3/15/2012 grab bars do not need to be relocated; there are no space requirements above and below grab bars in the 1991 Standards
	Is there at least 1½ inches clearance between the grab bar and projecting objects below?*	☒ Yes ☐ No Measurement:

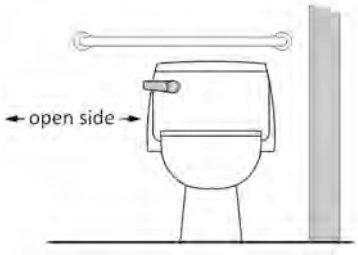
3.37	Is the flush control on the open side of the water closet?	☐ Yes ☒ No

Photo #:	• Move control • •
Toilet Compartments (Stalls) *(2010 Standards – 604)*					
3.42	If there is a front approach to the pull side of the door, is there at least 18 inches of maneuvering clearance beyond the latch side plus 60 inches clear depth?*	☐ Yes ☒ No Measurement: 6"

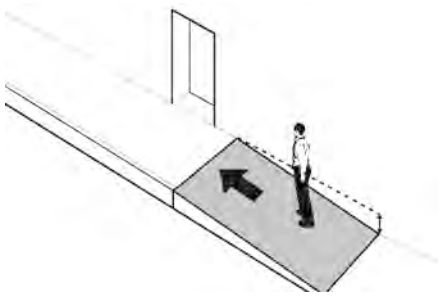
Priority 1 – Approach & Entrance			**Comments**	**Possible Solutions**
Exterior Accessible Route *(2010 Standards – Ch.4)*				
1.17 Is the running slope no steeper than 1:20, i.e. for every inch of height change there are at least 20 inches of route run? Or 5%	☒ Yes ☐ No Measurement: 6.8%

Photo #: 	• Regrade to 1:20 max. • If steeper than 1:20 and no steeper than 1:12, treat as a ramp and add other features such as edge protection and handrails •
1.18 Is the cross slope no steeper than 1:48? Or 2%	☐ Yes ☒ No Measurement: 4%

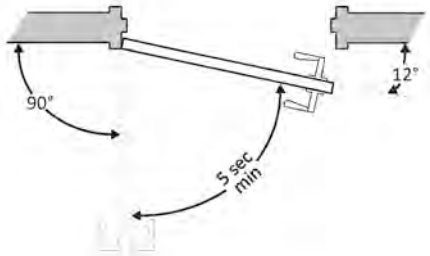
Photo #: 	• Regrade or Reconstruct curb ramp • •
Entrance *(2010 Standards – 404)*					
	If the door has a closer, does it take at least 5 seconds to close from an open position of 90 degrees to a position of 12 degrees from the latch? 70 Degrees and 3 min 1991 ADA	☐ Yes ☒ No Measurement: 4 sec

Photo #:	• Adjust closer • •

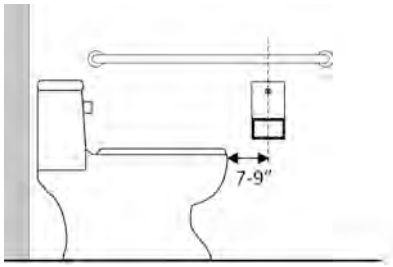
3.38 Is the toilet paper dispenser located no less than 7 inches and no greater than 9 inches from the front of the water closet to the centerline of the dispenser?*	☐ Yes ☒ No Measurement: 12"

Photo #: 	* If constructed before 3/15/2012 dispenser does not need to be relocated if it is within reach from the water closet seat; the 1991 Standards do not specify distance from the front of the water closet • Relocate dispenser • •

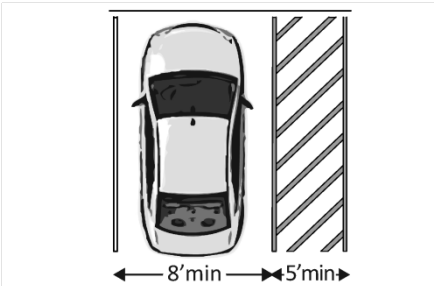
1.4	Are accessible spaces at least 8 feet wide with an access aisle at least 5 feet wide? 1991 ADA	☐ Yes ☒ No Measurement:

Photo #: 	• Reconfigure by repainting lines Two spaces can share an access aisle

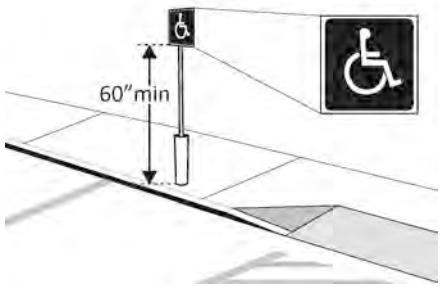
1.10	Are accessible spaces Identified with a sign that includes the International Symbol of Accessibility? Is the bottom of the sign at least 60 inches above the ground? MDOT say 7' to bottom of sign	☐ Yes ☒ No ☐ Yes ☒ No Measurement:

Photo #: 	• Install signs • • The International Symbol of Accessibility is not required on the ground by the 2010 Standards

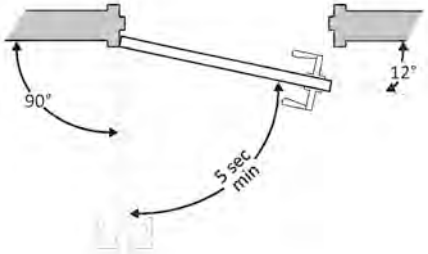
1.39	Do all inaccessible entrances have signs indicating the location of the nearest accessible entrance?	☐ Yes ☒ No		Photo #:	• Install signs • Install signs on route before people get to inaccessible entrances so that people do not have to turn around and retrace route •
1.40	If not all entrances are accessible, is there a sign at the accessible entrance with the International Symbol of Accessibility?	☐ Yes ☒ No		Photo #:	• Install sign • •
1.46	If the door has a closer, does it take at least 5 seconds to close from an open position of 90 degrees to a position of 12 degrees from the latch? 70 Degrees and 3 min 1991 ADA	☐ Yes ☒ No Measurement: 8 sec

Photo #:	• Adjust closer • •

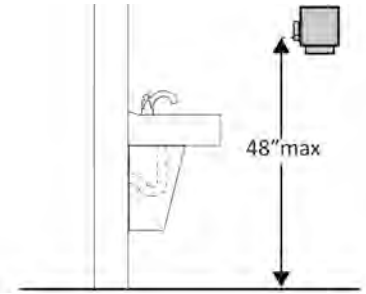
3.29 Can the operable parts of the hand dryer or towel dispenser be operated without tight grasping, pinching or twisting of the wrist? Is the force required to activate the hand dryer or towel dispenser no greater than 5 pounds?	☐ Yes ☒ No ☐ Yes ☒ No Measurement:

• Adjust dispensers • Replace with or provide additional accessible dispensers •

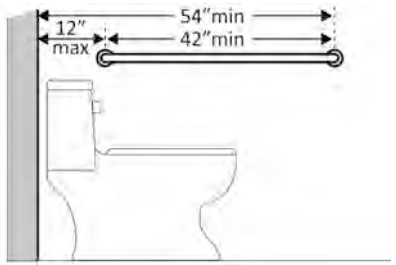
Water Closets in Single-User Toilet Rooms and Compartments (Stalls) *(2010 Standards – 603 & 609)* **Note: 2010 Standards refer to toilets as water closets.**				
3.33 Is it located no more than 12 inches from the rear wall?	☐ Yes ☒ No Measurement: 10"

Photo #: 	• Install grab bar • Relocate grab bar • Relocate objects •
3.38 Is the toilet paper dispenser located no less than 7 inches and no greater than 9 inches from the front of the water closet to the centerline of the dispenser?*	☐ Yes ☒ No Measurement: 12"

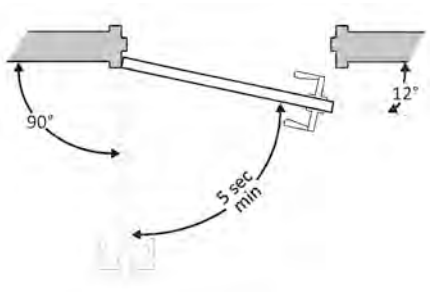
1.46	If the door has a closer, does it take at least 5 seconds to close from an open position of 90 degrees to a position of 12 degrees from the latch? 70 Degrees and 3 min 1991 ADA	☐ Yes ☒ No Measurement: 3 Sec.

Photo #:	• Adjust closer • •

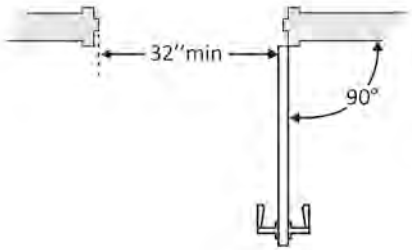
Entrance *(2010 Standards – 404)*				
3.6	Is the door opening width at least 32 inches clear, between the face of the door and the stop, when the door is open 90 degrees?	☐ Yes ☒ No Measurement: 30"

Photo #:	• Install offset hinges • Alter the doorway •

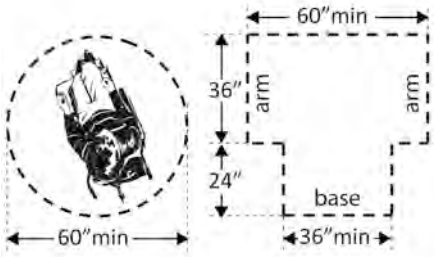
3.17	Is there clear floor space available for a person in a wheelchair to turn around, i.e. a circle at least 60 inches in diameter or a T-shaped space within a 60-inch square?*	☐ Yes ☒ No Measurement:

Photo #: 	*The door to the toilet room may swing into the required turning space • Move or remove partitions, fixtures or objects such as trash cans • •

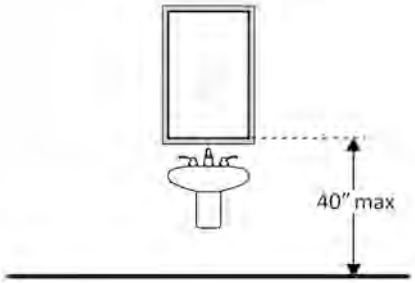
3.19	If the mirror is over a lavatory or countertop, is the bottom edge of the reflecting surface no higher than 40 inches above the floor? Or If the mirror is not over the lavatory or countertop, is the bottom edge of the reflecting surface no higher than 35 inches above the floor?*	☐ Yes ☒ No Measurement 47" ☐ Yes ☐ No Measurement:

Photo #:	* If installed before 3/15/2012 and the bottom edge of the reflecting surface is no higher than 40 inches above the floor, lowering the mirror to 35 inches is not required • Lower the mirror • Add another mirror •

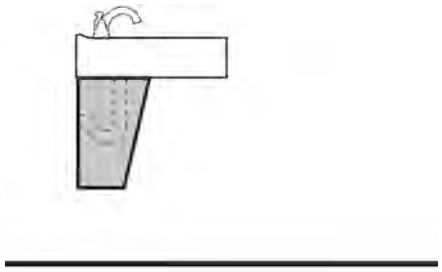
Lavatories *(2010 Standards – 606)* **Note: 2010 Standards refer to sinks in toilet rooms as lavatories.**				
3.26	Are pipes below the lavatory insulated or otherwise configured to protect against contact?	☐ Yes ☒ No

Photo #:	• Install insulation • Install cover panel •
Water Closets in Single-User Toilet Rooms and Compartments (Stalls) *(2010 Standards – 603 & 609)* **Note: 2010 Standards refer to toilets as water closets.**

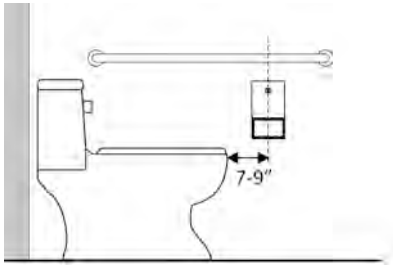
3.38	Is the toilet paper dispenser located no less than 7 inches and no greater than 9 inches from the front of the water closet to the centerline of the dispenser?*	☐ Yes ☒ No Measurement:

Photo #: 	* If constructed before 3/15/2012 dispenser does not need to be relocated if it is within reach from the water closet seat; the 1991 Standards do not specify distance from the front of the water closet • Relocate dispenser • •
Toilet Compartments (Stalls) *(2010 Standards – 604)*

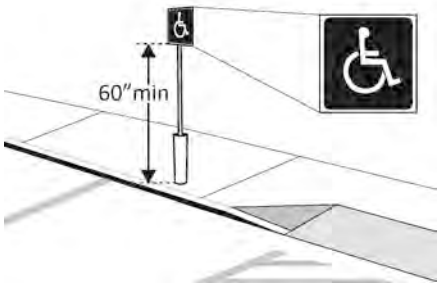
Priority 1 – Approach & Entrance			**Comments**	**Possible Solutions**
Parking *(2010 Standards – 208 & 502)* **Note: Accessible parking spaces should be identified by size, access aisle and signage.**				
1.10	Are accessible spaces Identified with a sign that includes the International Symbol of Accessibility? Is the bottom of the sign at least 60 inches above the ground? MDOT say 7' to bottom of sign	☐ Yes ☒ No ☐ Yes ☐ No Measurement:

No signs at site Photo #: 	• Install signs • • The International Symbol of Accessibility is not required on the ground by the 2010 Standards
1.11	Are there signs reading "van accessible" at van accessible spaces?	☐ Yes ☒ No		Photo #:

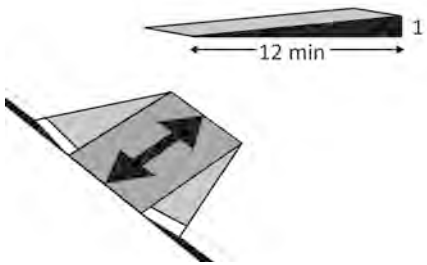
1.20	Is the running slope of the curb ramp no steeper than 1:12, i.e. for every inch of height change there are at least 12 inches of curb ramp run?	☐ Yes ☒ No Measurement: 8.9%

Photo #: 	• Regrade or Reconstruct curb ramp • •
1.21	Is the cross slope of the curb ramp, excluding flares, no steeper than 1:48? Or 2%	☐ Yes ☒ No Measurement: 4.6%

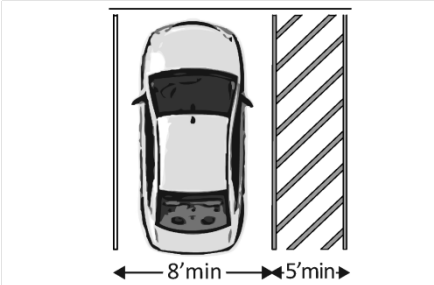
1.4	Are accessible spaces at least 8 feet wide with an access aisle at least 5 feet wide? 1991 ADA	☐ Yes ☒ No Measurement:

Photo #:	• Reconfigure by repainting lines Two spaces can share an access aisle
1.5	Is the van accessible space: At least 11 feet wide with an access aisle at least 5 feet wide? Or At least 8 feet wide with an access aisle at least 8 feet wide?	☐ Yes ☒ No Measurement: ☐ Yes ☒ No Measurement:

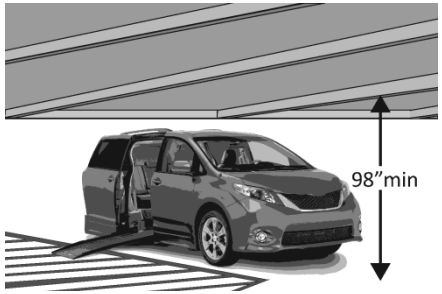
1991 on RT. 2010 on LT. Photo #:	• Reconfigure to provide van-accessible space(s) • •
1.6	Is at least 98 inches of vertical clearance provided for the van accessible space?	☐ Yes ☒ No Measurement:

Photo #:	• Reconfigure to provide van-accessible space(s) • •

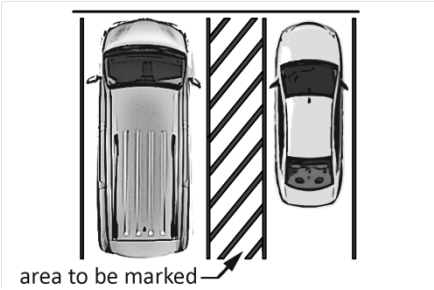
1.7	Are the access aisles marked so as to discourage parking in them?	☐ Yes ☒ No

Photo #:	• Mark access aisles • • The marking method and color may be addressed by state/local requirements
1.8	Is the slope of the accessible parking spaces and access aisles no steeper than 1:48 in all directions?	☐ Yes ☒ No Measurement: 6% x .3%		Photo #:	• Regrade surface or Modify grade • •
1.9	Do the access aisles adjoin an accessible route?	☐ Yes ☒ No		Photo #:	• Create accessible route • Relocate accessible space •
1.10	Are accessible spaces Identified with a sign that includes the International Symbol of Accessibility? Is the bottom of the sign at least 60 inches above the ground? MDOT say 7' to bottom of sign	☐ Yes ☒ No ☐ Yes ☒ No Measurement:

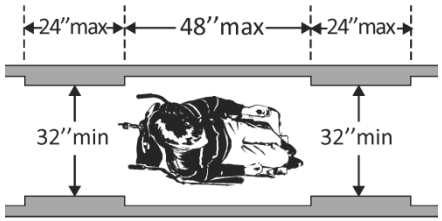
Exterior Accessible Route *(2010 Standards – Ch.4)*					
1.13	Is the route stable, firm and slip-resistant?	☒ Yes ☐ No		Photo #:	• Repair uneven paving • Fill small bumps and breaks with patches • Replace gravel with asphalt or other surface
1.14	Is the route at least 36 inches wide? Note: The accessible route can narrow to 32 inches min. for a max. of 24 inches. These narrower portions of the route	☐ Yes ☒ No Measurement:			• Change or move landscaping, furnishings or other items • Widen route •

must be at least 48 inches from each other.

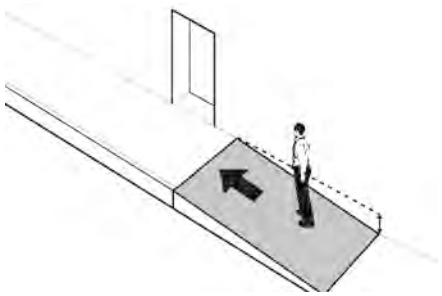
Photo #:	• Replace or move grate • •
1.17	Is the running slope no steeper than 1:20, i.e. for every inch of height change there are at least 20 inches of route run? Or 5%	☐ Yes ☒ No Measurement:

Photo #:	• Regrade to 1:20 max. • If steeper than 1:20 and no steeper than 1:12, treat as a ramp and add other features such as edge protection and handrails •

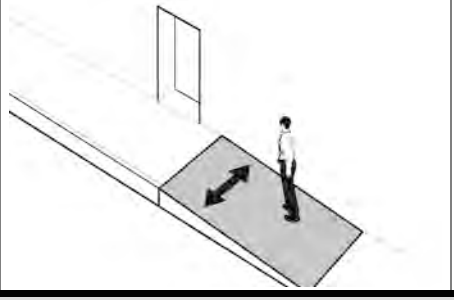
1.18	Is the cross slope no steeper than 1:48? Or 2%	☐ Yes ☒ No Measurement:

Photo #:	• Regrade or Reconstruct to 1:48 max. • •
Curb Ramps *(2010 Standards – 406)*					
1.19	If the accessible route crosses a curb, is there a curb ramp?	☐ Yes ☒ No

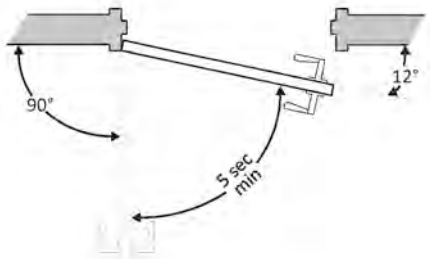
Photo #:	• Change hardware height • •
1.46	If the door has a closer, does it take at least 5 seconds to close from an open position of 90 degrees to a position of 12 degrees from the latch? 70 Degrees and 3 min 1991 ADA	☐ Yes ☒ No Measurement: 6 Sec

Photo #:	• Adjust closer • •
1.47	If there are two doors in a series, e.g. vestibule, is the distance between the doors at least 48 inches plus the width of the doors when swinging into the space?	☐ Yes ☐ No Measurement:

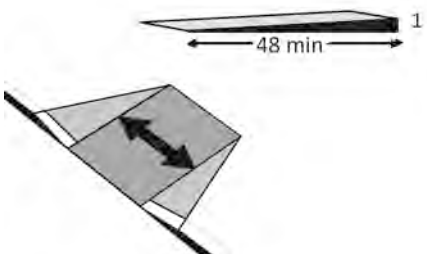
1.21	Is the cross slope of the curb ramp, excluding flares, no steeper than 1:48? Or 2%	☐ Yes ☒ No Measurement: 5.6%

Photo #:	• Regrade or Reconstruct curb ramp • •
1.23	At the top of the curb ramp is there a level landing (slope no steeper than 1:48 in all directions) that is at least 36 inches long and at least as wide as the curb ramp? If there are curb ramp flares, are the slopes of the flares no steeper than 1:10, i.e. for every inch of height change there are at least 10 inches of flare run?	☐ Yes ☒ No Measurement: 2.3% ☐ Yes ☐ No Measurement:

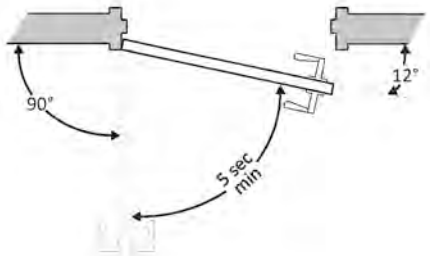
Photo #:	• Reconfigure • Add ramp flares •
Entrance *(2010 Standards – 404)*					
1.46	If the door has a closer, does it take at least 5 seconds to close from an open position of 90 degrees to a position of 12 degrees from the latch? 70 Degrees and 3 min 1991 ADA	☐ Yes ☒ No Measurement: 3 Sec

Photo #:	• Adjust closer • •

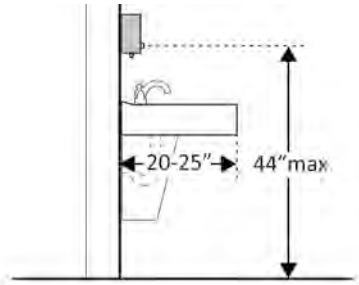
3.28	Are the operable parts of the soap dispenser within one of the following reach ranges: Above lavatories or counters no less than 20 inches and no greater than 25 inches deep: no higher than 44 inches above the floor?	☒ Yes ☐ No Measurement: 39"

• Adjust dispensers • Replace with or provide additional accessible dispensers •

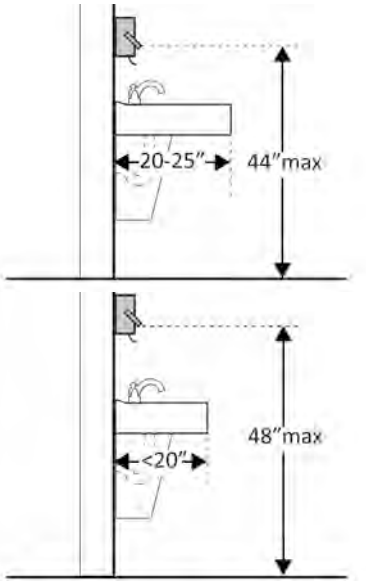
Photo #:	
3.29	Are the operable parts of the hand dryer or towel dispenser within one of the following reach ranges: Above lavatories or counters no less than 20 inches and no greater than 25 inches deep: no higher than 44 inches above the floor? Above lavatories less than 20 inches deep: no higher than 48 inches above the floor? Not over an obstruction: no higher than 48 inches above the floor?	☐ Yes ☐ No Measurement: ☐ Yes ☐ No Measurement: ☒ Yes ☐ No Measurement: 46"

• Adjust dispensers • Replace with or provide additional accessible dispensers •

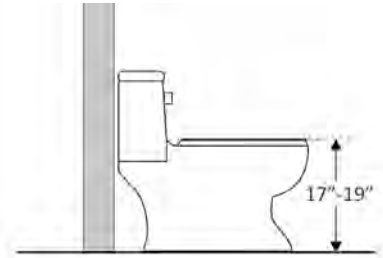
Photo #:	door to the room does not swing into the required clearances at fixtures (such as lavatories, water closet and urinals) and the edge of the lavatory is at least 18 inches from the centerline of the water closet • Alter room/compartment for clearance • •
3.32	Is the height of the water closet no less than 17 inches and no greater than 19 inches above the floor measured to the top of the seat?	☒ Yes ☐ No Measurement: 18"

Photo #:	• Adjust toilet height • Replace toilet •
3.33	Is there a grab bar at least 42 inches long on the side wall? Is it located no more than 12 inches from the rear wall? Does it extend at least 54 inches from the rear wall?	☒ Yes ☐ No Measurement: ☐ Yes ☒ No Measurement: 4" ☐ Yes ☐ No Measurement:

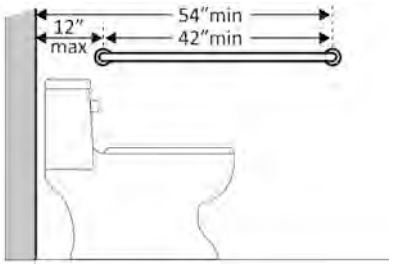
Is it mounted no less than 33 inches and no greater than 36 inches above the floor to the top of the gripping surface? Is there at least 12 inches clearance between the grab bar and protruding objects above?* Is there at least 1½ inches clearance between the grab bar and projecting objects below?* Is the space between the wall and the grab bar 1 ½ inches?	☒ Yes ☐ No Measurement: 36" ☐ Yes ☒ No Measurement: 4" ☒ Yes ☐ No Measurement: ☒ Yes ☐ No Measurement:

• Install grab bar • Relocate grab bar • Relocate objects •

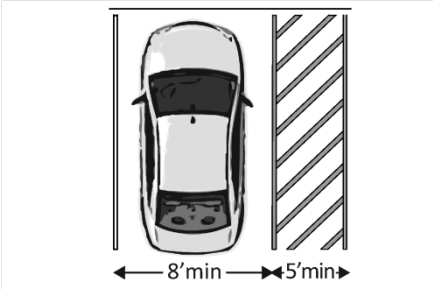
1.4	Are accessible spaces at least 8 feet wide with an access aisle at least 5 feet wide? 1991 ADA	☐ Yes ☒ No Measurement:

Photo #: 	• Reconfigure by repainting lines Two spaces can share an access aisle

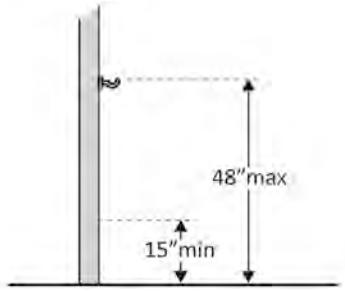
3.20	If there is a coat hook, is it no less than 15 inches and no greater than 48 inches above the floor? 54" for side reach 1991 ADA	☐ Yes ☒ No Measurement: 53"

• Adjust hook • Replace with or provide additional accessible hook •
Soap Dispensers and Hand Dryers *(2010 Standards – 603)*

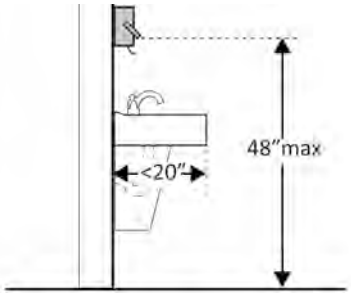
3.29	Not over an obstruction: no higher than 48 inches above the floor? Can the operable parts of the hand dryer or towel dispenser be operated without tight grasping, pinching or twisting of the wrist?	☐ Yes ☒ No Measurement: 40" ☐ Yes ☒ No Measurement:

Photo #: 	• Adjust dispensers • Replace with or provide additional accessible dispensers •

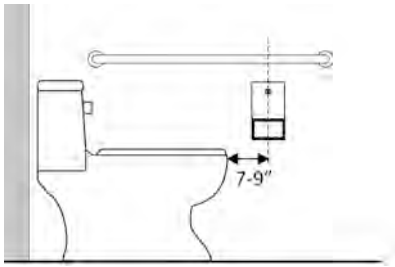
Photo #: 	• Move control • •
3.38	Is the toilet paper dispenser located no less than 7 inches and no greater than 9 inches from the front of the water closet to the centerline of the dispenser?*	☐ Yes ☒ No Measurement: 16"

Photo #: SEE ABOVE PHOTO	* If constructed before 3/15/2012 dispenser does not need to be relocated if it is within reach from the water closet seat; the 1991 Standards do not specify

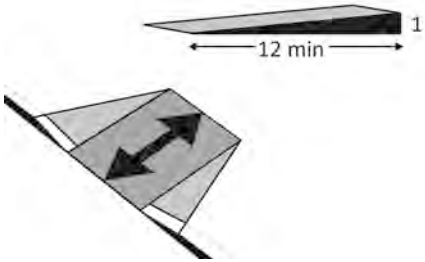
Curb Ramps *(2010 Standards – 406)*					
1.20	Is the running slope of the curb ramp no steeper than 1:12, i.e. for every inch of height change there are at least 12 inches of curb ramp run?	☐ Yes ☒ No Measurement: 8%

Photo #:	• Regrade or Reconstruct curb ramp • •
1.23	At the top of the curb ramp is there a level landing (slope no steeper than 1:48 in all directions) that is at least 36 inches long and at least as wide as the curb ramp? If there are curb ramp flares, are the slopes of the flares no steeper than 1:10, i.e. for every inch of height change there are at least 10 inches of flare run?	☒ Yes ☐ No Measurement: 2.1% ☐ Yes ☒ No Measurement:

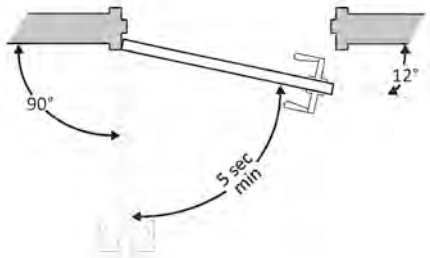
Exterior Accessible Route *(2010 Standards – Ch.4)*					
1.46	If the door has a closer, does it take at least 5 seconds to close from an open position of 90 degrees to a position of 12 degrees from the latch? 70 Degrees and 3 min 1991 ADA	☐ Yes ☒ No Measurement: 3 Sec.

Photo #:	• Adjust closer • •

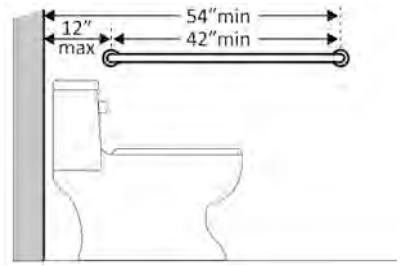
3.33	Is there a grab bar at least 42 inches long on the side wall?	☒ Yes ☐ No Measurement:

• Install grab bar • Relocate grab bar • Relocate objects •
	Is it located no more than 12 inches from the rear wall?	☐ Yes ☒ No Measurement:			
	Does it extend at least 54 inches from the rear wall?	☐ Yes ☒ No Measurement: 48"			
	Is it mounted no less than 33 inches and no greater than 36 inches above the floor to the top of the gripping surface?	☒ Yes ☐ No Measurement: 34"

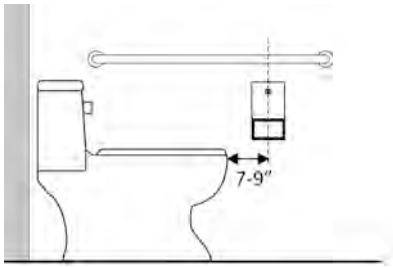
3.38	Is the toilet paper dispenser located no less than 7 inches and no greater than 9 inches from the front of the water closet to the centerline of the dispenser?*	☐ Yes ☒ No Measurement: 12"

Photo #: 	* If constructed before 3/15/2012 dispenser does not need to be relocated if it is within reach from the water closet seat; the 1991 Standards do not specify distance from the front of the water closet • Relocate dispenser • •
Toilet Compartments (Stalls) *(2010 Standards – 604)*					
3.43	Is the door self-closing?	☐ Yes ☒ No		Photo #:

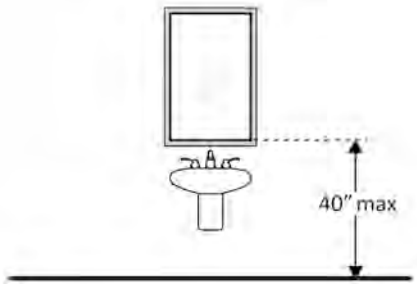
3.19	If the mirror is over a lavatory or countertop, is the bottom edge of the reflecting surface no higher than 40 inches above the floor? Or If the mirror is not over the lavatory or countertop, is the bottom edge of the reflecting surface no higher than 35 inches above the floor?*	☐ Yes ☒ No Measurement: 41" ☐ Yes ☐ No Measurement:

Photo #: 	* If installed before 3/15/2012 and the bottom edge of the reflecting surface is no higher than 40 inches above the floor, lowering the mirror to 35 inches is not required • Lower the mirror • Add another mirror •
3.20	If there is a coat hook, is it no less than 15 inches and no greater than 48 inches above the floor? 54" for side reach 1991 ADA	☐ Yes ☒ No Measurement: 64"

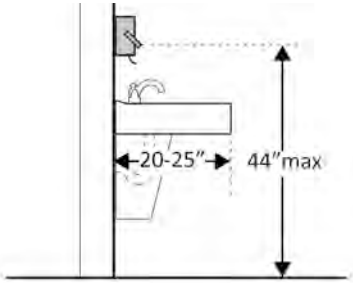
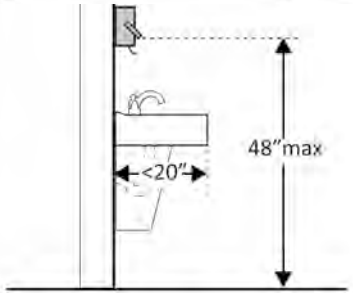
3.29	Are the operable parts of the hand dryer or towel dispenser within one of the following reach ranges: Above lavatories or counters no less than 20 inches and no greater than 25 inches deep: no higher than 44 inches above the floor? Above lavatories less than 20 inches deep: no higher than 48 inches above the floor? Not over an obstruction: no higher than 48 inches above the floor? Can the operable parts of the hand dryer or towel dispenser be operated without tight grasping, pinching or twisting of the wrist? Is the force required to activate the hand dryer or towel dispenser no greater than 5 pounds?	☐ Yes ☐ No Measurement: ☐ Yes ☐ No Measurement: ☒ Yes ☐ No Measurement: 48" ☐ Yes ☒ No ☐ Yes ☒ No Measurement:

• Adjust dispensers • Replace with or provide additional accessible dispensers •

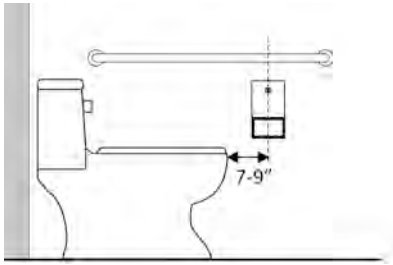
Photo #:	• Move control • •
3.38	Is the toilet paper dispenser located no less than 7 inches and no greater than 9 inches from the front of the water closet to the centerline of the dispenser?*	☐ Yes ☒ No Measurement: 5"

Photo #:	* If constructed before 3/15/2012 dispenser does not need to be relocated if it is within reach from the water closet seat; the 1991 Standards do not specify distance from the front of the water closet • Relocate dispenser • •
Toilet Compartments (Stalls) *(2010 Standards – 604)*					
3.43	Is the door self-closing?	☐ Yes ☒ No		Photo #:
