ELEVATION BENT 2

Member	Comments	Photo No.	Looking
N. Col.	Cracks in N. Col. on West Face	195	E
S. Col.	Cracks in S. Col. on West Face	196	E
Bent 2	Overall Picture of Bent 2	2746	W

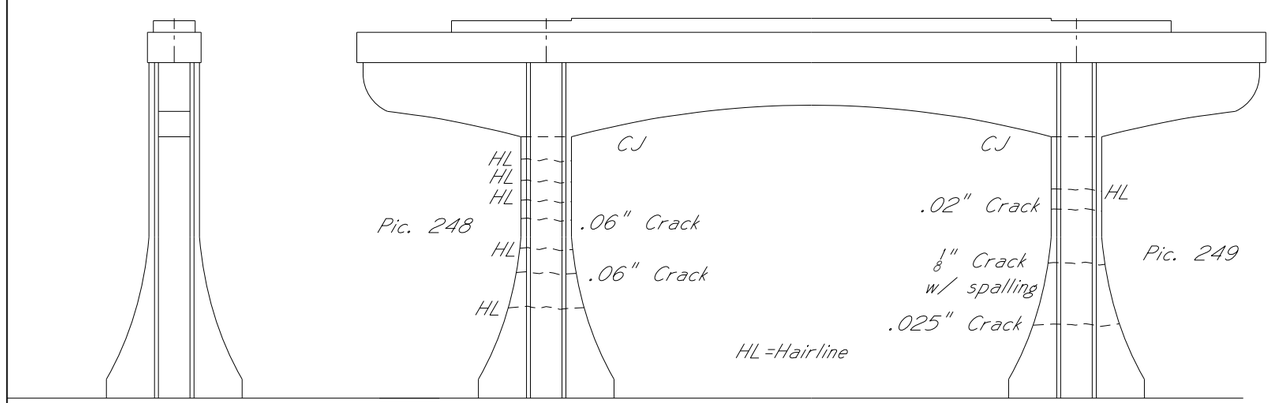
ELEVATION BENT 3

Member	Comments	Photo No.	Looking
N. Col.	Cracks in N. Col. on West Face	248	E
S. Col.	Cracks in S. Col. on West Face	249	E
Bent 3	Overall Picture of Bent 3	2747	E

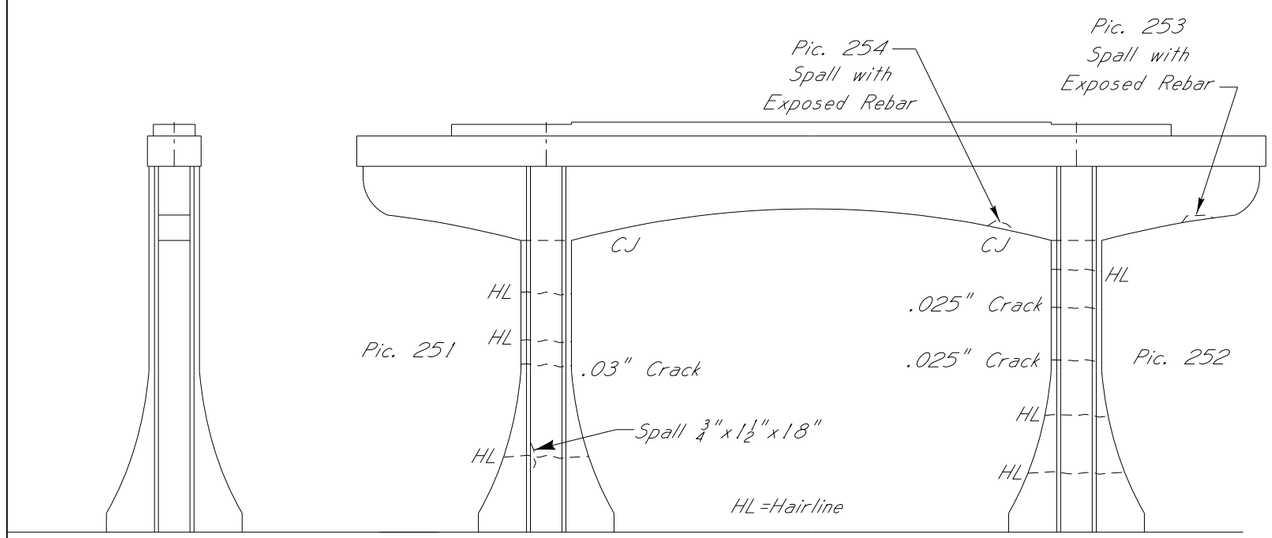
ELEVATION BENT 4

Member	Comments	Photo No.	Looking
Bent 4	Overall Picture of Bent 4	250	E
N. Col.	Cracks/Spalls in N. Col. on West Face	251	E
S. Col.	Cracks in S. Col. on West Face	252	E
S. Overhang	Exposed Rebar on South Face of Overhang	253	E
Cap	Exposed Rebar on West Face of Arch	254	E

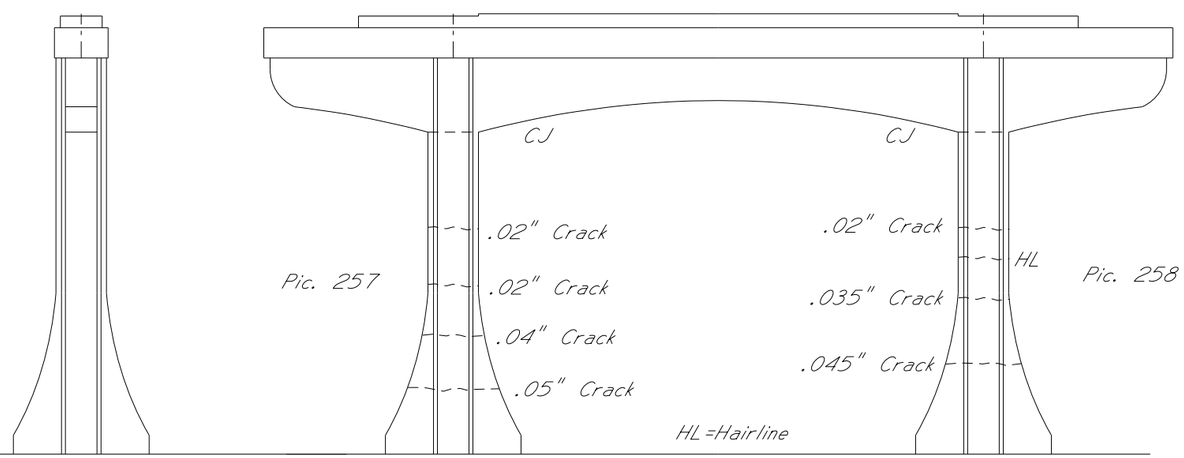
ELEVATION BENT 5
Looking East

Member	Comments	Photo No.	Looking
Bent 5	Overall Picture of Bent 5	256	E
N. Col.	Cracks in N. Col. on West Face	257	E
S. Col.	Cracks in S. Col. on West Face	258	E

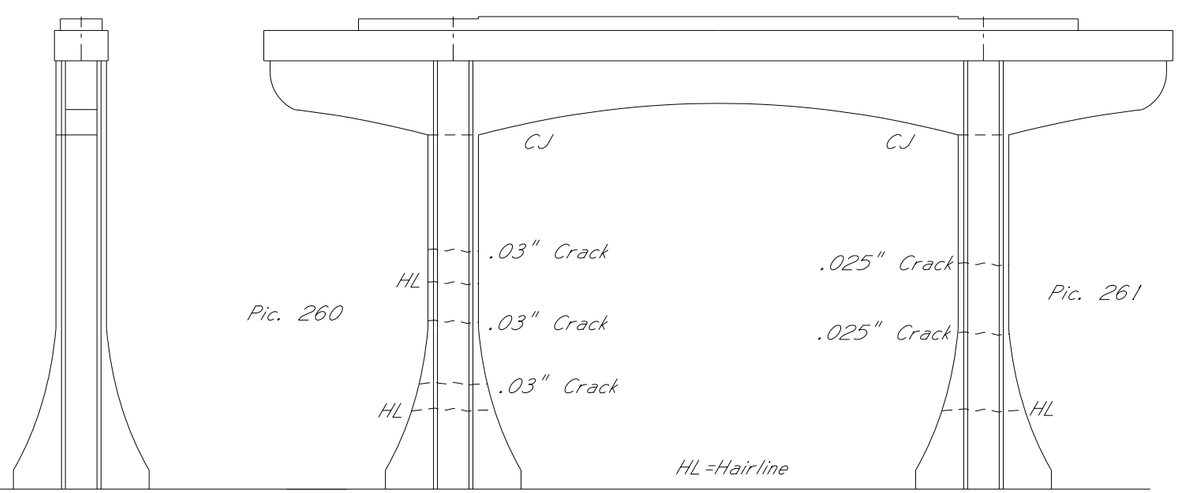
ELEVATION BENT 6

Member	Comments	Photo No.	Looking
Bent 6	Overall Picture of Bent 6	259	W
N. Col.	Cracks in N. Col. on West Face	260	E
S. Col.	Cracks in S. Col. on West Face	261	E

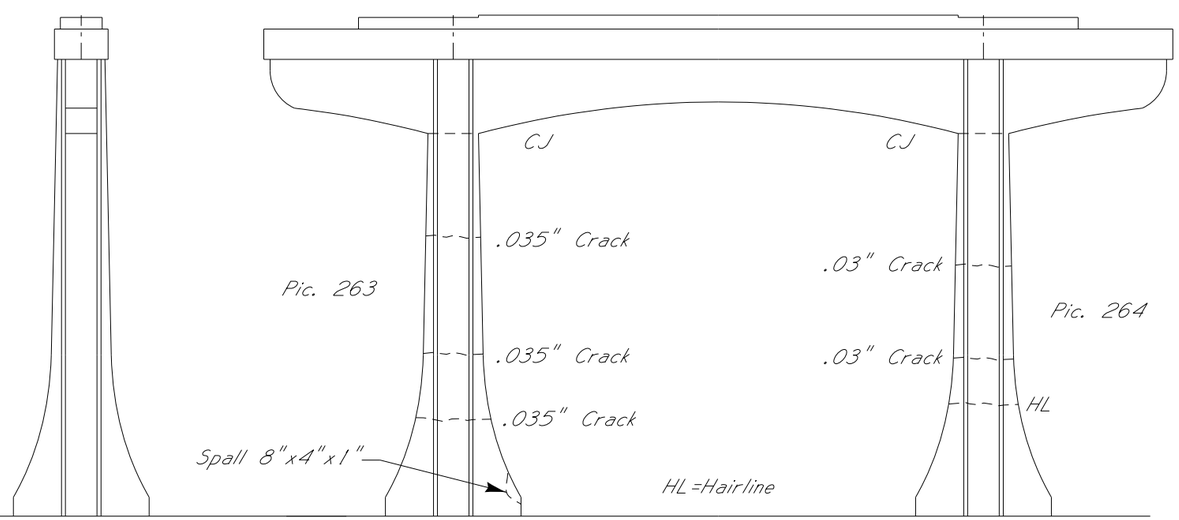
ELEVATION BENT 7

Member	Comments	Photo No.	Looking
Bent 7	Overall Picture of Bent 7	262	SE
N. Col.	Cracks in N. Col. on West Face	263	E
S. Col.	Cracks in S. Col. on West Face	264	E

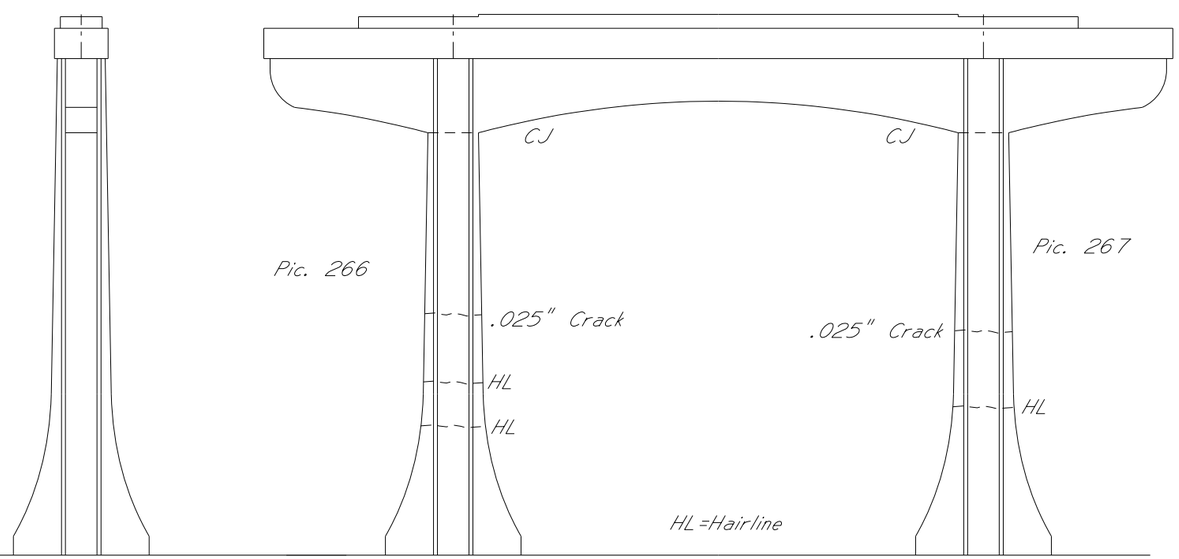
ELEVATION BENT 8

Member	Comments	Photo No.	Looking
Bent 8	Overall Picture of Bent 8 Side View	265	N
N. Col.	Cracks in N. Col. on West Face	266	NE
S. Col.	Cracks in S. Col. on West Face	267	SE

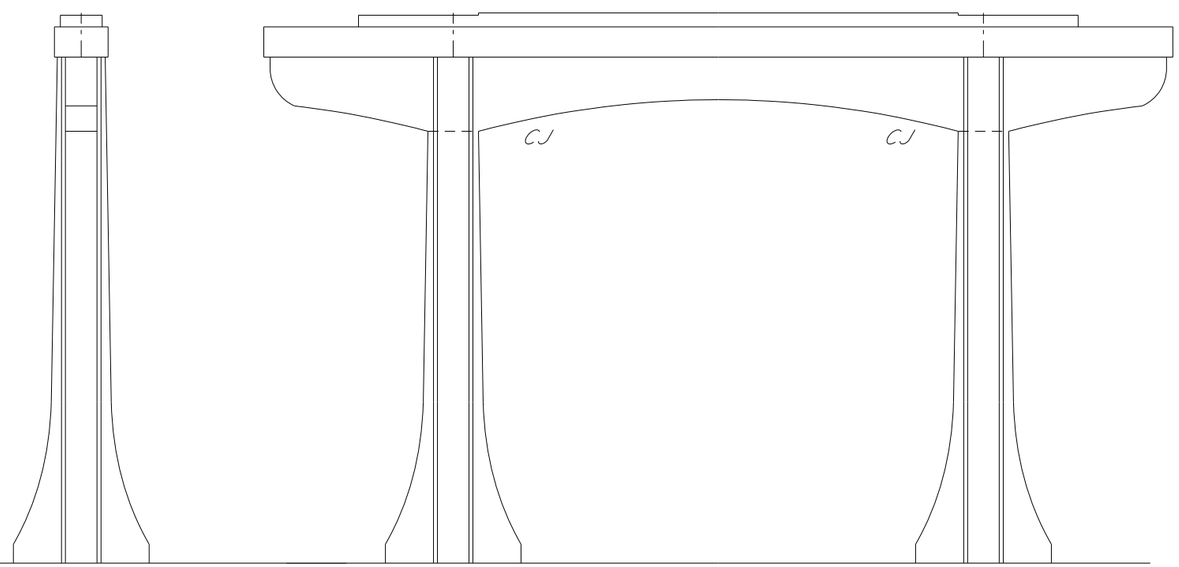
ELEVATION BENT 9

Member	Comments	Photo No.	Looking
Bent 9	Overall Picture of Bent 9 - No Cracks	268	NE

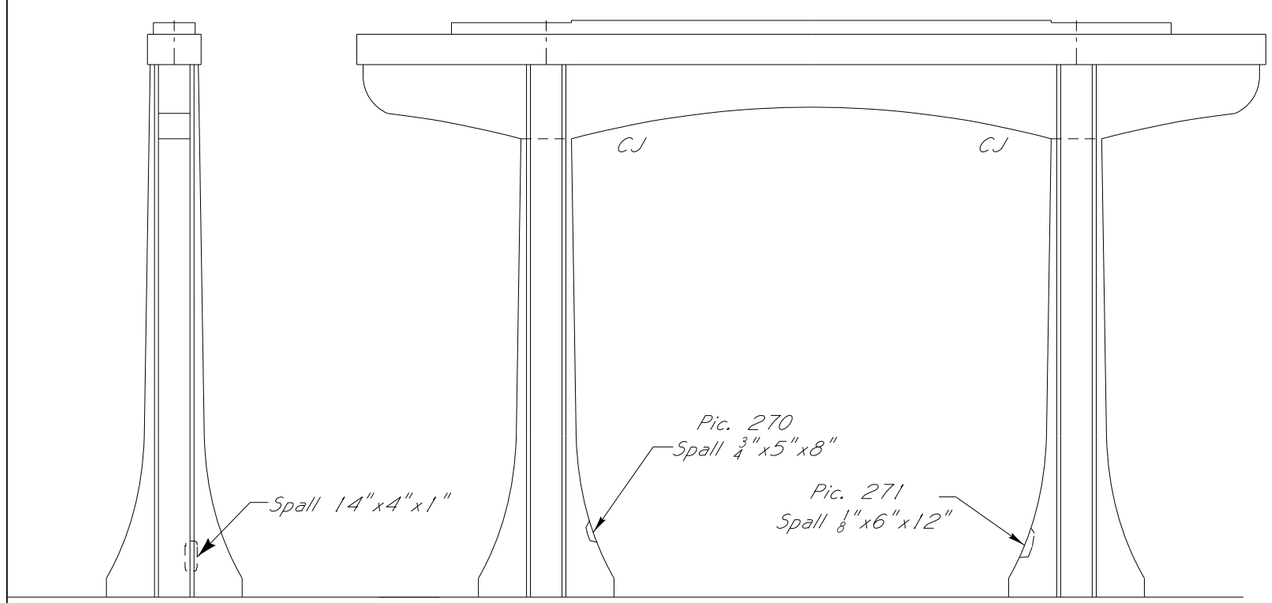
ELEVATION BENT 10

Member	Comments	Photo No.	Looking
Bent 10	Overall Picture of Bent 10	269	E
N. Col.	Spall / Exposed Rebar South Face	270	N
S. Col.	Spall North Face	271	S

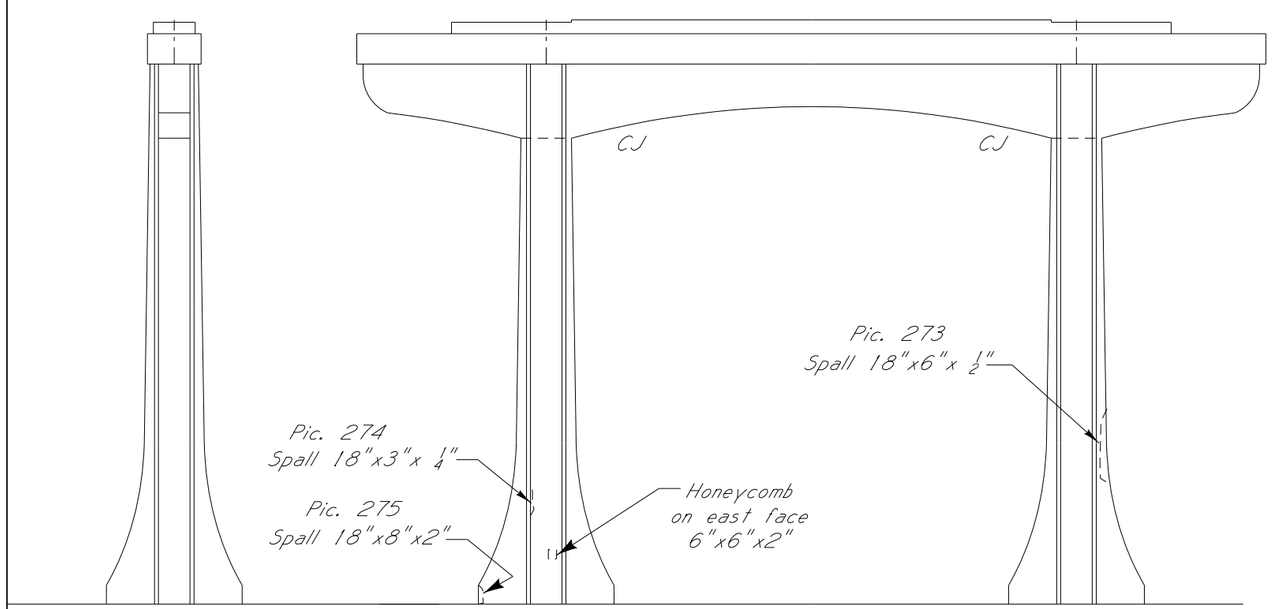
ELEVATION BENT 11

Member	Comments	Photo No.	Looking
Bent 11	Overall Picture of Bent 11	272	E
S. Col.	Spall SW Face	273	NE
N. Col.	Spall NW Face	274	E
N. Col.	Spall East Face	275	SW

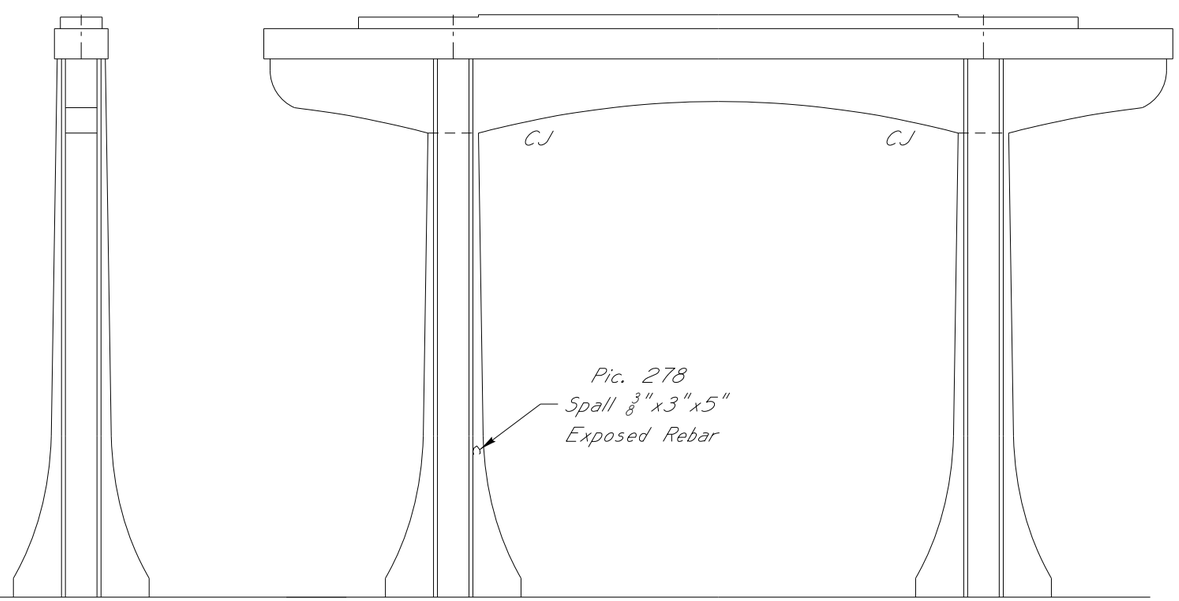
ELEVATION BENT 12

Member	Comments	Photo No.	Looking
Bent 12	Overall Picture of Bent 12	276	E
N. Col.	Spall With Exposed Rebar East Face	278	W

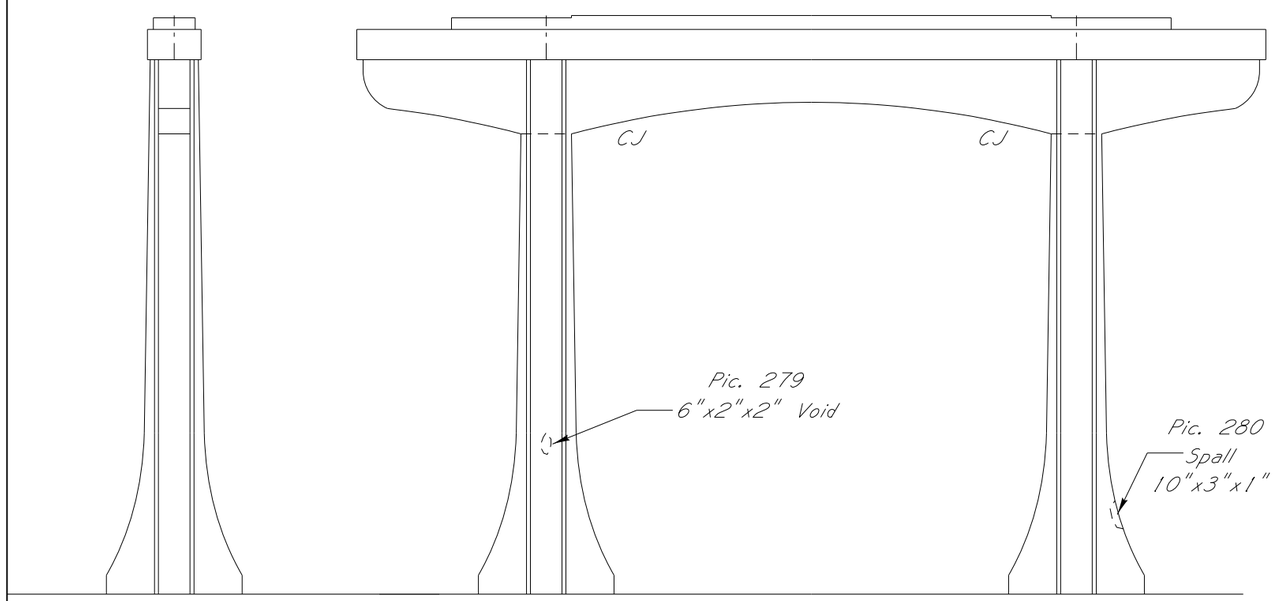
ELEVATION BENT 13

Member	Comments	Photo No.	Looking
Bent 13	Overall Picture of Bent 13	277	E
N. Col.	Void In Column West Face	279	E
S. Col.	Spall SE Face	280	N

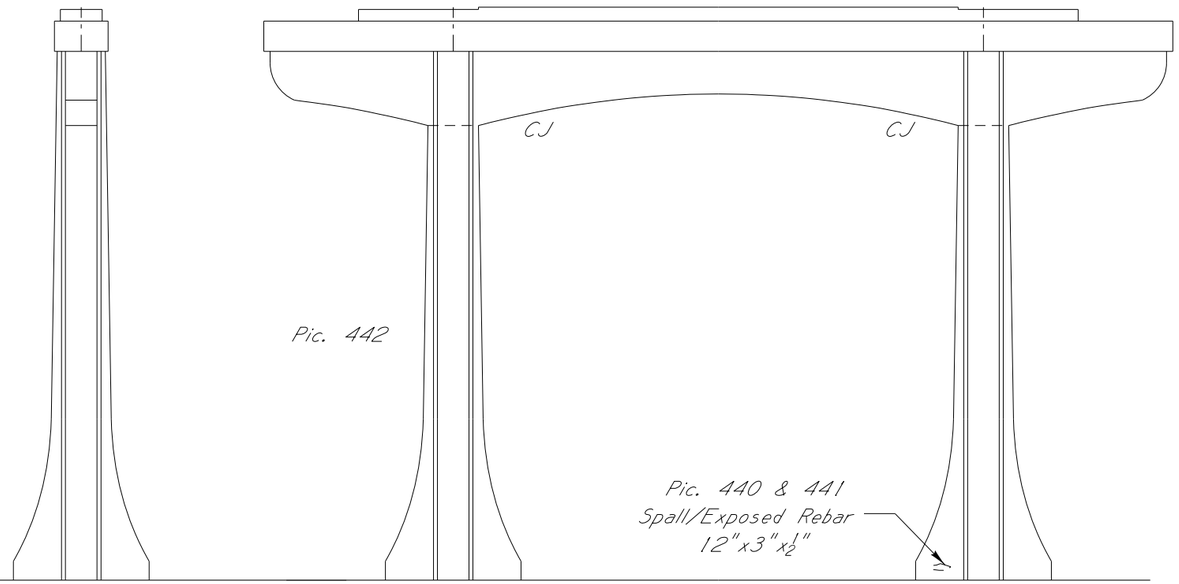
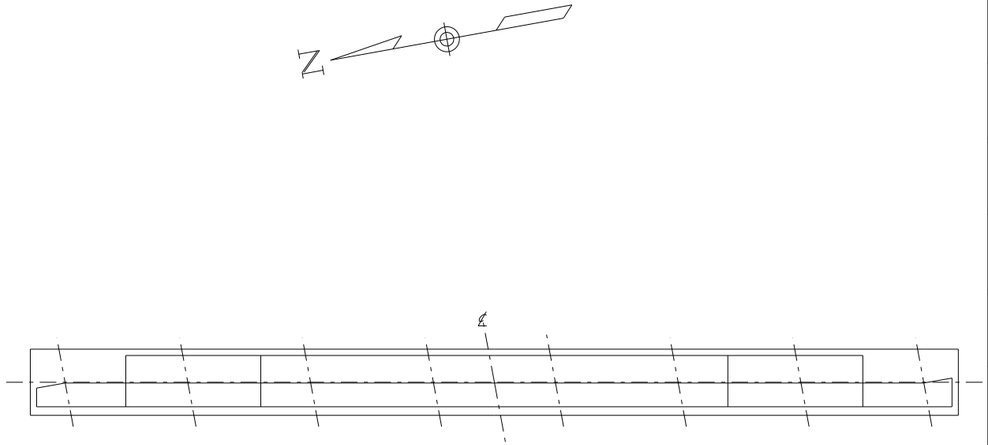
ELEVATION BENT 14

Member	Comments	Photo No.	Looking
Bent 14	Overall Picture of Bent 14	439	W
N. Col.	North Column	442	W
S. Col.	Spall Exposed Rebar 12"x3"x ½" East Face	440 441	W W

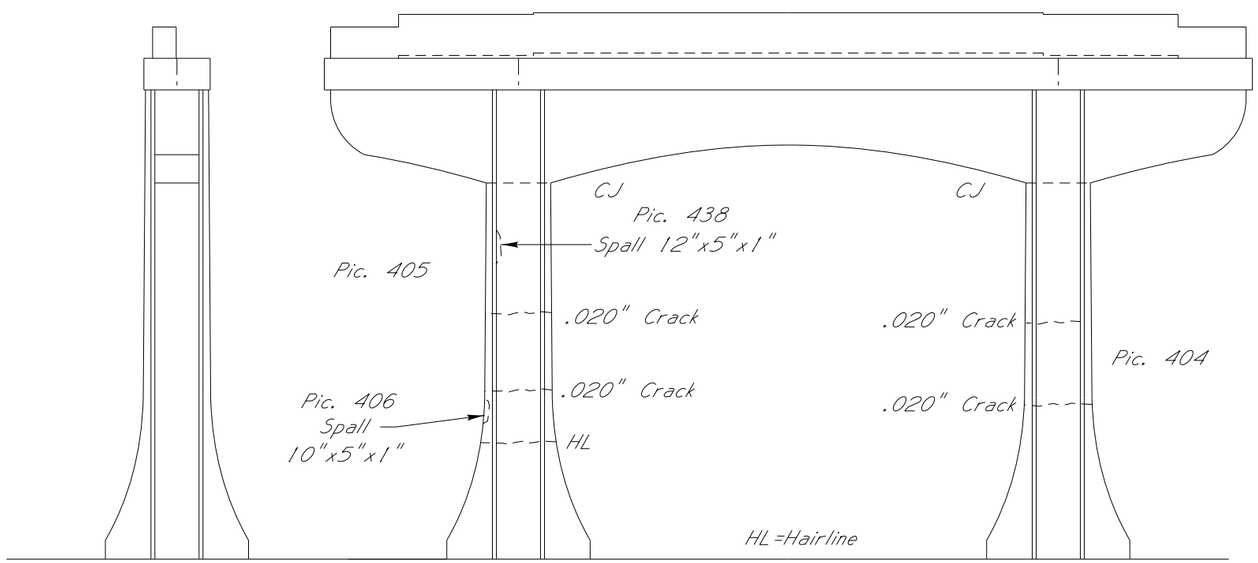
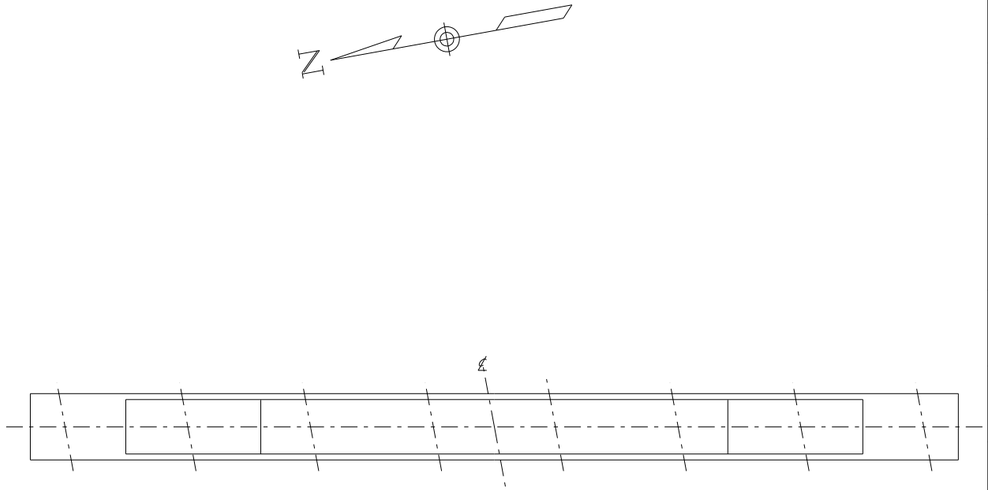
ELEVATION BENT 15

Member	Comments	Photo No.	Looking
Bent 15	Overall Picture of Bent 15	403	W
S. Col.	South Column	404	W
N. Col.	North Column	405	W
N. Col.	Spall/ 10"x5"x1" NE Face	406	W
N. Col.	Spall/ 12"x5"x1" West Face	438	E

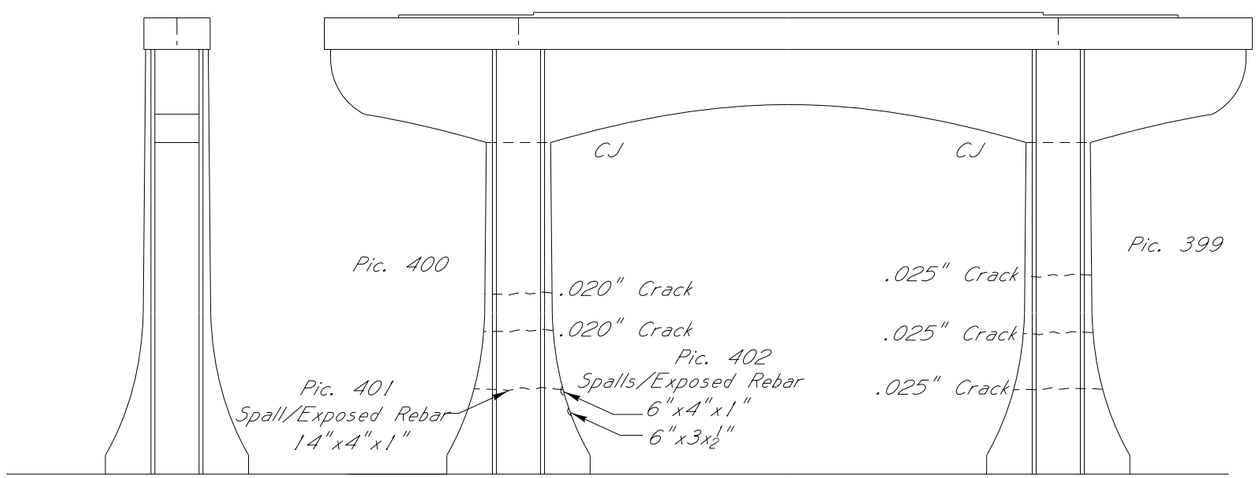
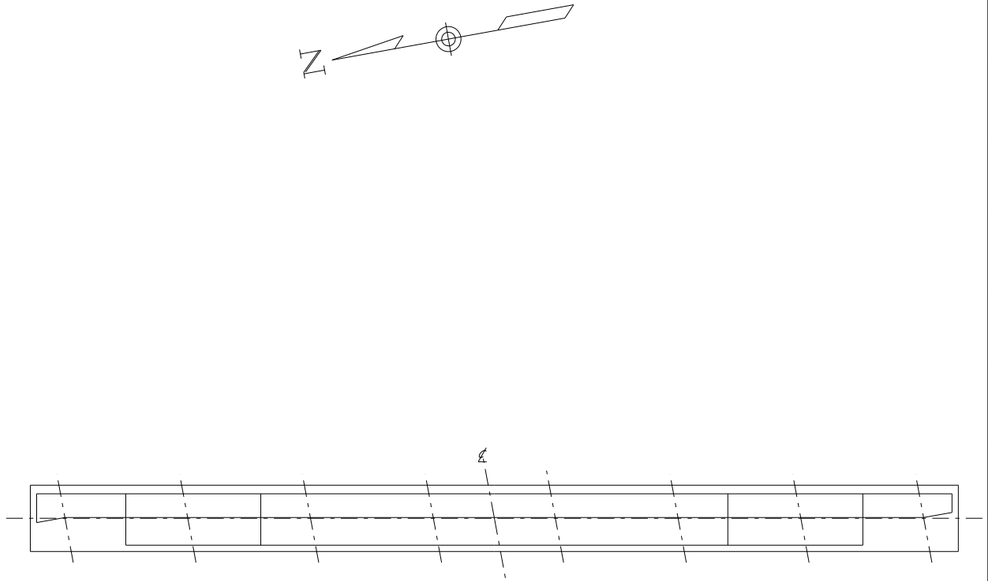
ELEVATION BENT 16

Member	Comments	Photo No.	Looking
Bent 16	Overall Picture of Bent 16	398	W
S. Col.	0.025" Cracks	399	W
N. Col.	Spall/Cracks/Exposed Rebar East Face	400	W
N. Col.	Spall/Exposed Rebar 14"x4"x1" East Face	401	W
N. Col.	Spall/Exposed Rebar 6"x4"x1"/ 6"x3x½" South Face	402	N

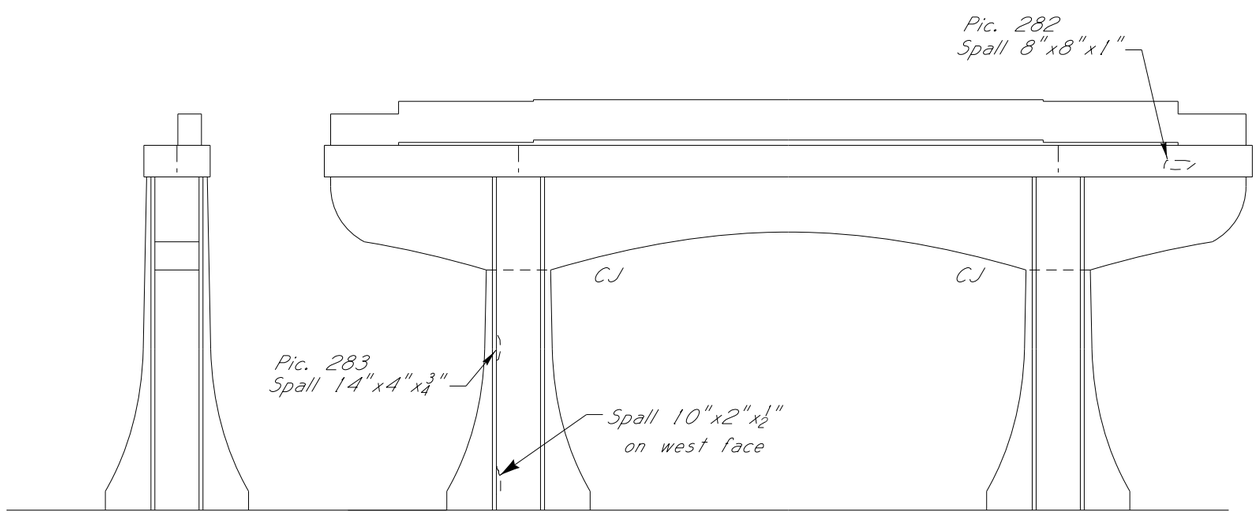
ELEVATION BENT 17

Member	Comments	Photo No.	Looking
Bent 17	Overall Picture of Bent 17	281	W
Cap	Spall on East Face of Cap 8"x8"x1"	282	W
N. Col.	Spall NE Face/ 14"x4"x3/4"	283	W

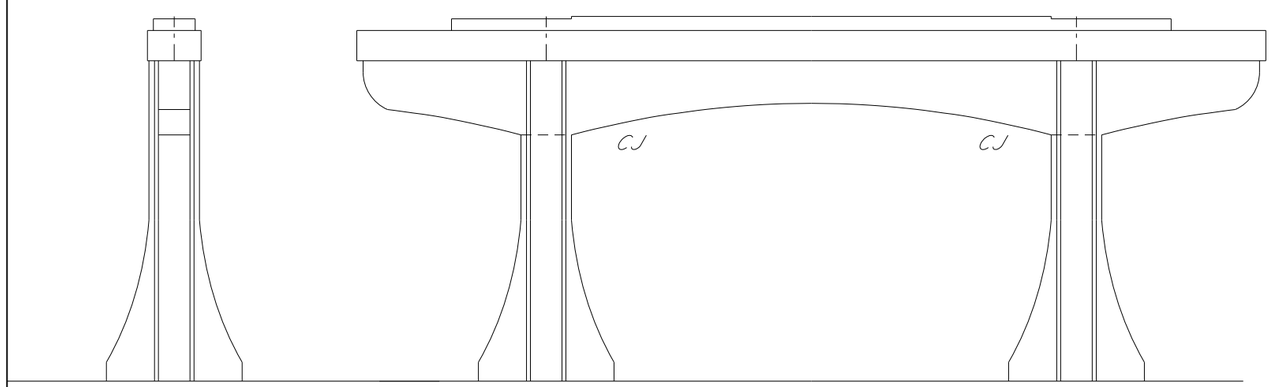
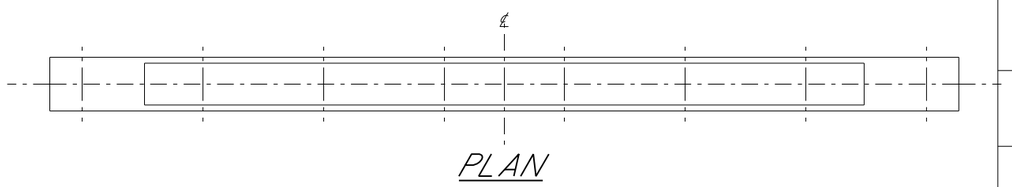
ELEVATION BENT 18

Member	Comments	Photo No.	Looking
Bent 18	Overall Picture of Bent 18	284	W

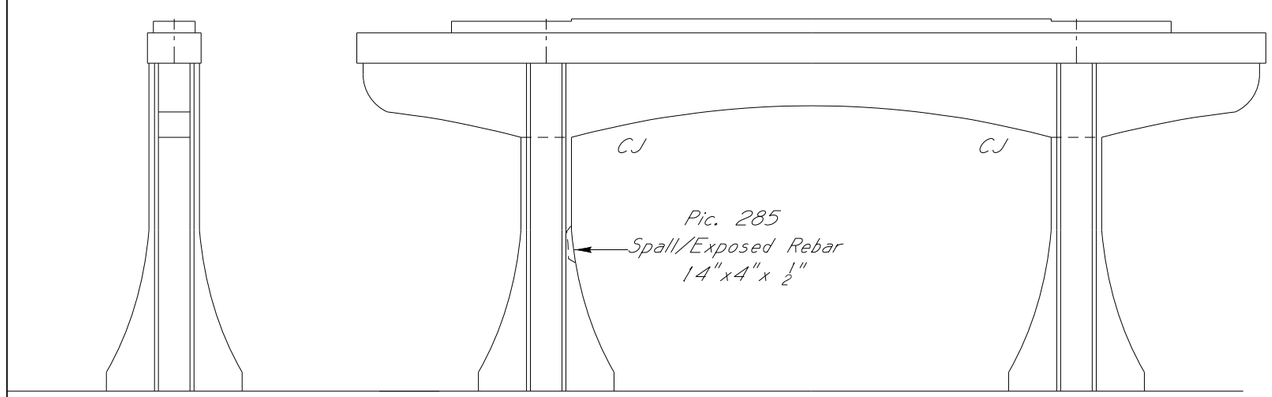
ELEVATION BENT 19

Member	Comments	Photo No.	Looking
Bent 19	Overall Picture of Bent 19	286	W
N. Col.	Spall/Exposed Rebar South Face 14"x4"x ½"	285	N

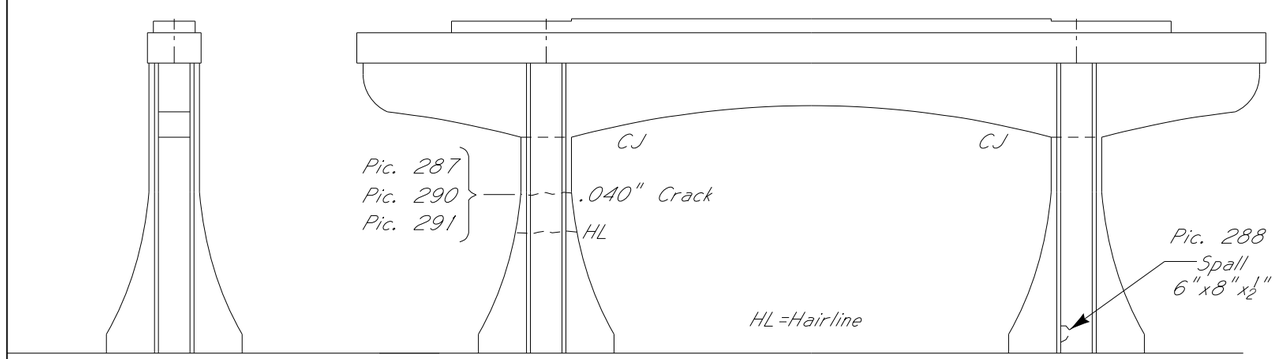
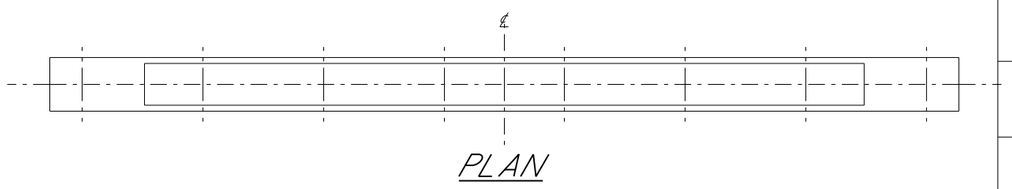
ELEVATION BENT 20

Member	Comments	Photo No.	Looking
Bent 20	Overall Picture of Bent 20	289	W
N. Col.	Crack Around East, South & North Face	287 290 291	NW
S. Col.	Spall East Face/ 6"x8"x ½"	288	W

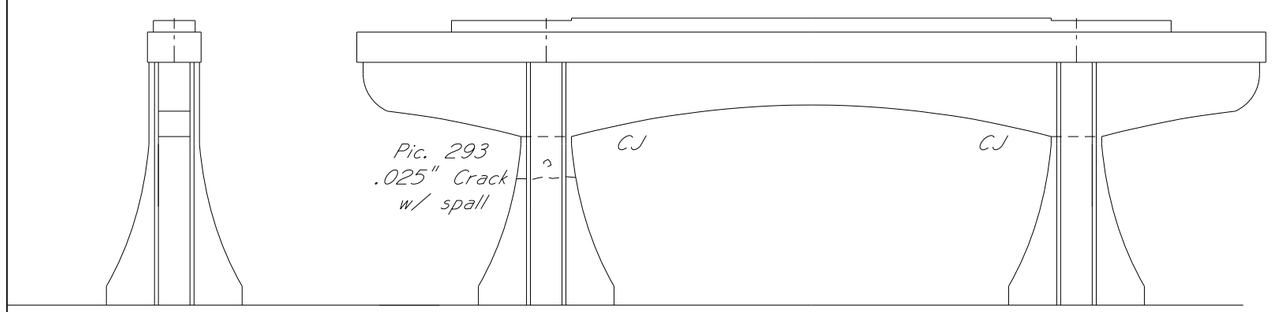
ELEVATION BENT 21

Member	Comments	Photo No.	Looking
Bent 21	Overall Picture of Bent 21	292	E
N. Col.	East Face Spall/Crack	293	W
