RETAINING WALL ELEVATION - NORTH SIDE

RETAINING WALL ELEVATION - SOUTH SIDE

EAST APPROACH RETAINING WALLS

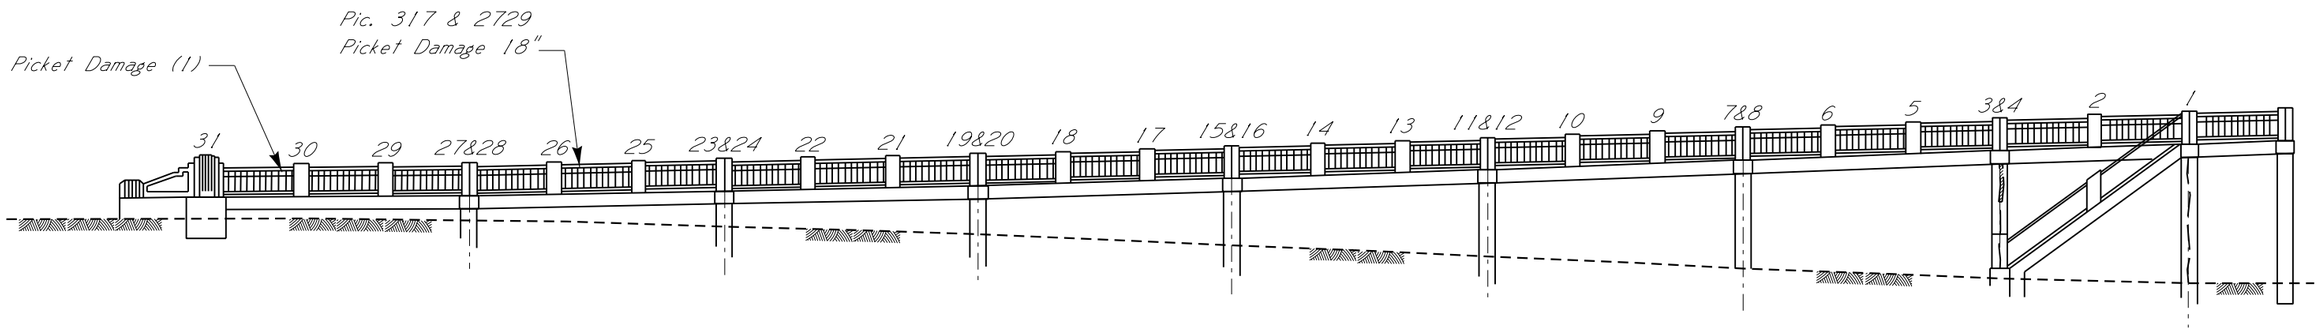
Member	Comments	Photo No.	Looking
Post 1	No damage @ post - Cracking in outside stair retaining wall joint - 2"x4"x14'	313	S
Post 2	Minor cracking in top of post		
Post 3 & Post 4	No damage @ post - cracking and large spall area with exposed rebar near top of wall - 6"x7"x4'	314 315	S S
	No damage @ post - heavy cracking w/ large potential spall area near bottom of wall - 6"x7"x6'	316	S
	1½" horiz. wall misalignment for full wall height and posts; Post 4 and east wall have shifted 1½" north		
Post 5	No damage		
Post 6	No damage		
Post 7 & Post 8	No damage	2721	W
	Cracking in south and east sides near bottom rail connection		
Post 9	Old repair at top NW corner; cracking at west side top and bottom rail connections	2722 2723	E E
Post 10	Minor cracking in top of post		
Post 11 & Post 12	No damage		
	No damage		
Post 13	No damage		
Post 14	No damage		
Post 15 & Post 16	No damage		
	No damage

Member	Comments	Photo No.	Looking
Post 17	Minor cracking in top of post		
Post 18	Minor cracking in top of post		
Post 19 & Post 20	No damage	2724	W
	Post is leaning approx. 1" north at top with a gap between the post and sidewalk on the south side		
Post 21	Cracking in top and on west and south sides near top rail connection	2725	E
Post 22	Old spall with exposed rebar at east top rail connection	2726	W
Post 23 & Post 24	No damage	2727 319	W S
	Minor cracking on east side near top rail connection; heavy cracking with spalling on east side near bottom rail connection		
Post 25	Crack with minor spalling in top NW corner extending thru west top rail connection	2728 318	E S
Post 26	Minor cracking in top of post		
Post 27 & Post 28	No damage		
	Minor cracking in top of post		
Post 29	Minor cracking in top of post		
Post 30	Heavy previous damage at bottom with poor repair on south side; cracking at both bottom rail connections; minor cracking in top of post	2730 2731	NE NW

Post 31	No damage		
Steel Rail	Picket damage 18" (3 pickets)	317 2729	S N
Steel Rail	Picket damage (1 picket)

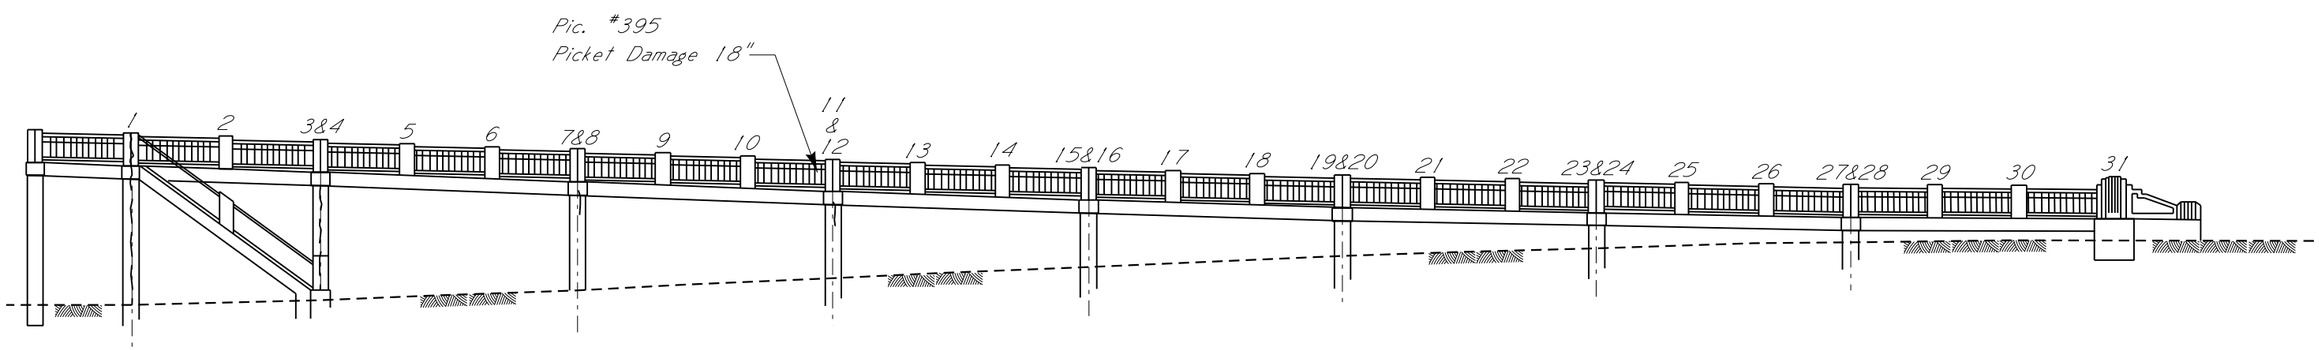
Member	Comments	Photo No.	Looking
Post 1	Widespread cracking on inside stair wall post; large spall on bottom NE corner with exposed rebar	242 394	SW S
	Widespread cracking on inside stair wall post; large spall on bottom SE corner with exposed rebar	243	NW
	Crack in outside stair retaining wall - 3"x4"x12'	309	N
	2½" horizontal wall misalignment at outside stair wall for full wall height and posts		
Post 2	Small crack in top of post		
Post 3 & Post 4	3" horiz. wall misalignment for full wall height and posts; Post 4 and east wall have shifted 3" south		
	Vertical crack/spall for full wall height - 3"x3"x10'	310	N
Post 5	Crack across top extends down north & south faces	2717	S
Post 6	No damage		
Post 7 & Post 8	No damage @ post - Cracking near top of wall - 2"x3"x2'	311	N
	No damage @ post - Spalling for most of wall height		
Post 9	No damage		
Post 10	No damage		
Post 11 & Post 12	No damage @ post - Cracking near top of wall - 2"x4"x2'	312	N

No damage @ post - Spalling near top of wall - 2"x4"x2'		
Post 13	No damage		
Post 14	No damage

Member	Comments	Photo No.	Looking
Post 15 & Post 16	No damage @ post - Cracking near top of wall - 2"x4"x2'	2719	N
	No damage @ post - Spalling near top of wall - 2"x4"x2'		
Post 17	No damage		
Post 18	Large crack across top extends down north & south faces; crack at east side top rail connection	246 396 2718	S S W
Post 19 & Post 20	No damage		
	No damage		
Post 21	No damage		
Post 22	No damage		
Post 23 & Post 24	No damage		
	No damage		
Post 25	No damage		
Post 26	No damage		
Post 27 & Post 28	No damage		
	No damage		
Post 29 Post 30	No damage		
Post 31	No damage		
Steel Rail	Picket damage 18" (3 pickets)	395	S
