Appendices for the Proposed Improvements to State Route 15 from County Road 312 to Vicinity of US 72

MDOT Project No. SDP-0022-04(053)V21 / 101633-001000

Hazardous Materials Technical Report

HAZARDOUS MATERIALS STUDY
ENVIRONMENTAL ASSESSMENT
SR 15
TIPPAH COUNTY, MISSISSIPPI

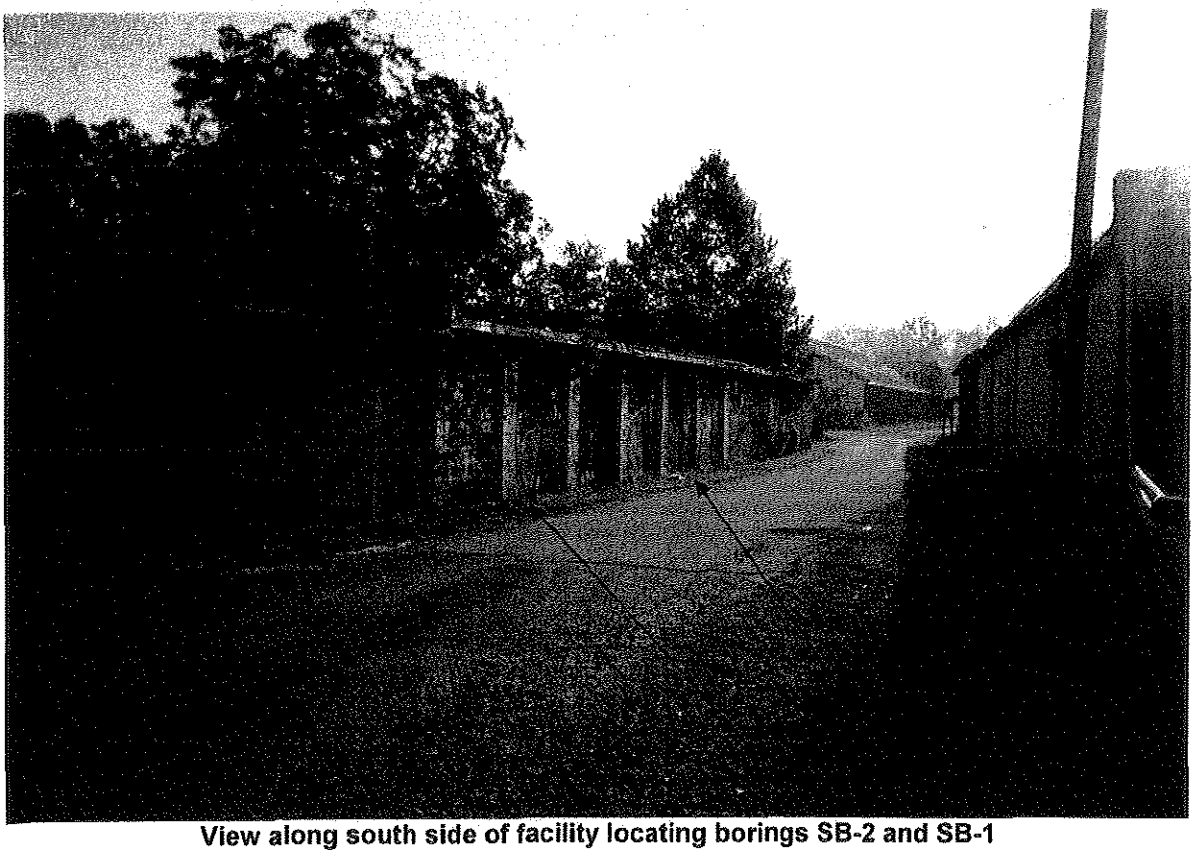
View along south side of facility locating borings SB-2 and SB-1

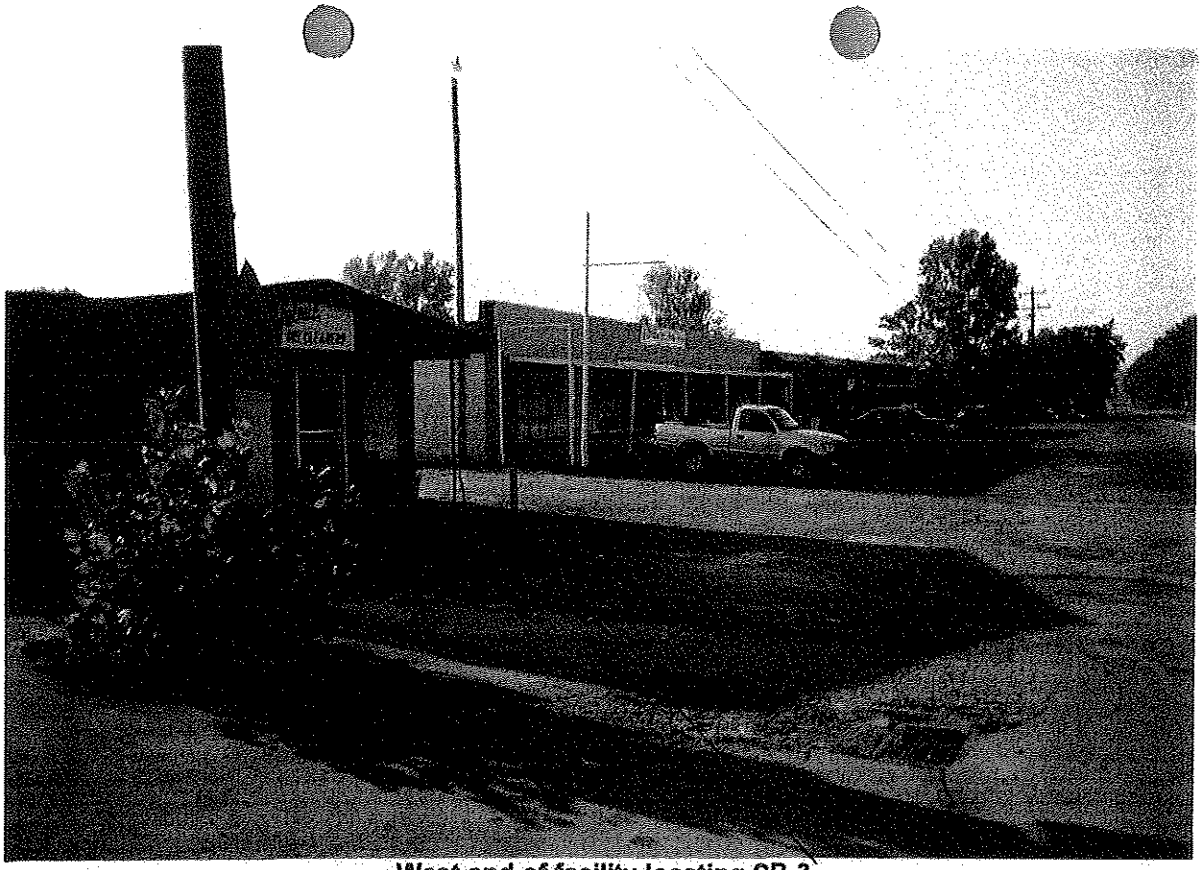
West end of facility locating SB-3

North side of facility locating borings SB-5 and SB-4

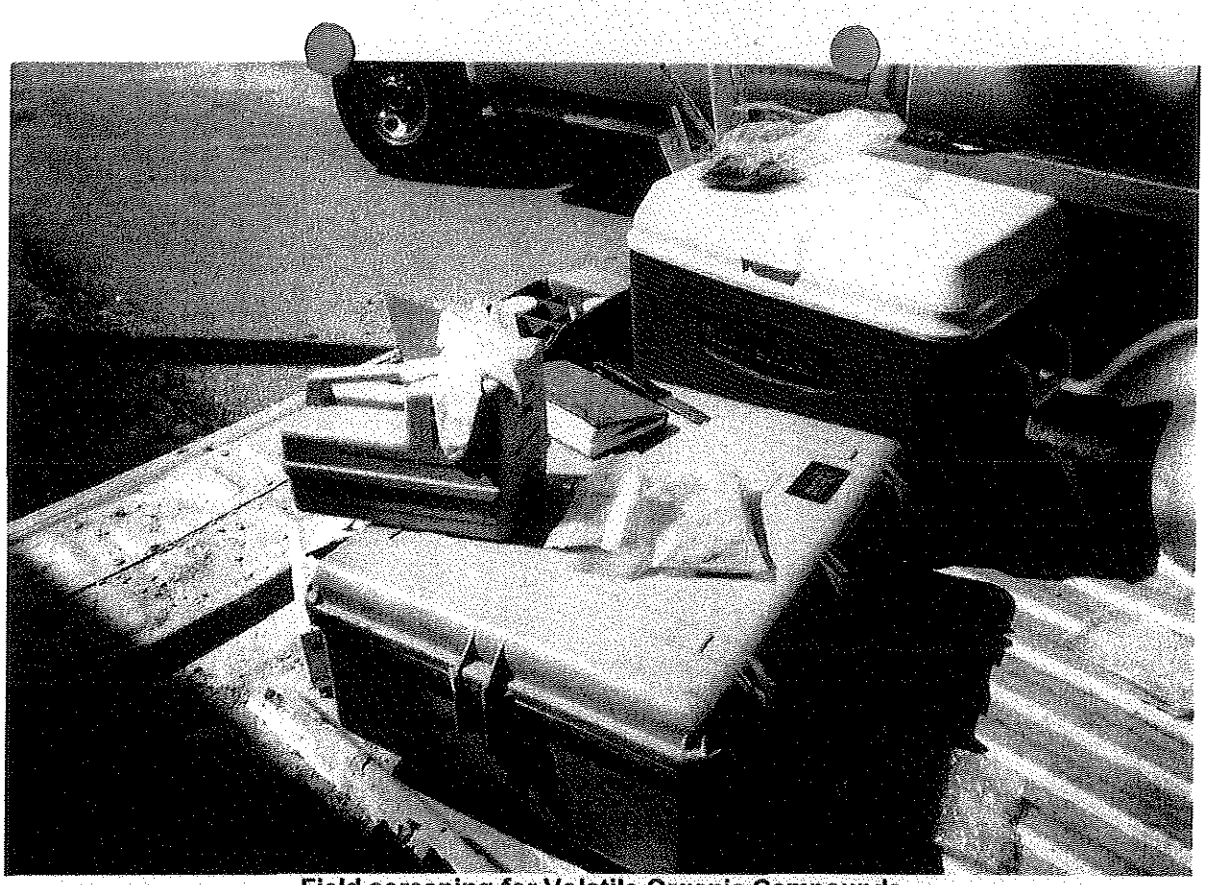
Field screening for Volatile Organic Compounds

Clayton Formation encountered in SB-2 at the interval 25 feet to 28 feet below ground level
